PROJECT 3 Northgate Street

DRAWING STATUS Listed Building Consent

DRG TITLE Section AA Roof Repair Details

JOB/DRG No. 496/503

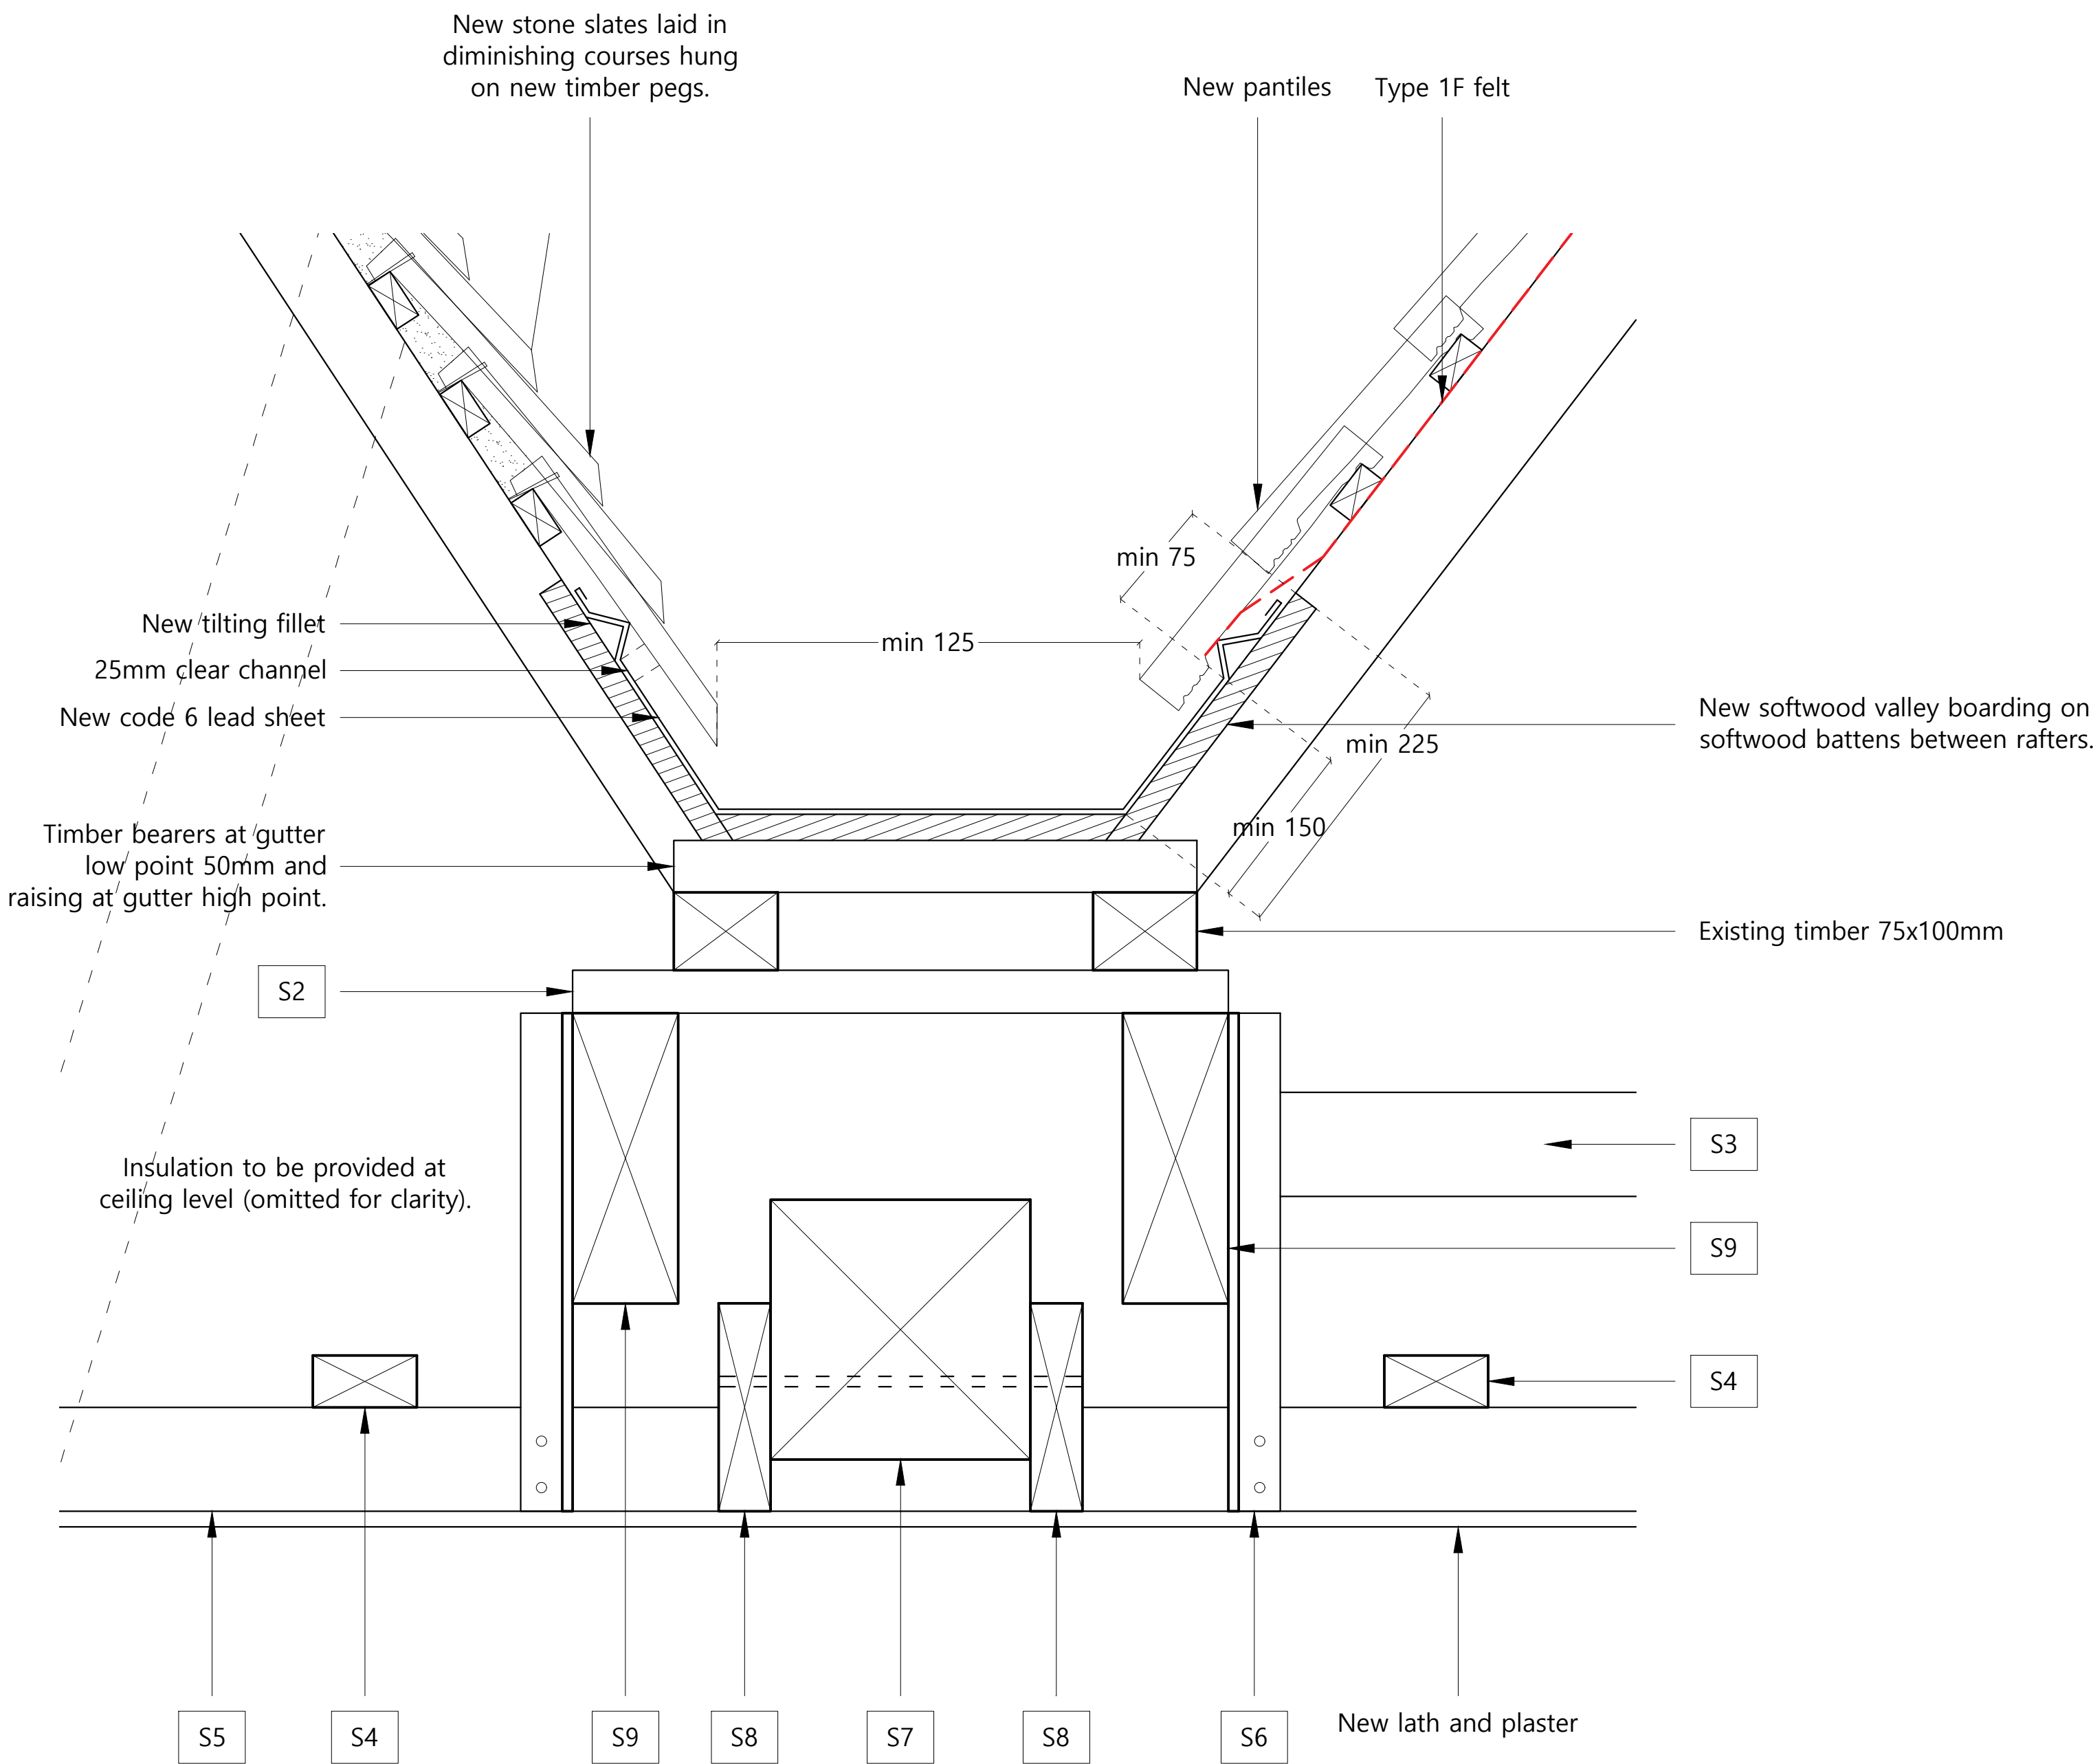
1.0 Lead Valley detail

Cross bears 20% charred. Replace charred to structural engineer's specification.
- S3

Install new tie between every third rafter fixing to 11x4" bearer by new plate or joist hanger, see structural engineer's details.
- S4

Install new 100x50mm binder to structural engineer's details.
- S5

Remove all ceiling joists and replace full length with 100x50mm joists at 400mm centres to tie eaves.
- S6

Install 2No. New angle section steels either side of every third ceiling joist to structural engineer's details.
- S7

Badly fire damaged beam at mid span to be kept in place and supported by existing 11x4" beams
- S8

200x50mm plates through bolted with M10 through bolt to structural engineer's details.
- S9

Retain existing 11x4" beam.
