**Customer Name:** David Brain Partnership

**Site Address:** Beacon Centre, Solar Way, Amesbury, SP4 7SZ

**Description:** Soakaway Investigation

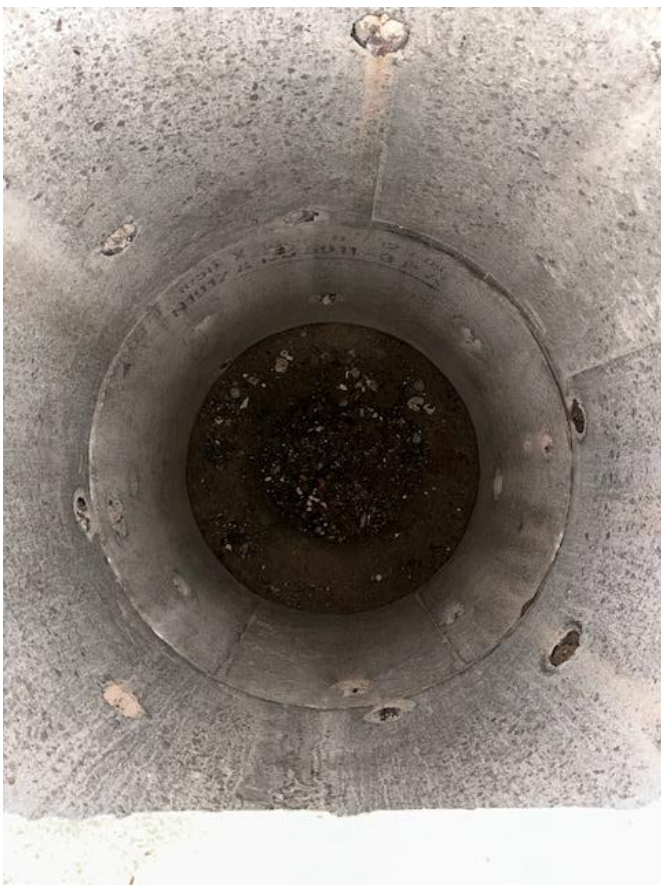
**SOAKAWAY COVER 3**

We attended site and located the soakaway access covers as shown on the plan. The soakaways are around 2.2m deep and constructed as concrete preformed chambers with preformed soakaway holes. The chambers are surround with clean granular stone. There is very minimal silt build up in the line and the chambers, and the soak aways are working efficiently. In the chambers you can see tide marks where the water is rising to before it soaks away and this is approximately 700mm deep, proving the soak aways are working well. We did not note any defects at the time of our survey.
