FRONT (SOUTH) ELEVATION

SIDE (EAST) ELEVATION

REAR (NORTH) ELEVATION

SIDE (WEST) ELEVATION

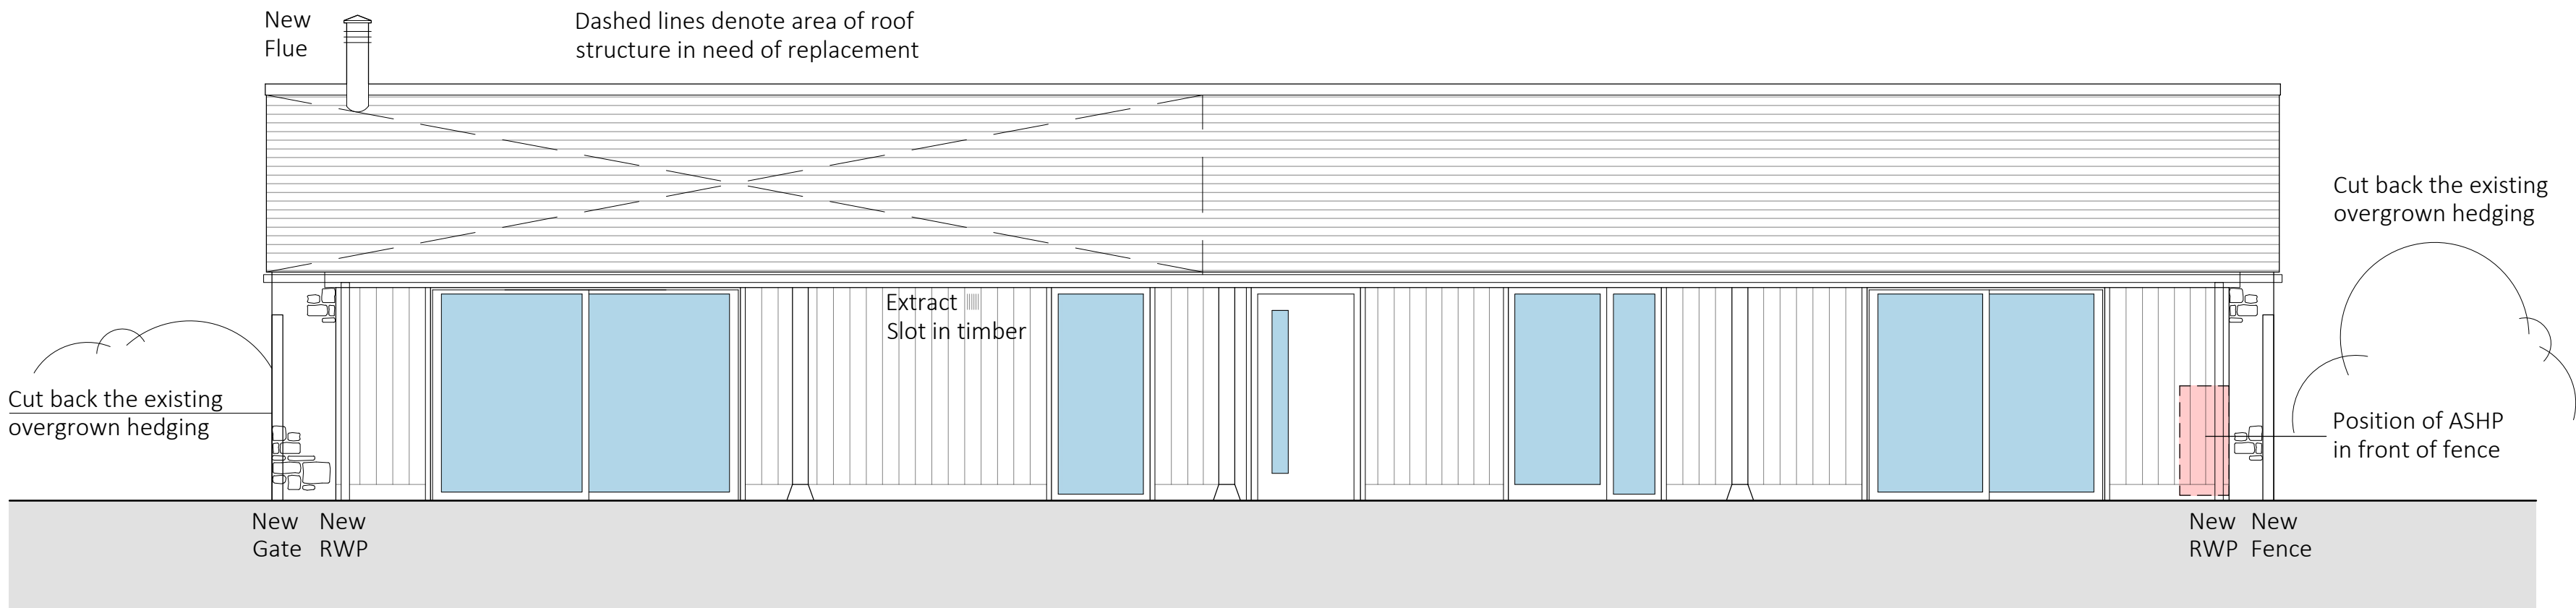
- Works to Existing Beams and Posts  
Existing timber beams and posts to be retained with repairs and strengthening works carried out as required
- New Infill Walls to Front (South) Elevation  
New infill walls to be formed in timber and to be finished externally using square edge vertical timber Cladding. Cladding to be set back approx. 150m from outer face of existing timber posts
- New External Widows and Doors  
All new windows and doors to be in polyester powder coated aluminum, dark grey in colour

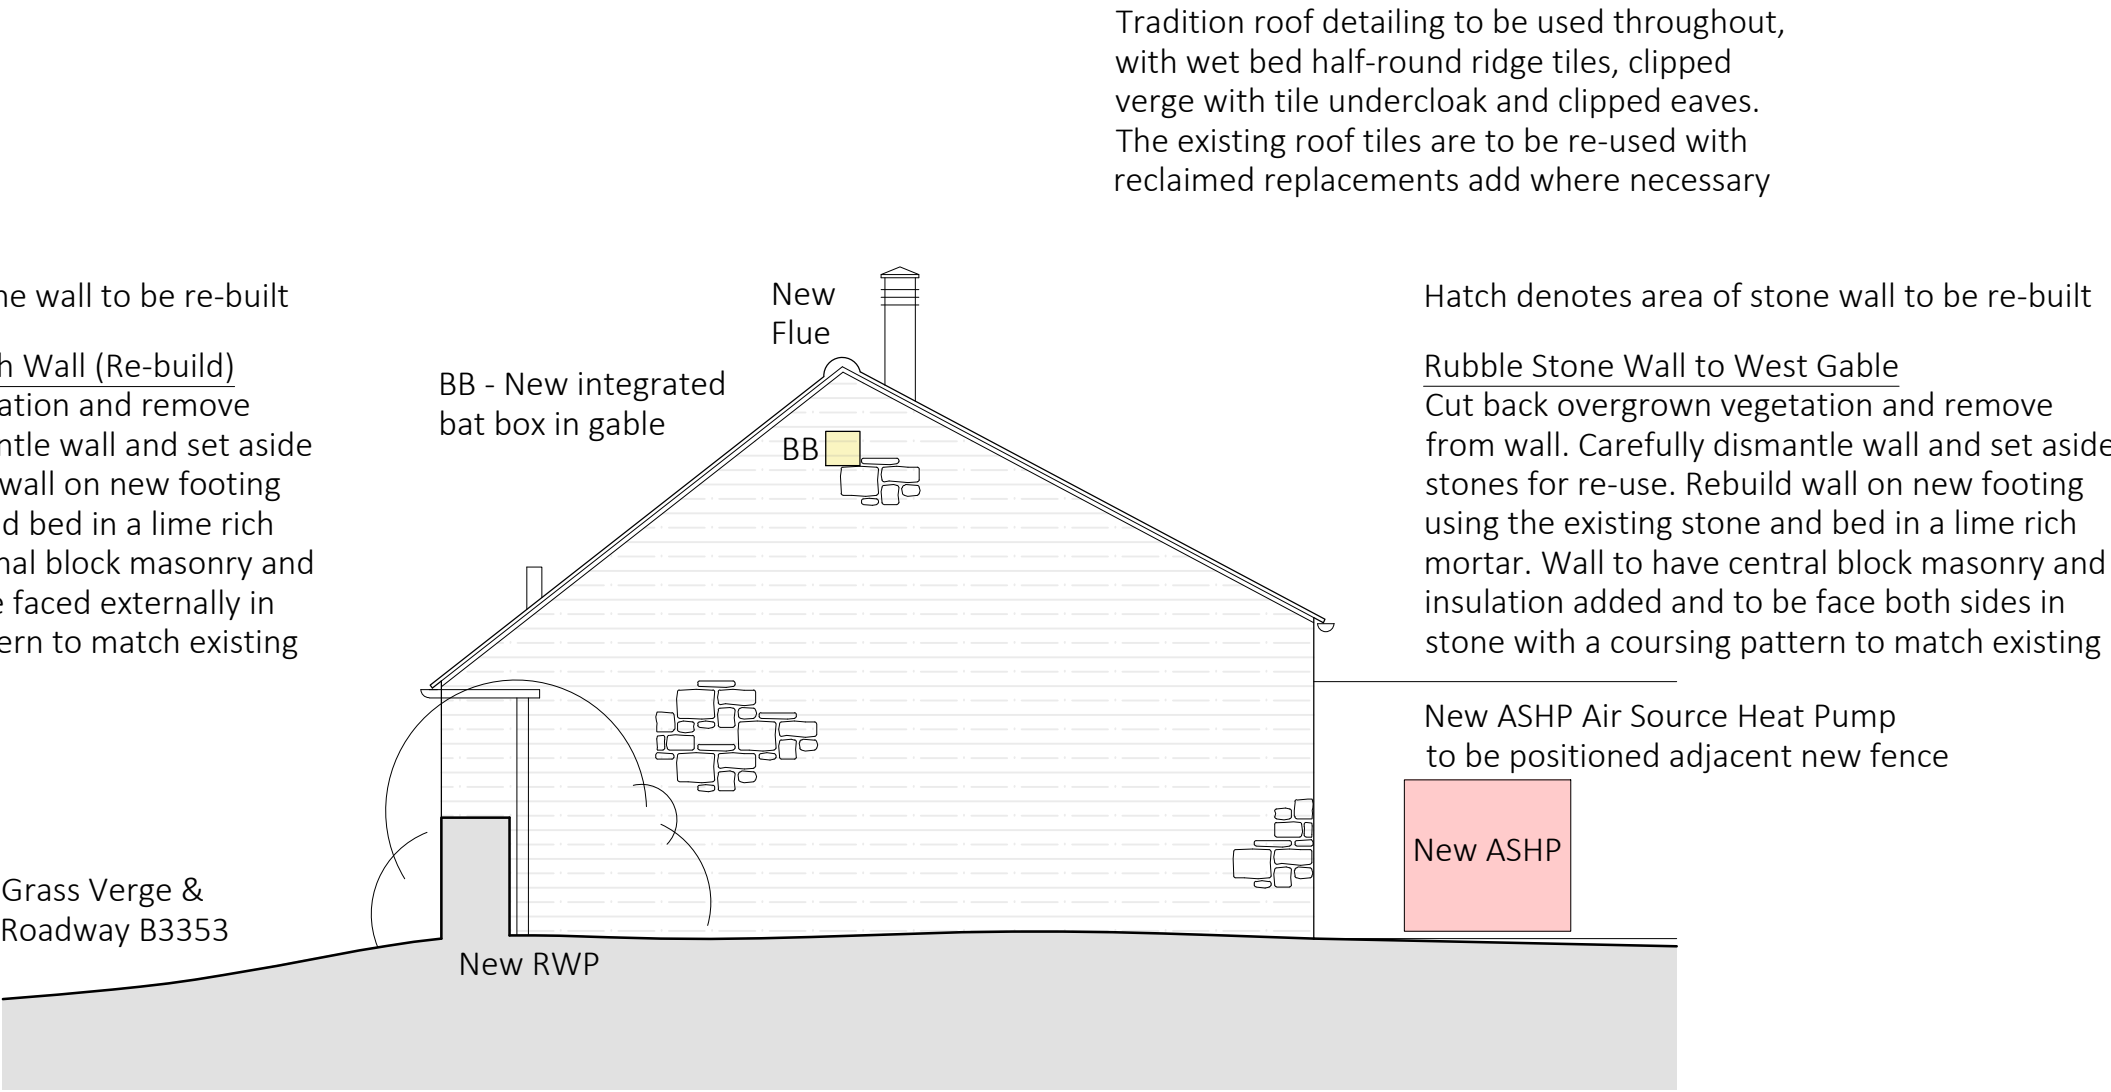
Ecological Enhancements  
BB on Elevation - New integrated Bat Box  
2No. one on each gable

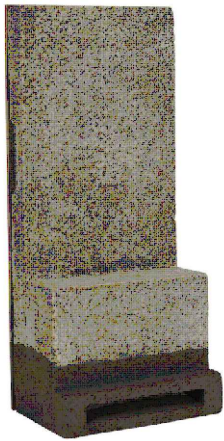
Bat box image on the right.  
'Verona Built-in Woodstone Bat Box'  
<https://www.wildcare.co.uk/vivara-verona-built-in.html>

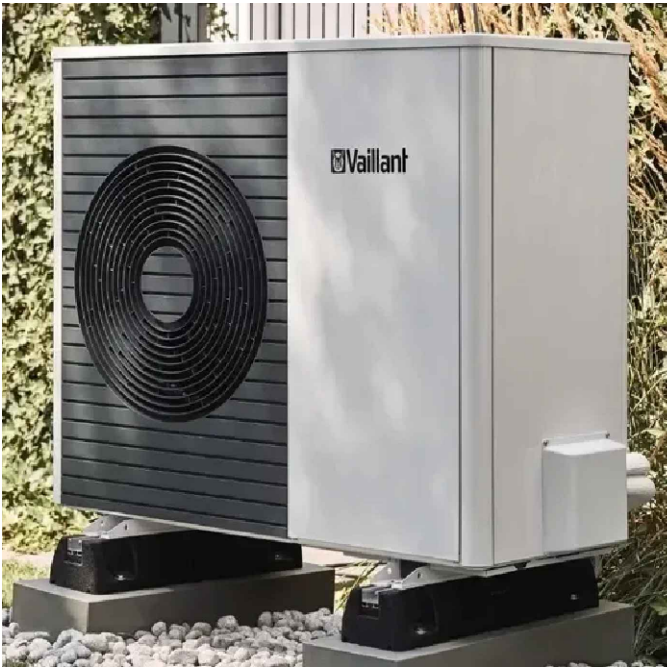
Notes on ASHP - Air Source Heat Pump

Image of a typical Air Source Heat Pump for a medium size property. The exact specification and model is currently unknown. Select of product is dependant on future M&E design and the detail of any green energy grants available at the time of installation. Approximate dimensions based on the above model; 965mm(h) x1100mm(w) x450mm(d)
