## Heritage and Planning Statement

**Site Address:**  
66 Frome Road,  
Trowbridge,  
BA14 0DG

**Proposal:** Retrospective application to regularise external render and slate roof, along with Proposed dropped kerb to facilitate two off-street parking bays.

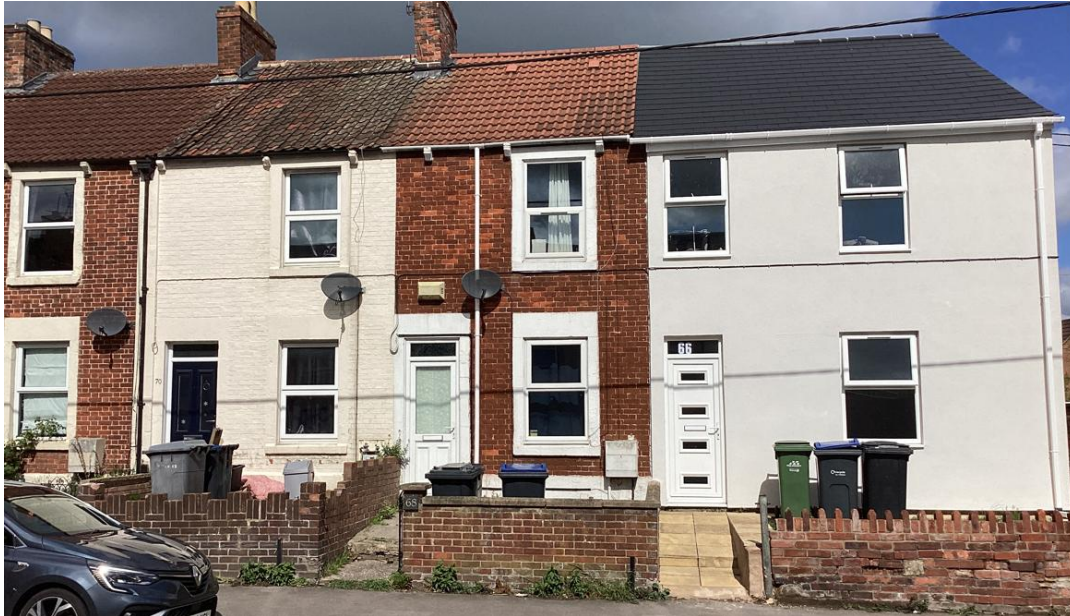
1. No 66, 68 and 70 Frome Road: Showing Render of 66 and Paint of 70 Frome Rd

- **Contextual Justification:** Frome Road is defined by a rhythmic variety of rendered and painted frontages.
  - **Direct Precedents:** Nos. 60, 62, and 64 feature prominent coloured render finishes. No. 90 likewise utilizes a coloured render.
  - **Textural Consistency:** Nos. 70, 80, 88, 92, 94, and 96 all benefit from painted masonry.
- **Heritage Impact:** By selecting a white silicone render, the proposal utilizes a "neutralizing" aesthetic. This crisp, clean finish acts as a visual "anchor" within the terrace, bridging the gap between more vibrantly coloured neighbours. It replaces a dilapidated and stained facade with a high-quality finish that enhances the overall cleanliness and order of the Conservation Area.

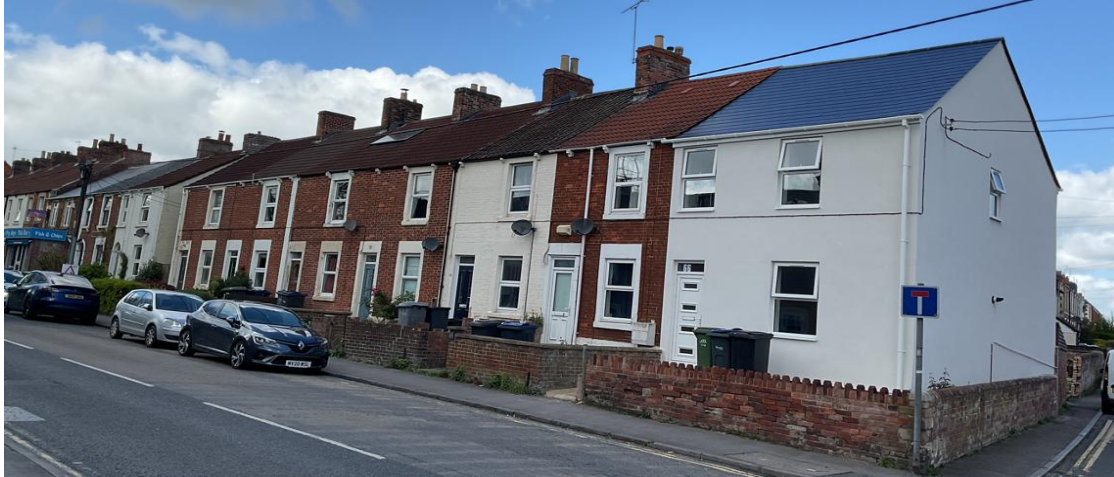
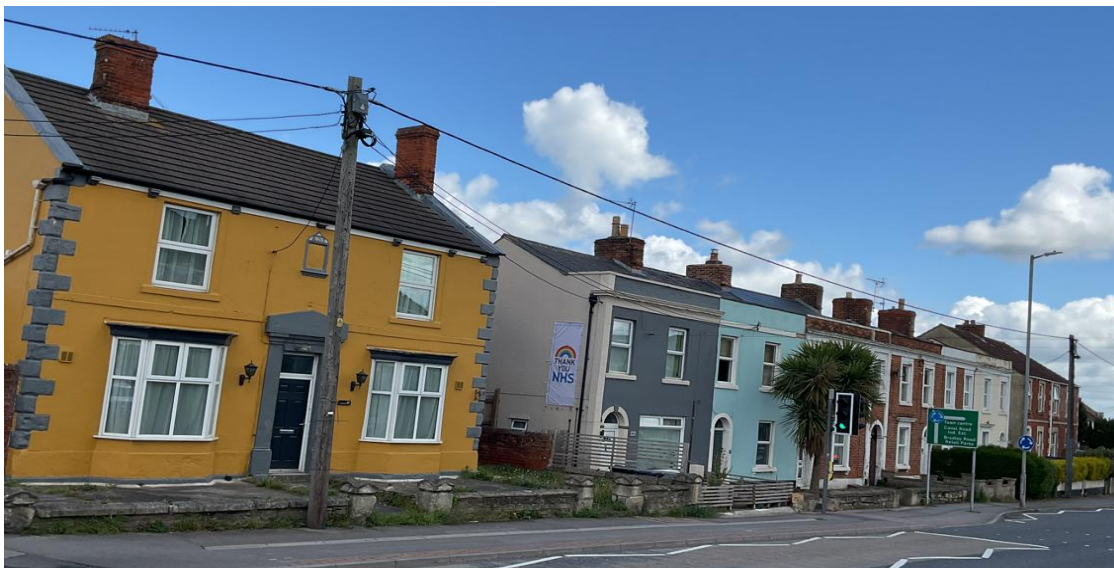
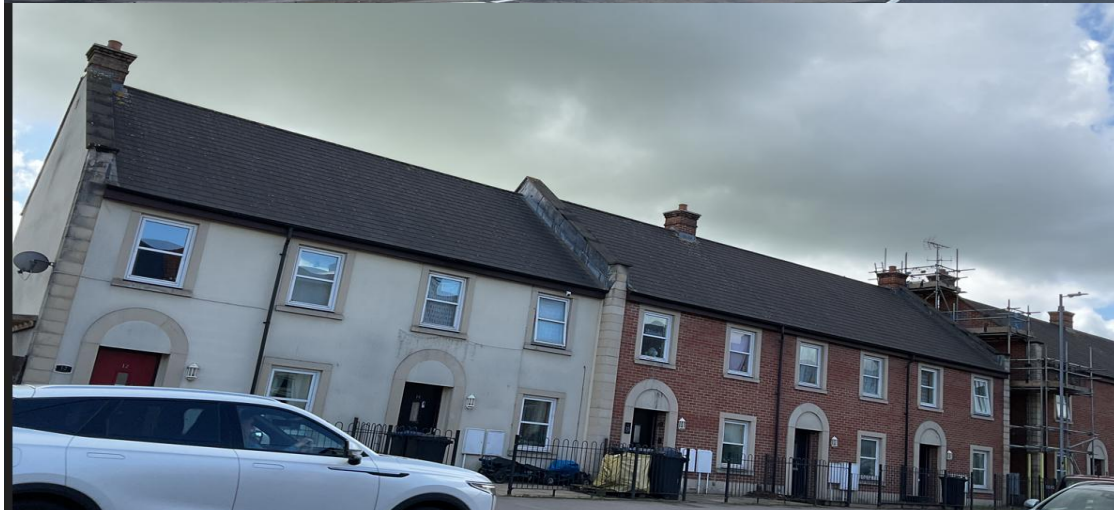
3. Terraces showing no 66-96 Frome Road, 52-62 Frome Rd, 64 and 12, 14, 15, 16, 17, 19, 20, and 22 Frome road  
Street Scene showing Different coloured façade and roof of neighbouring properties.

- **Material Authenticity:** Slate is a high-status, traditional material integral to the Trowbridge historic vernacular. Its reintroduction replaces failing materials with a medium that is historically appropriate for this period of terrace.
- **Visual Dialogue with the Streetscape:** Slate roofs are an established feature of the Frome Road skyline:
  - **Immediate Terrace:** Nos. 82, 84, and 62 all retain slate tiled roofs.
  - **Wider Context:** Directly opposite the site, a significant cluster of properties (Nos. 12, 14, 15, 16, 17, 19, 20, and 22) exhibit slate roofs.
- **Heritage Impact:** The use of slate provides a continuous visual link across the streetscape, reinforcing the historic silhouette of the terrace and demonstrating a clear commitment to traditional materiality.
