STREET (NORTH) ELEVATION - scale 1:50

SIDE (WEST) ELEVATION - scale 1:50

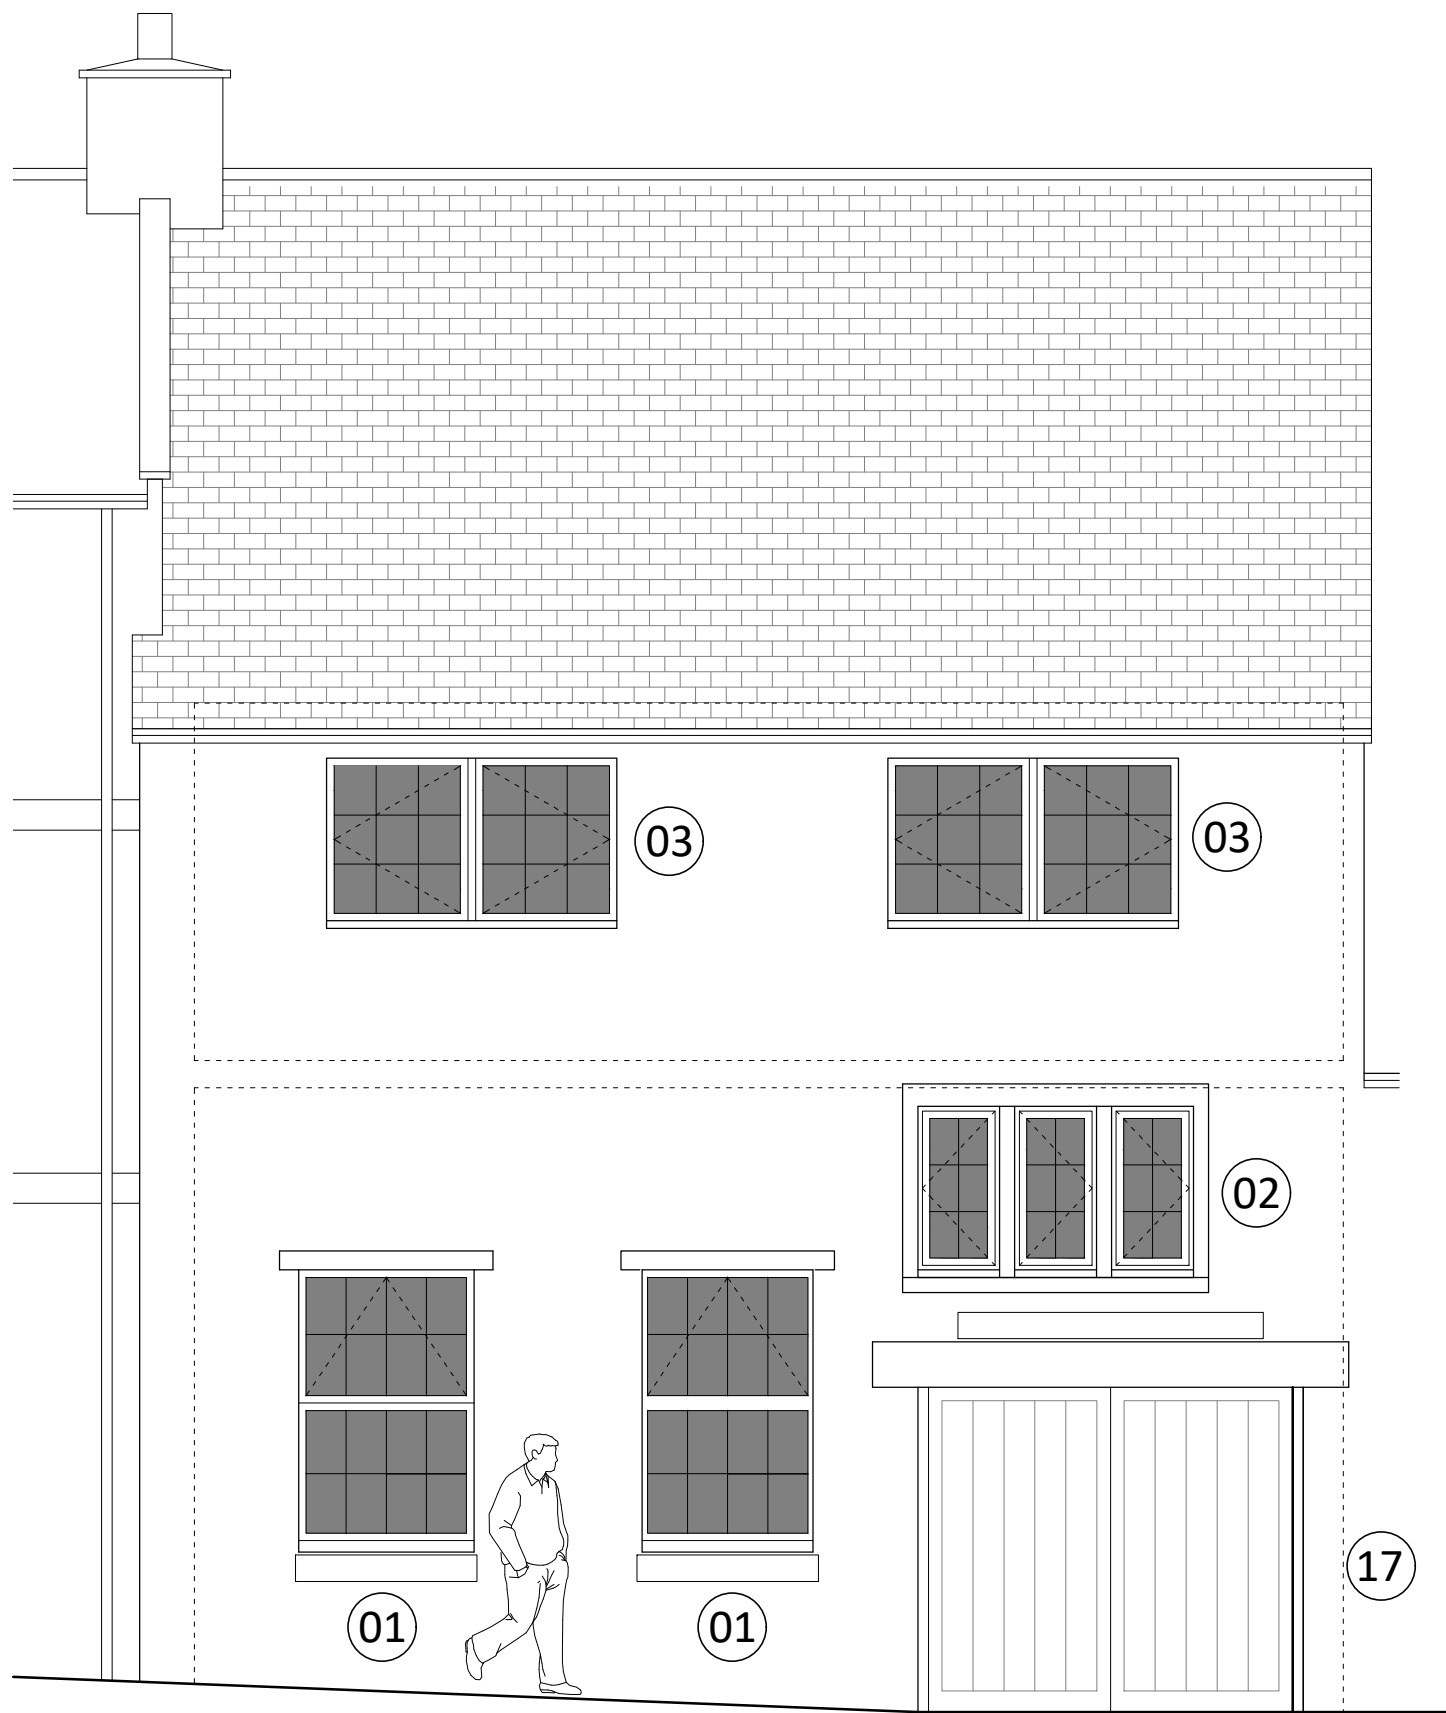
- 01 - Windows replaced with traditionally detailed 6 over 6 casement windows ,timber, painted white
- 02 - Modern windows replaced with traditionally detailed 6 part casement windows ,timber, painted white
- 03 - Modern windows replaced with traditionally detailed paired 9 part casement windows, timber, painted white
- 17 - Existing entry doors to be un-hung, stripped back, repaired and made ready for automation. all timber to be repainted along with all associated metalwork

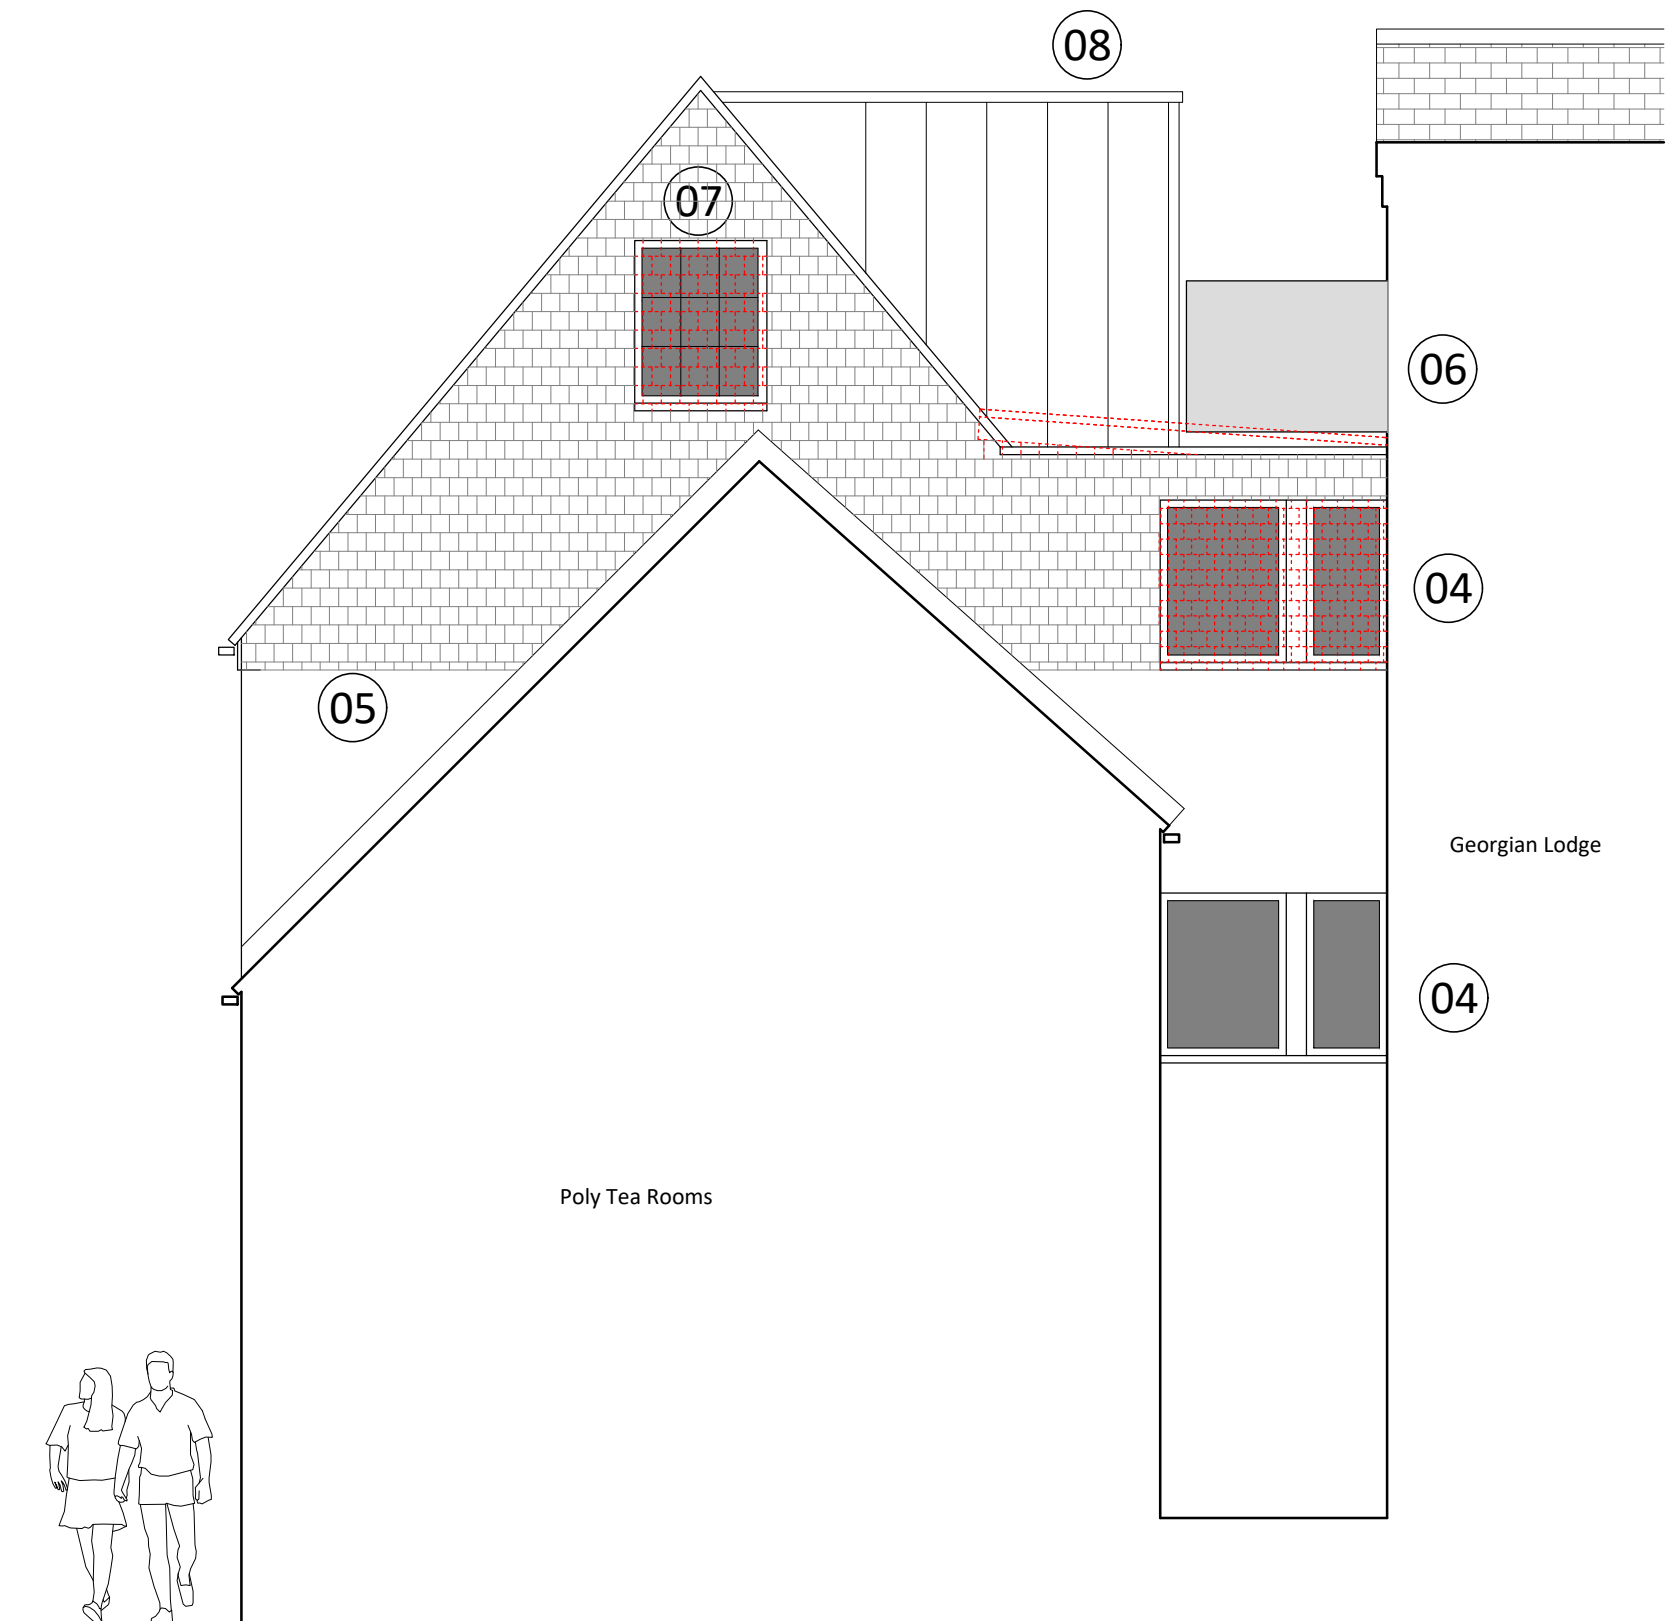
- 04 - Existing windows to be replaced - slim aluminium frames, colour tbc
- 05 - Existing tile hanging removed and timber framework below repaired and insulated. Overclad in new clay plain tiles
- 06 - Accessible roof terrace with balustrade surround (to detail)
- 07 - Create New window. Install traditionally detailed fixed casement window, timber, painted white.
- 08 - New timber frame dormer cheeks overclad in aluminum cladding
