### **Report Reference : Sash Windows May 2026 at Friarton, Semley, SP7 9AU.**

### Overview of all windows

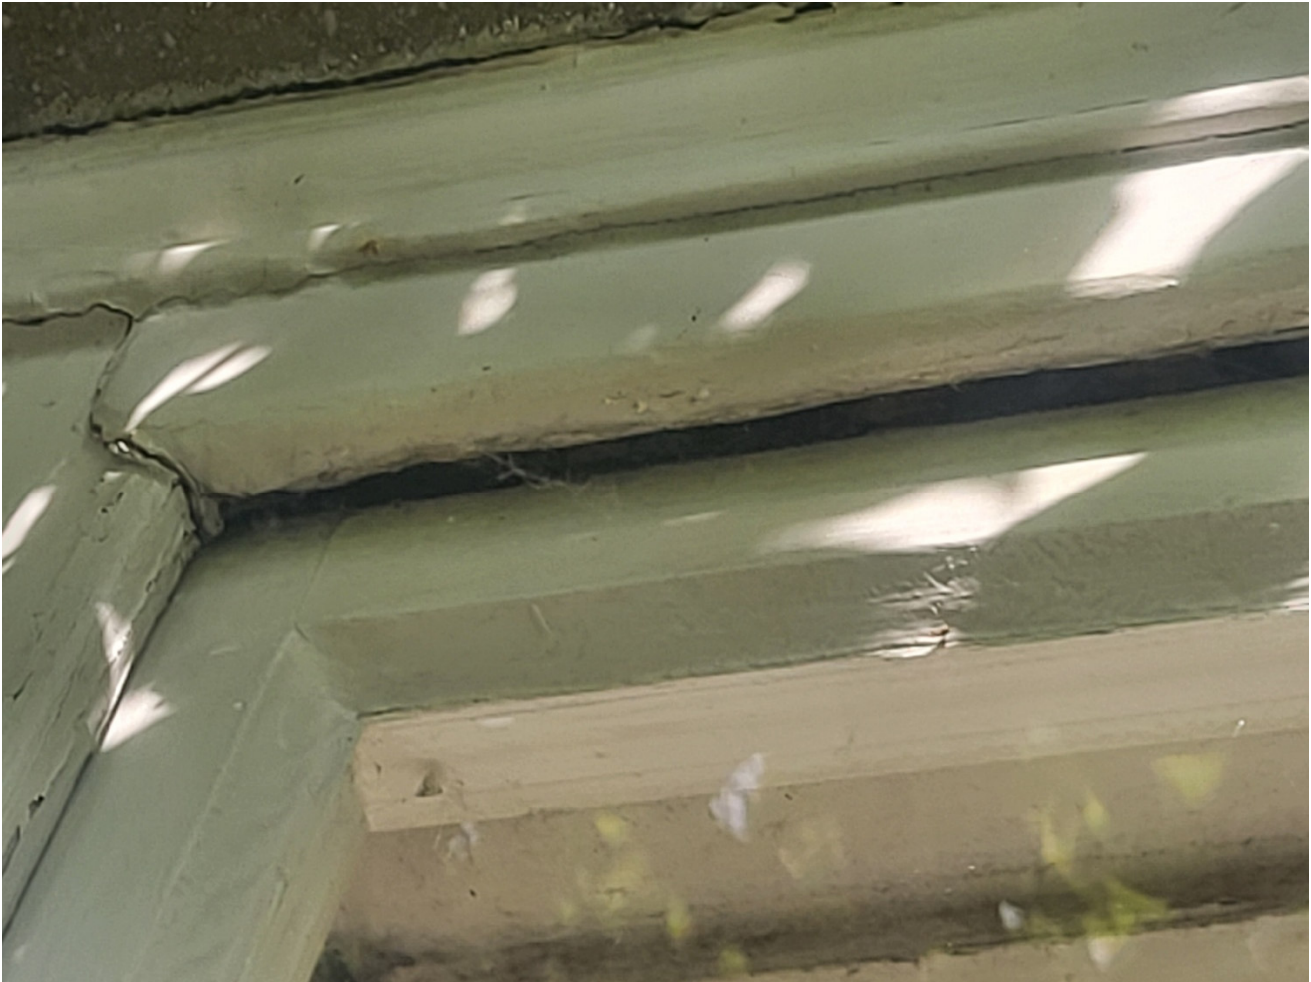
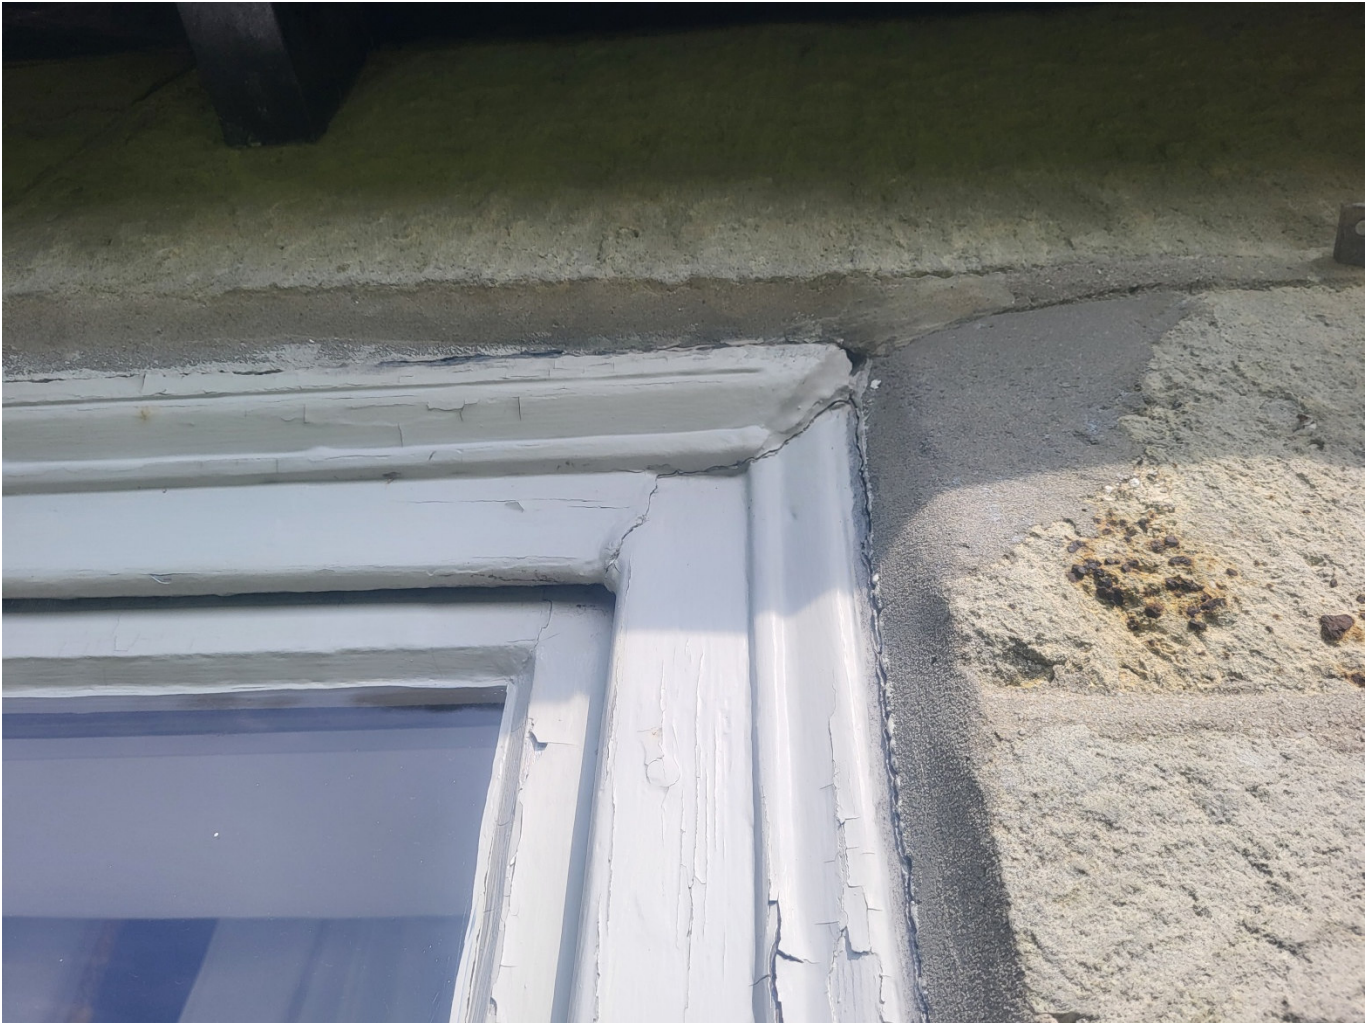
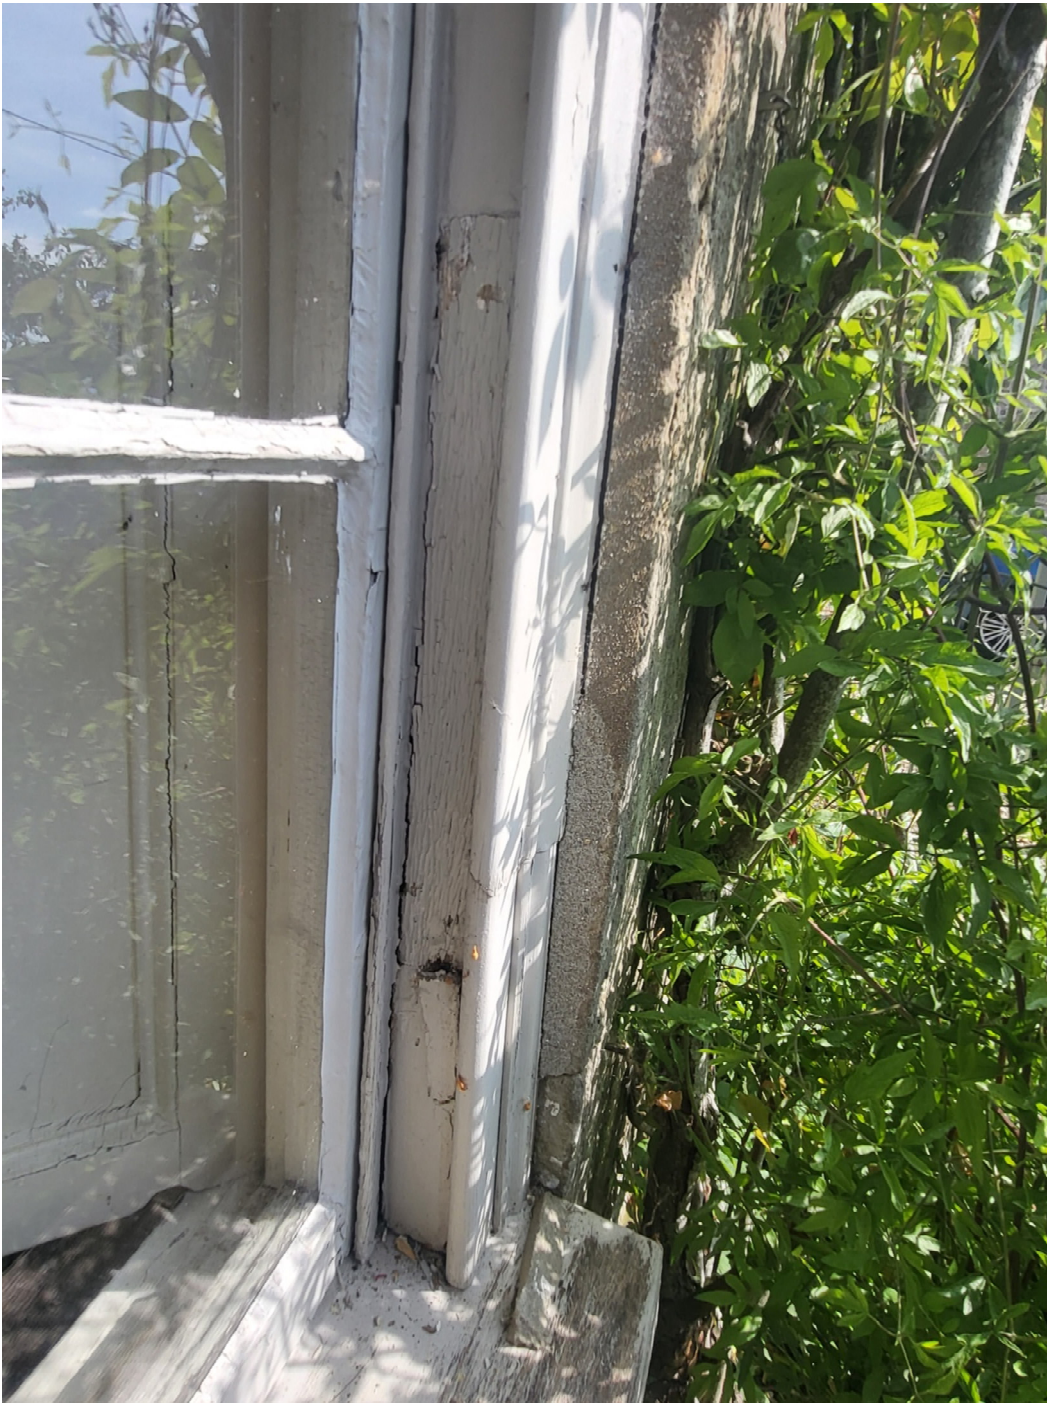
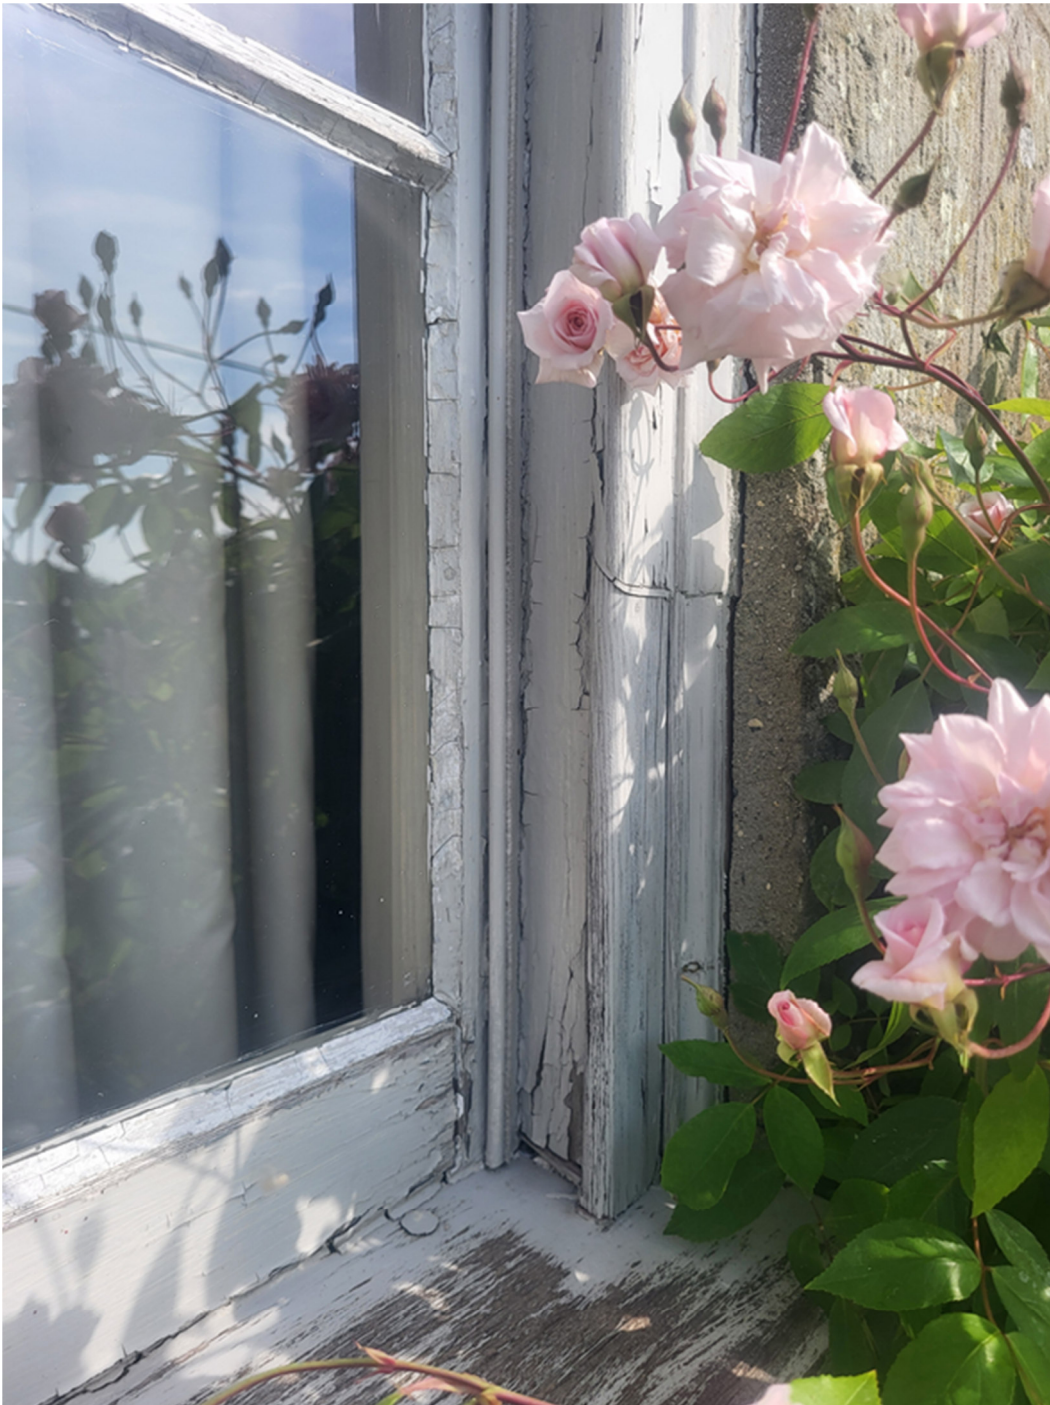
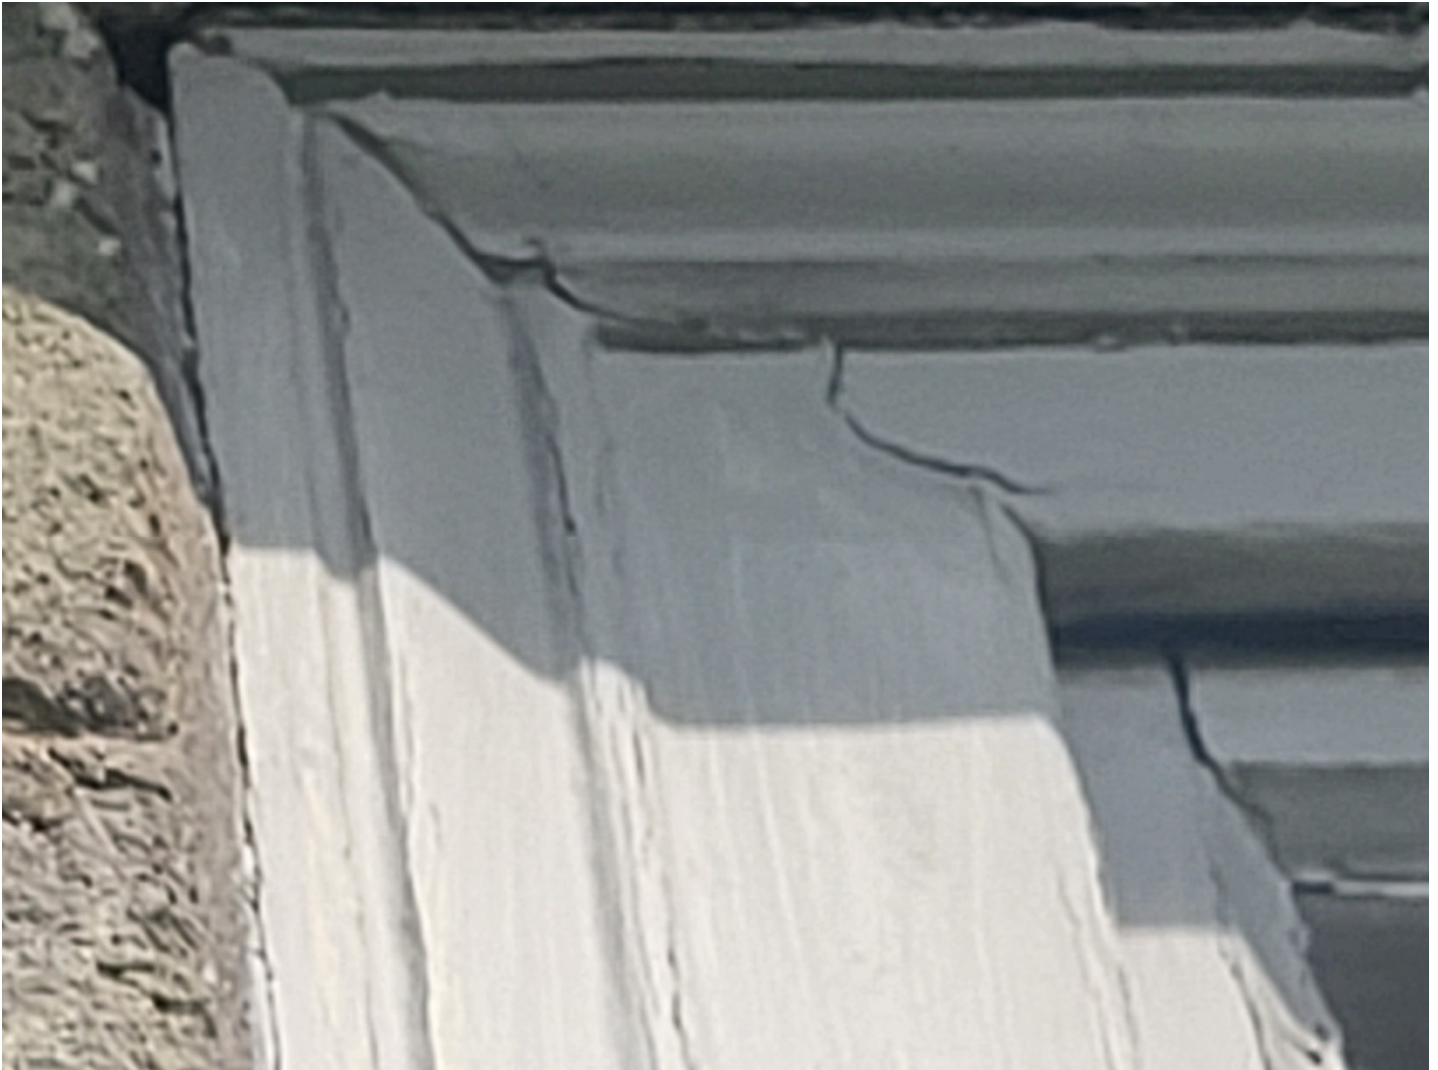
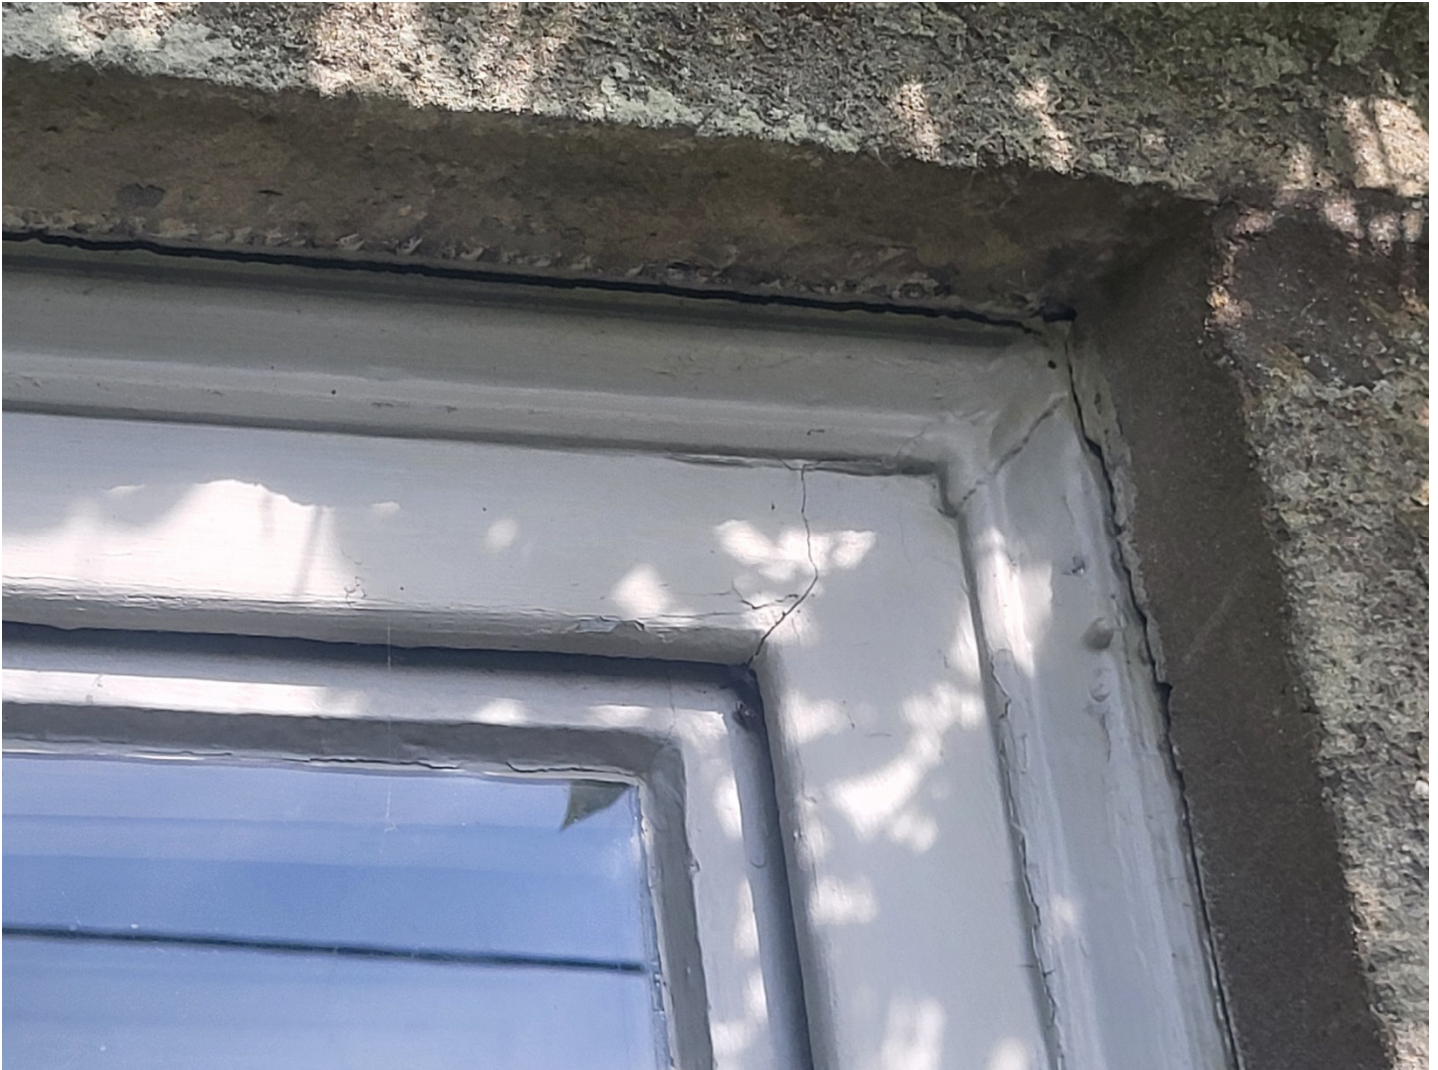
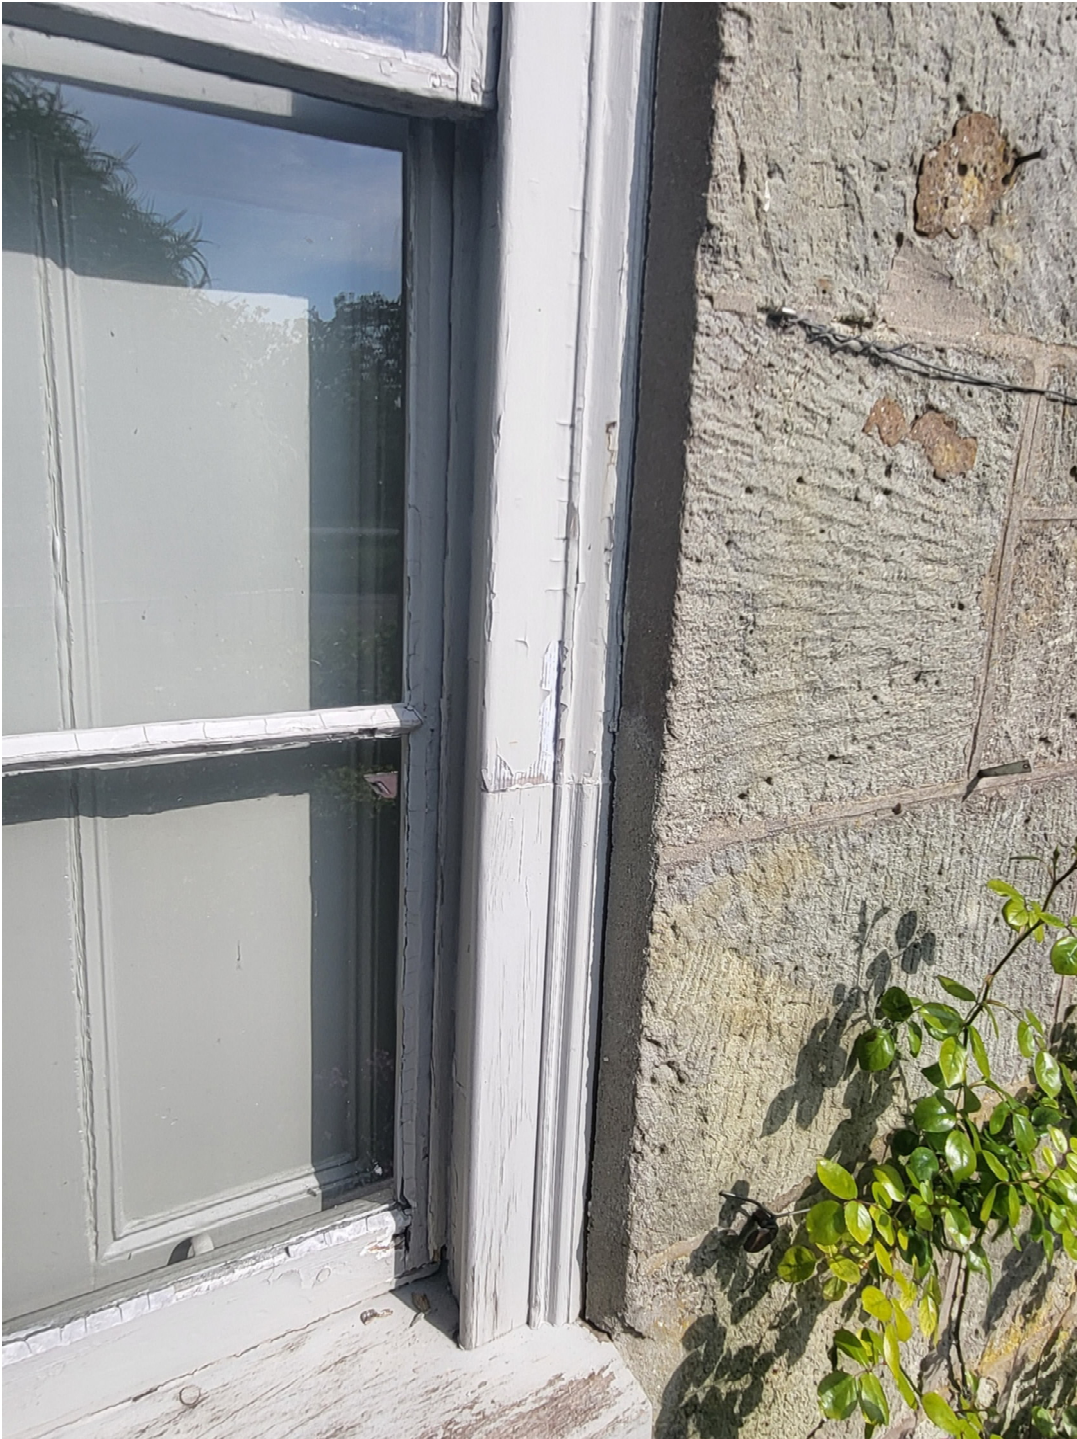
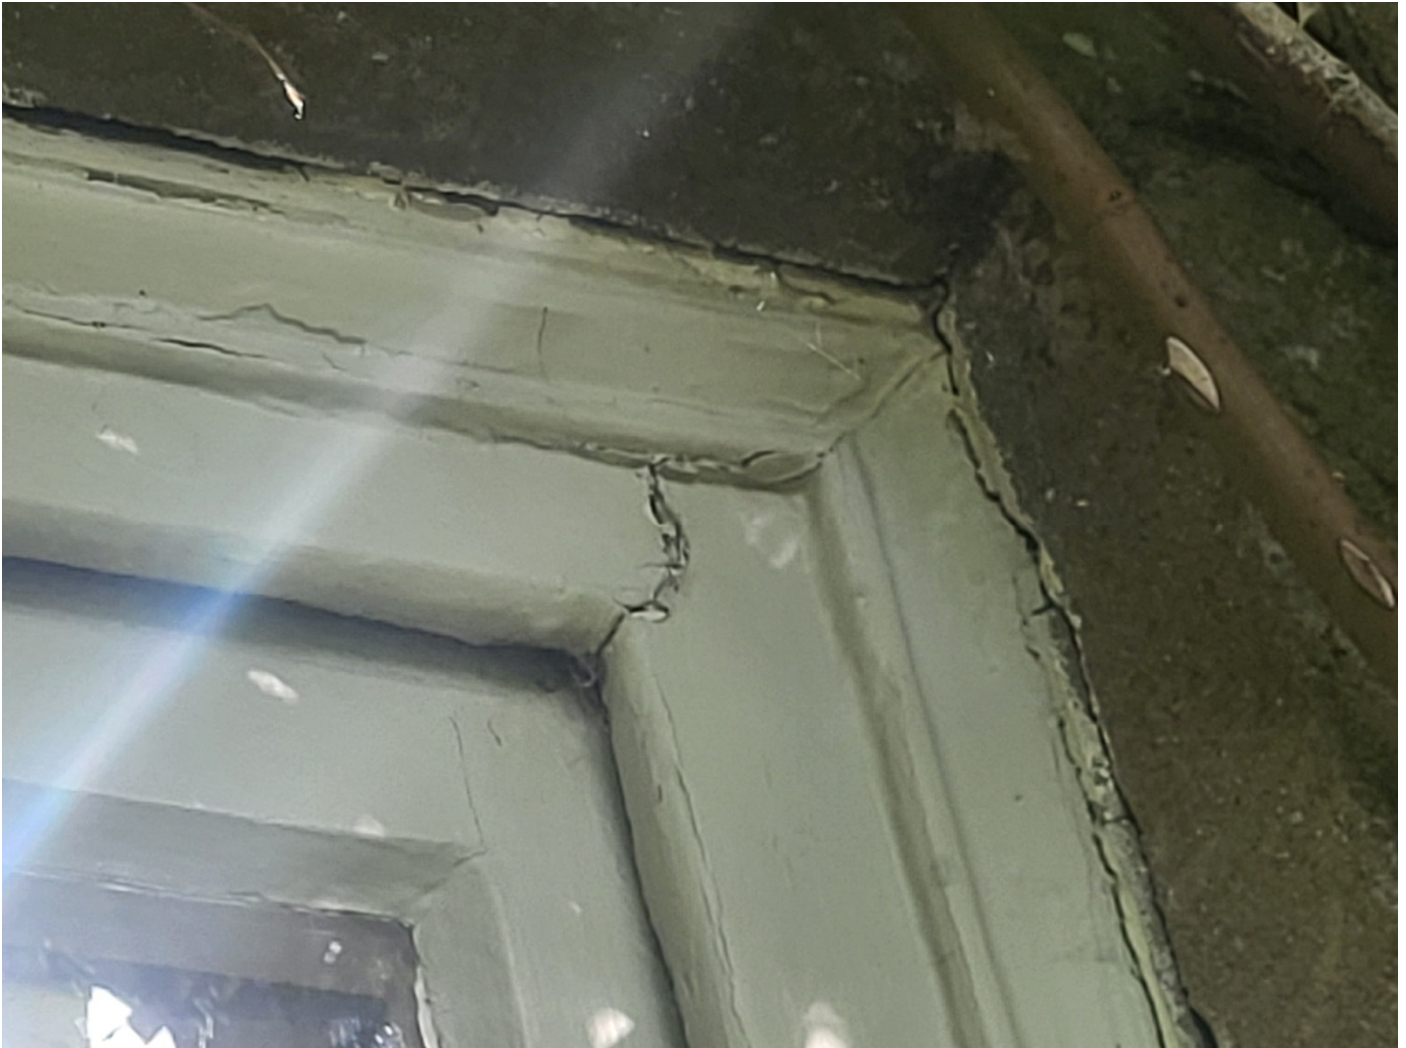
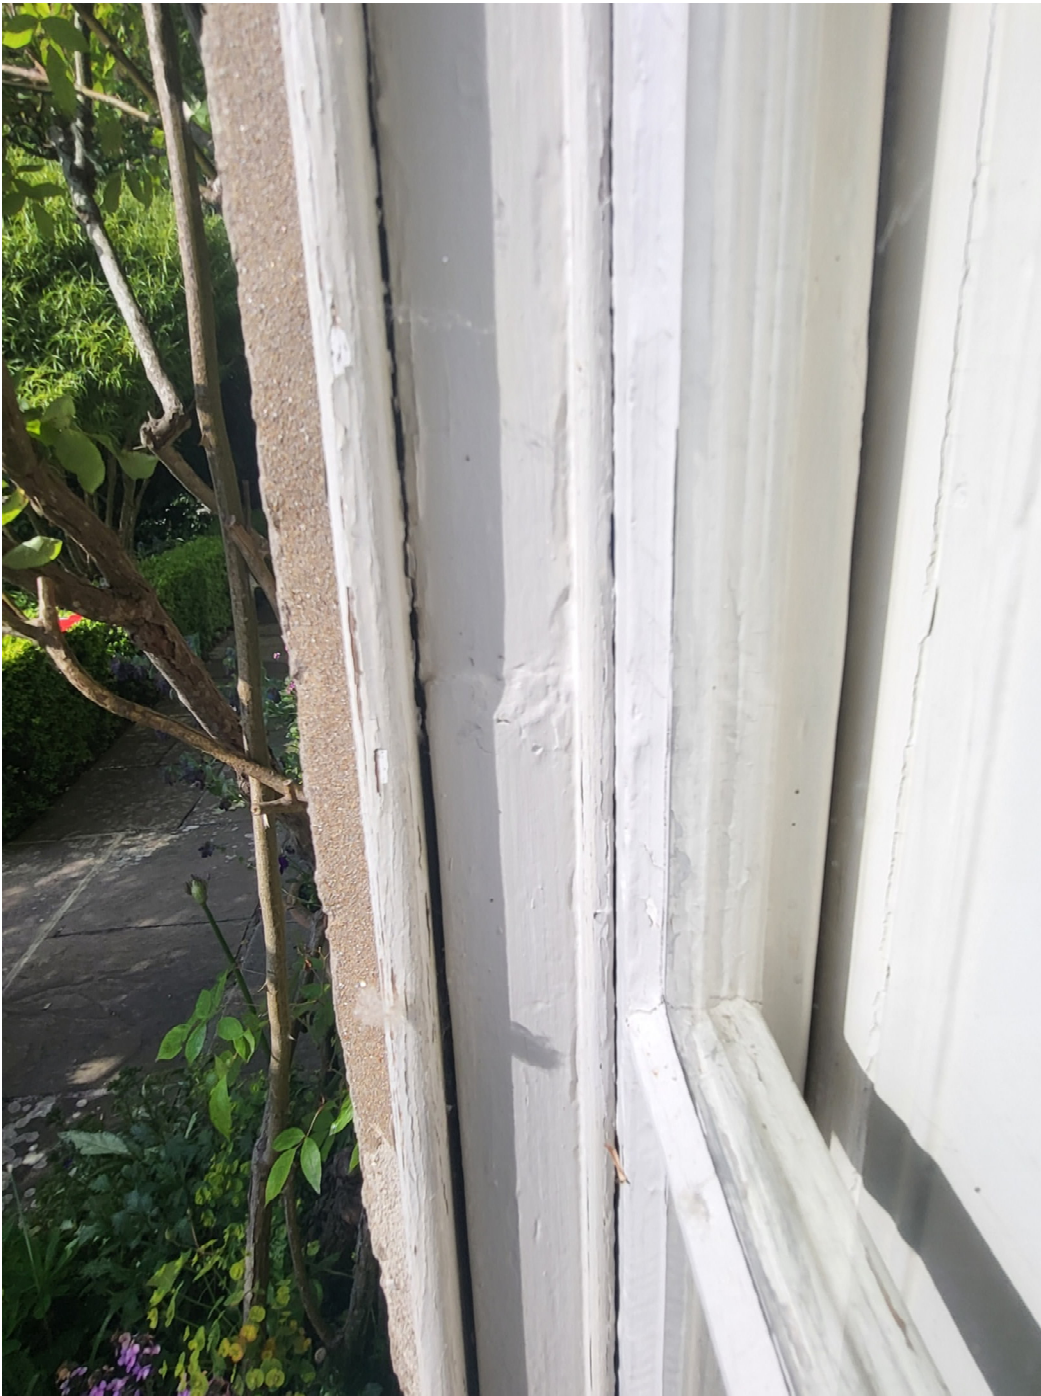
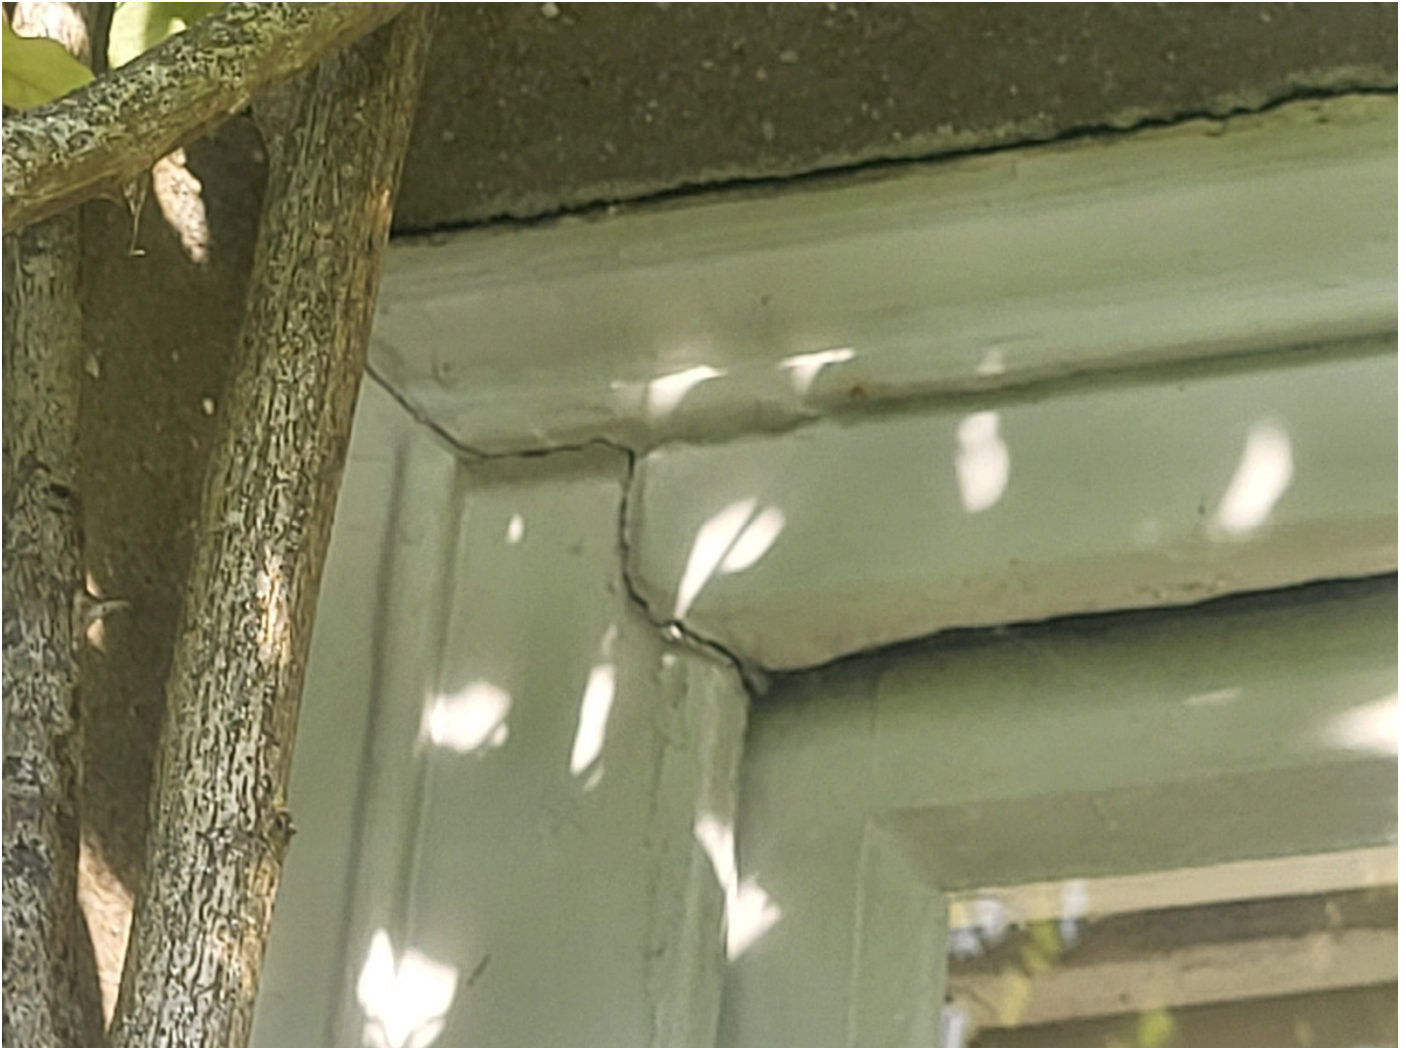
With all five sliding sash windows being situated on the front elevation and of the same age they are all subject to similar deterioration. The sashes have a considerable amount of putty missing or broken down. The joints on the heads, meeting rails and bottom rails tenoned into the sash stiles have rot and are failing, resulting in these sashes being unsafe to move.

The main boxes have all had repairs previously which have now deteriorated. As you can see by the photos the joints on the outer face of the boxes where the head and jambs intersect have broken down and are out of line. This means the sashes will not slide properly or seal when in their closed position. In my opinion the sashes and the boxes are beyond repair. The existing boxes are not fixed securely. If restoration work was attempted the existing boxes would not withstand the work needed.
