PROJECT  
**Manton Library**

TITLE  
**Over Eaves Window  
Details**

| DRAWING NUMBER<br>A106 | | REV |

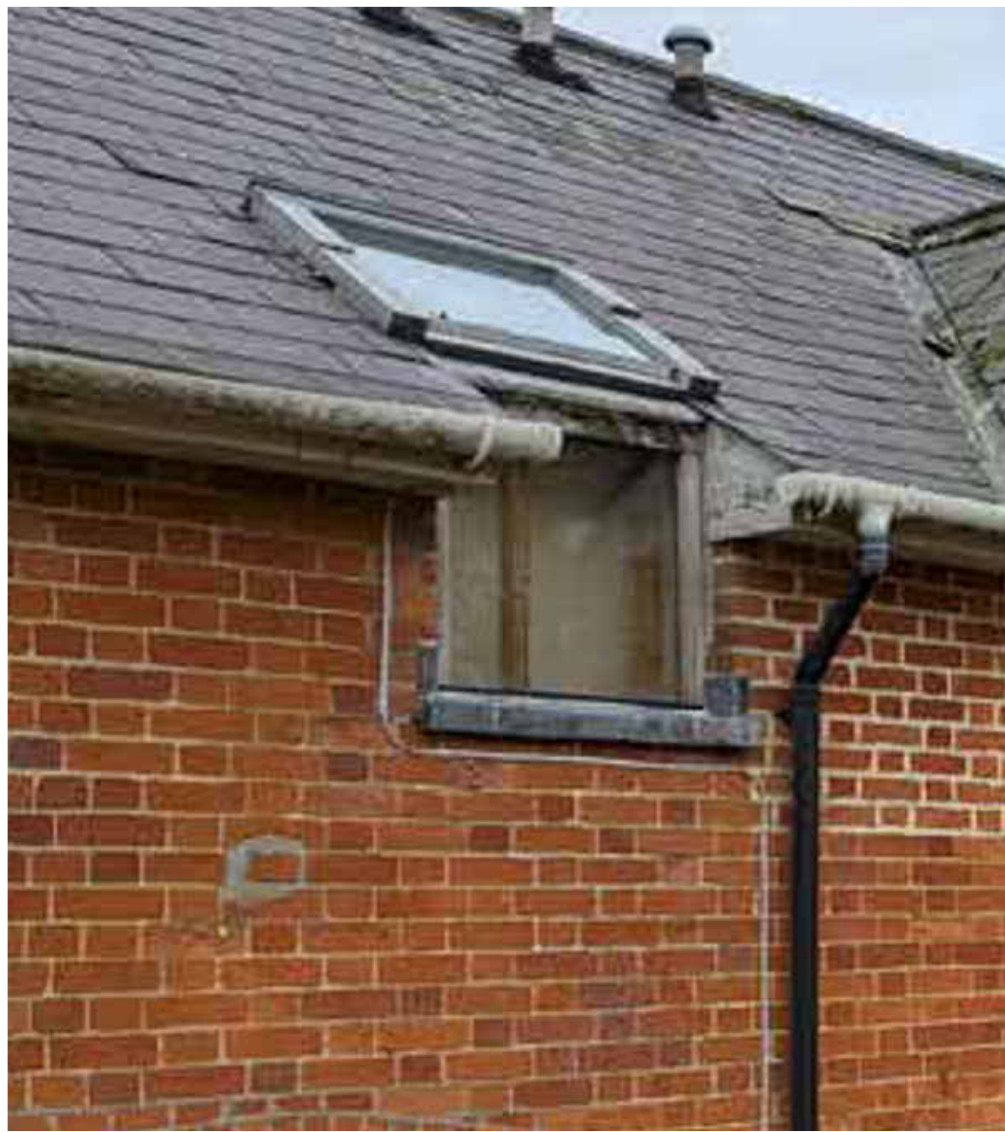
Existing over eaves window - in poor condition.

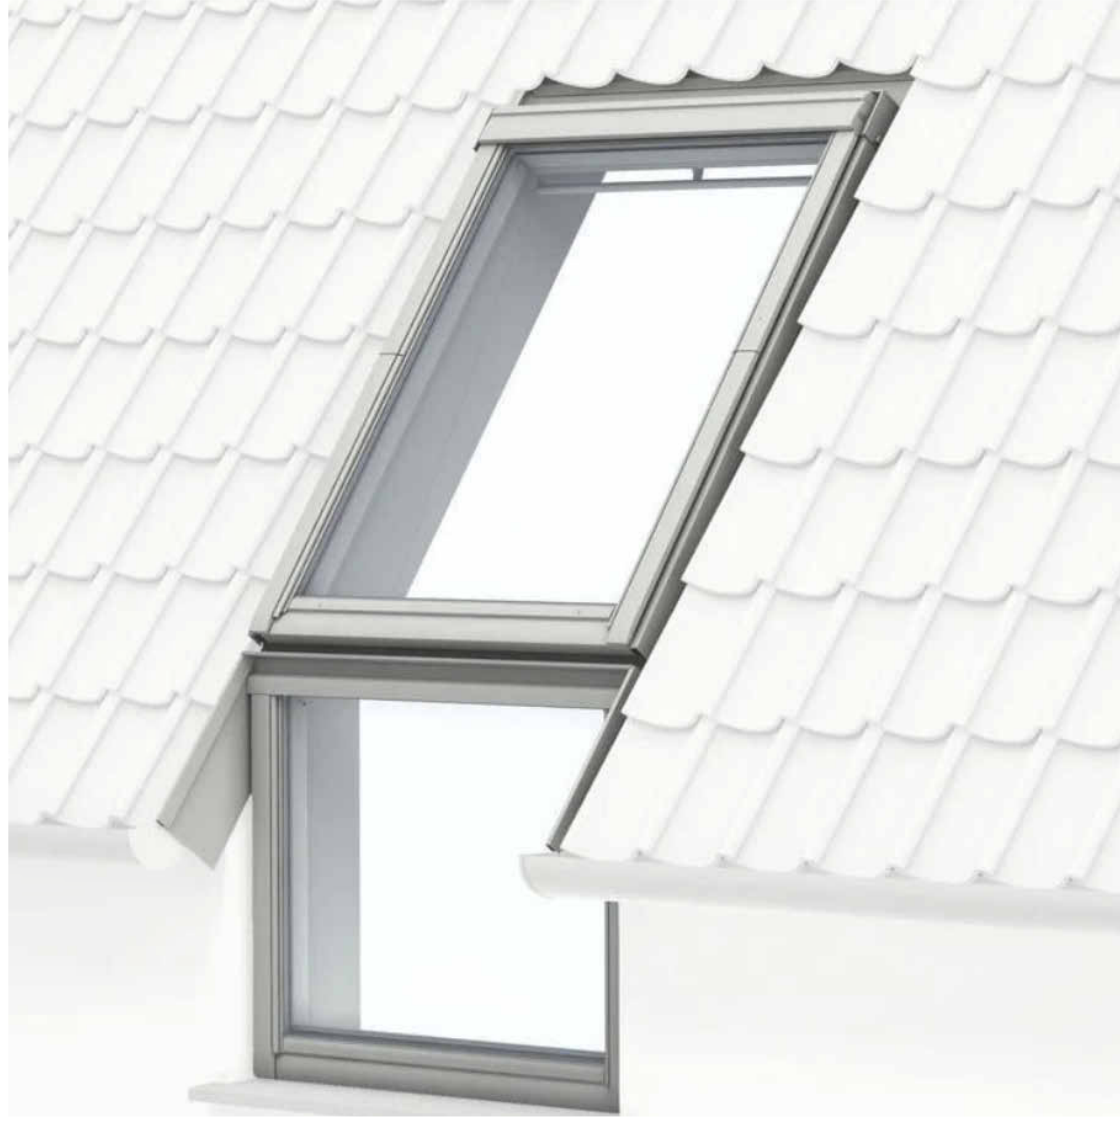
Proposed over eaves window - to match new approved conservation Velux windows.

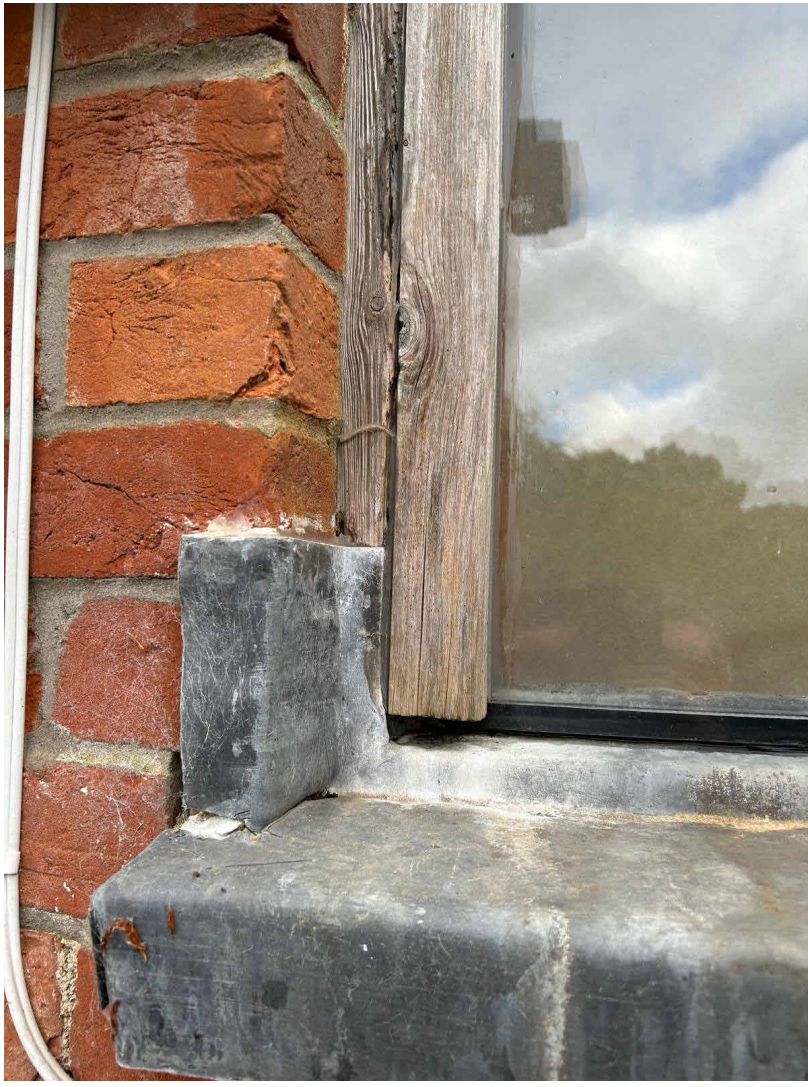
Existing cill detail - Proposed window to match

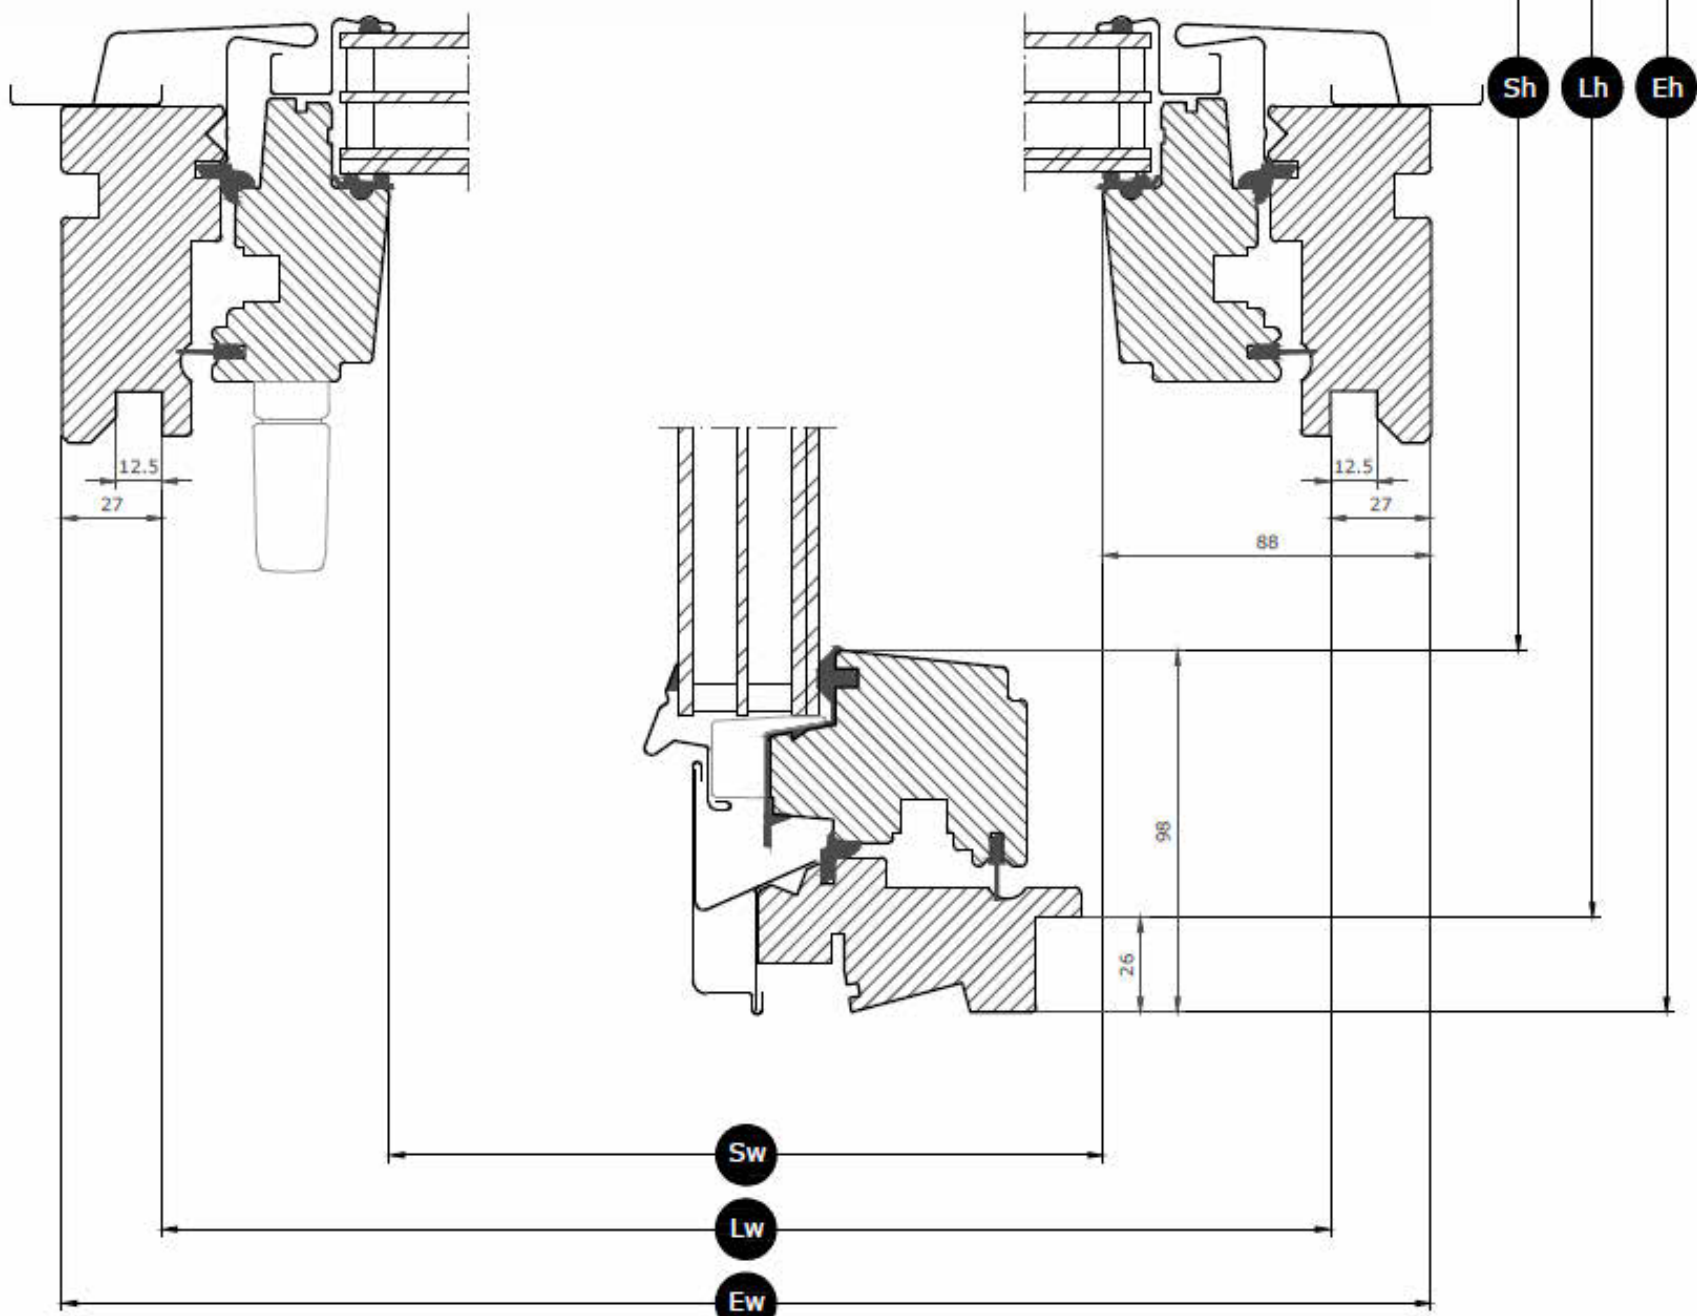
Frame Details - See appended data sheet
