# Kennet & Avon Canal Trust

## Pumphouse Cottage : Crofton Beam Engines

### Application for Listed Building Consent for external render removal

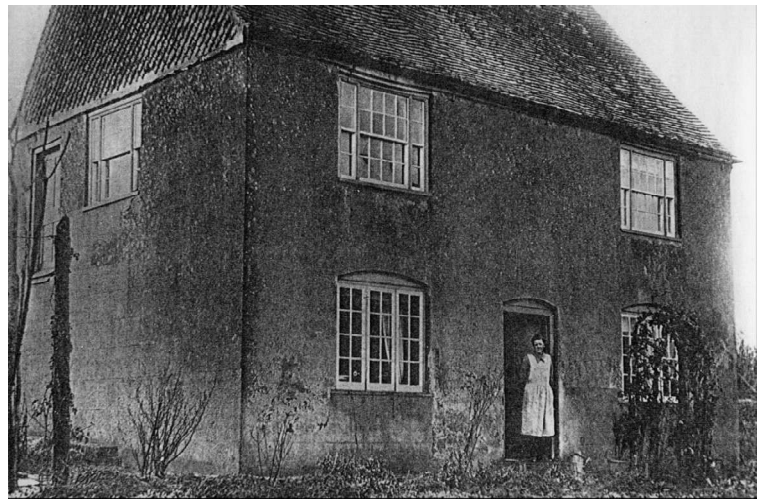
Historic photographs of Pumphouse Cottage are incomplete but show that whereas the south and west elevations had been rendered by 1930, with simulated stone joint markings, the other elevations continued to display their original brickwork. The above photograph is believed to have been taken towards the end of the 1920s and shows Ethel Giles, wife of the engineman, in the doorway. It also shows the ground floor windows as having been side-

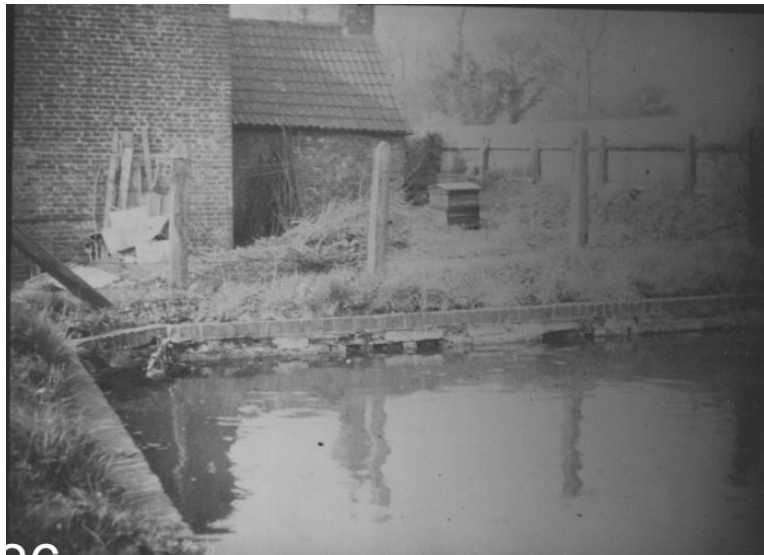
hung casements, whereas the first floor windows appear to be tripartite sash windows. The doorway in the western elevation once gave access to the engineman's office via an external staircase. The east elevation is less clearly depicted, but in the late 1940s view (see right), from across the launder basin, it is clear the east gable of the cottage and its rear wing are both still displaying English bond brickwork. It is also clear the rear wing is roofed in either pantiles or double Roman clay tiles, whereas the main roof in the 1930 view appears to have been roofed in plain tiles (but they do not appear to be in very good order so may have been renewed by the late 1940s).

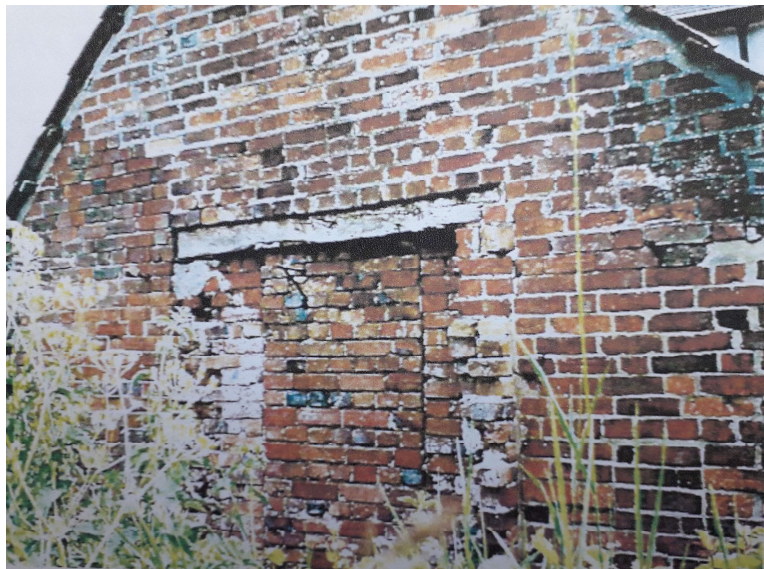
By the time of the purchase of the site by the Kennet & Avon Canal Trust, it would appear only the rear wing remained un-rendered, and as can be seen below, the brickwork was by now in poor condition with some spalling brickwork and also some unsympathetic pointing. During the 1970s various repairs were done as a 'holding operation' to allow use of the cottage, but a more substantial repair programme was taken on around 2000 which included the replacement of the rear wing with a new cavity wall structure which was finished in render to match the adjoining north wall of the cottage. The consequence of this sequence of repairs and alterations has been a building now finished in a number of different materials. However, the background to the current proposal is the deteriorating condition of the south and west wall external render.

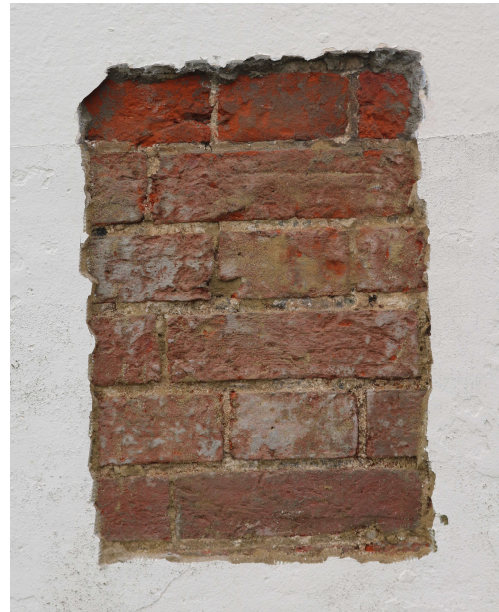
created new problems by trapping wind-driven moisture beneath this impervious layer and preventing effective drying-out. Since 2021 a number of trial areas of removal have been undertaken to establish the ease of removal of the render and the condition of the 18<sup>th</sup> century brickwork beneath. The first such trial, to right, was undertaken near the west end of the south elevation at the lower level, within what may be the initial lime render covering the ground floor part of the elevation and shows the brickwork in good order with more-or-less intact pointing.

Similar trials were undertaken in areas covered in cement-based render, and whilst the technique needed to remove it was different, the condition was found to be generally similar provided great care was taken in removal to avoid surface damage to the bricks. This suggests that if the render were to be removed, either to display the original brickwork or to allow re-rendering with a more sympathetic lime-based mix, it would be possible to achieve this with little or no damage to the underlying brickwork.

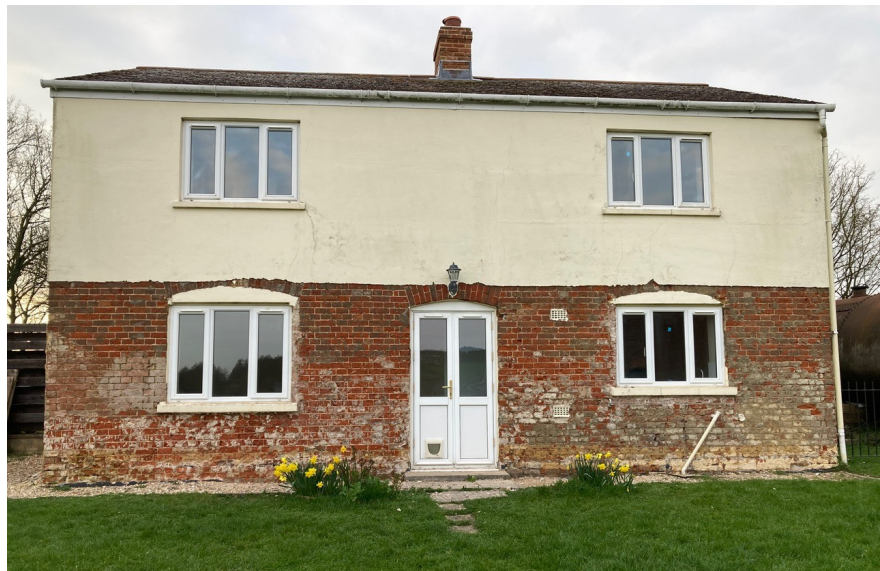
In the years since 2021, the condition of the render has continued to deteriorate and we now need to decide whether to attempt to re-render it to retain the post-1930 appearance or whether this offers an opportunity to return the cottage's appearance to that which it would have been in 1810. In view of the continuing deterioration of (in particular) the lower areas of render and public safety issues around falling areas of loose render, the Trust's volunteers have now carried out the removal of the lower part of the render to the south elevation, as can here be seen to the right. Broadly, the brickwork condition is

good, particularly on the upper part of the ground floor section, and, to our surprise, the door and window arches do seem to be intact. If this condition were to be replicated on the west elevation and the upper parts of the two elevations, it might be feasible to consider removing the render to return these two elevations to their 1810 appearance. Some doubt remains about the upper window-head treatment, since the eaves was altered in the 1970s, it is

Since Pumphouse Cottage forms part of the curtilage of the site of Crofton Beam Engines, we assume that it should be treated as listed at Grade 1, even though many changes have occurred during the 20<sup>th</sup> century. The Trust is therefore applying for Listed Building Consent for the removal of the render to the south and west elevations, followed by any required pointing of the brickwork revealed and renewal of any frost-damaged bricks with matching salvaged bricks. The Trust has explored the feasibility and cost of re-applying the render in a more sympathetic lime-based mix in the event that Officers feel that the post-1930 appearance is now sufficiently established to be considered the accepted aesthetic and will not grant Listed Building Consent. However, we very much hope that a decision can be made promptly since both pointing or re-rendering using lime-based mortars needs to be done during the summer months for optimal curing.
