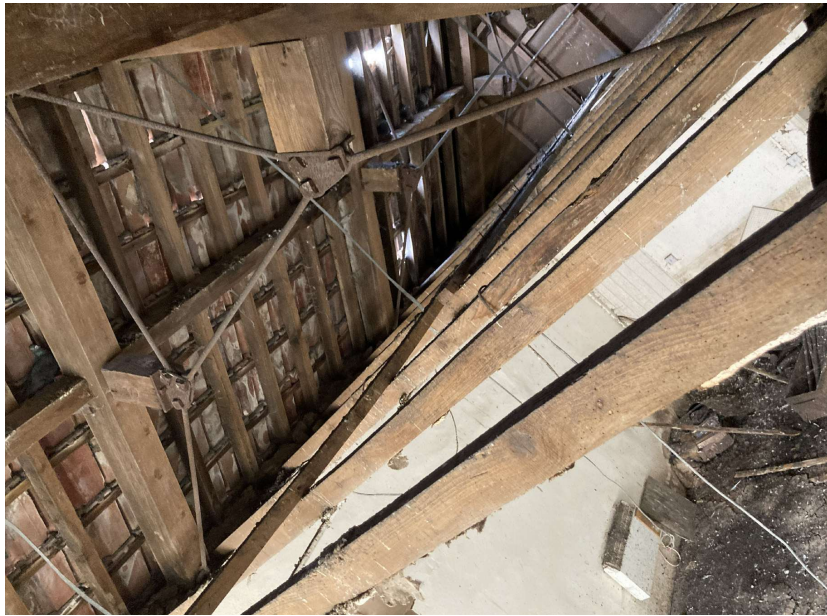
Existing roof trusses with metal tie rods and purlins between. Rafters over. Timber battens with double Roman tiles hooked over. Ceiling joists below, no ceiling currently. All roof timbers to be retained, splice repair made if required. Structural engineer to inspect the roof

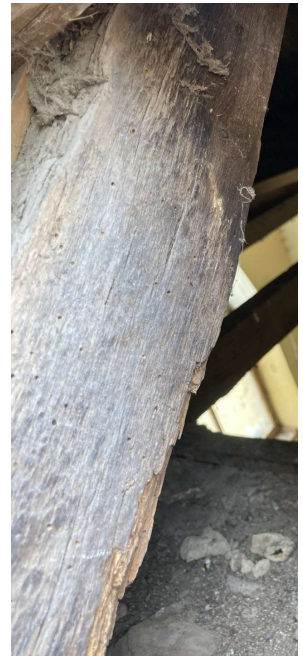
Roof timbers showing signs of woodboring insect attack. All existing timbers to be treated
