# South Pavenhill Farm, Purton, Swindon, SN5 4FH

Arboricultural Impact Assessment

**P.1464.26**  
May 2026

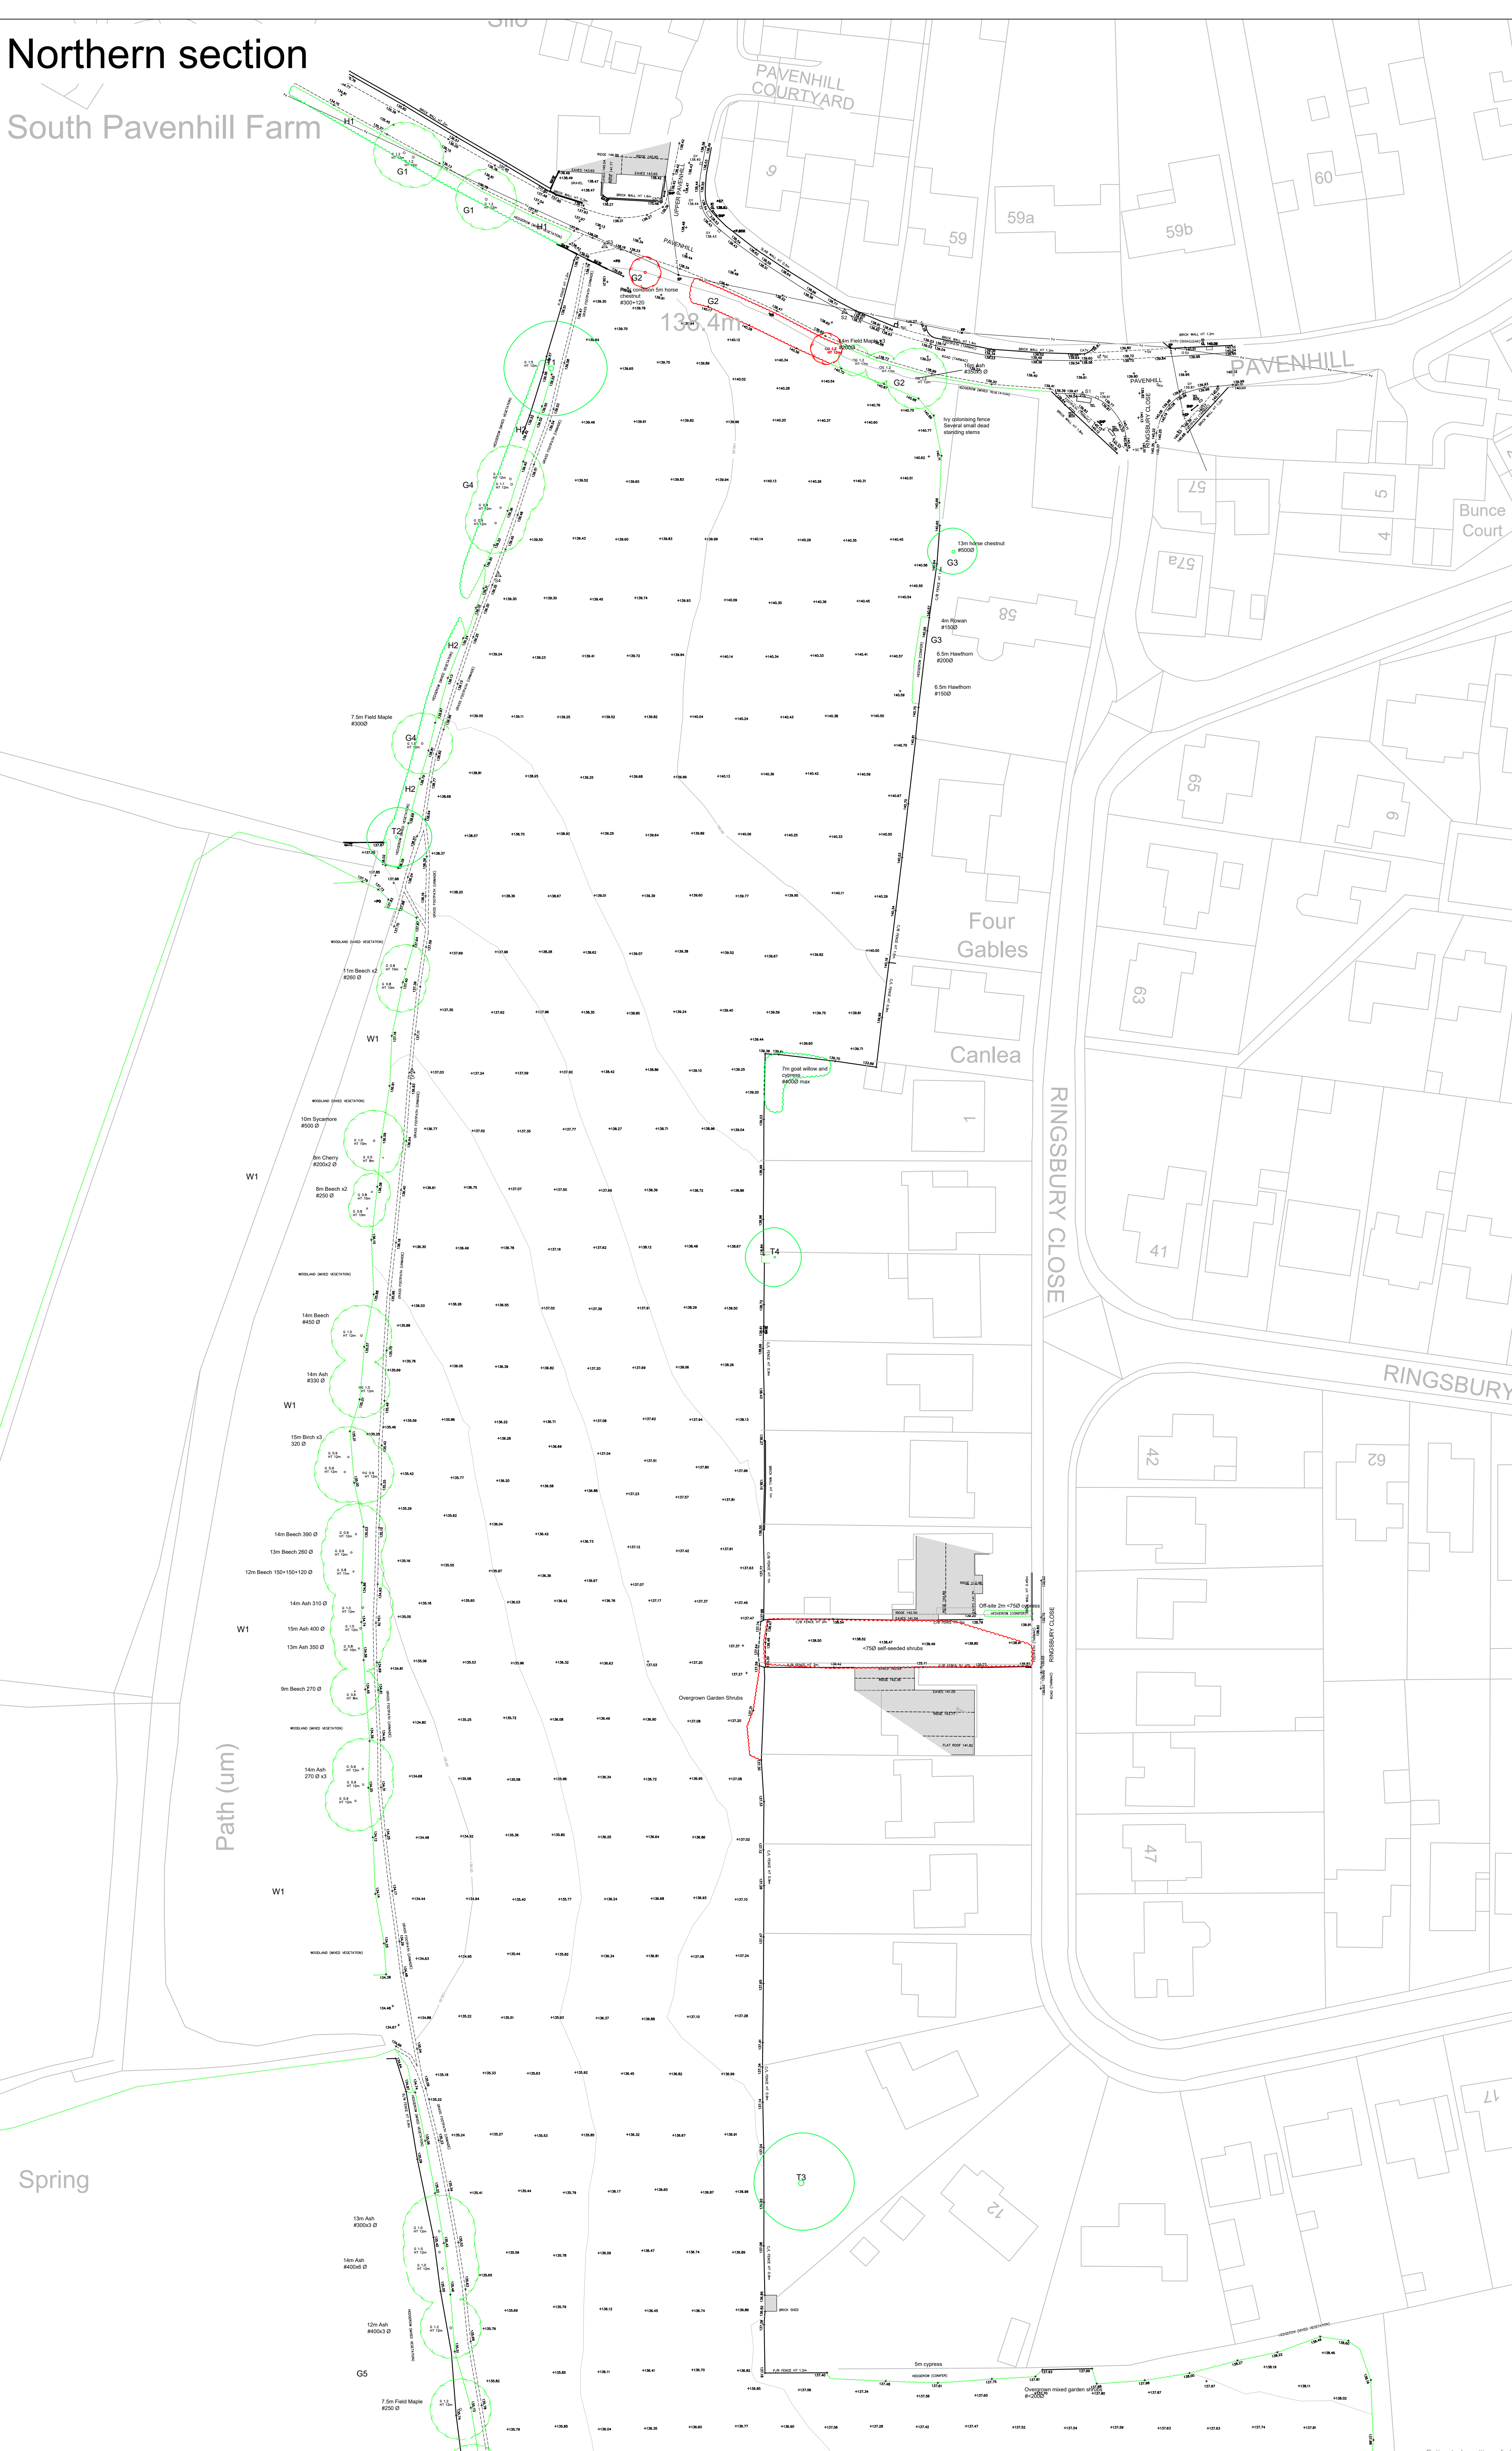
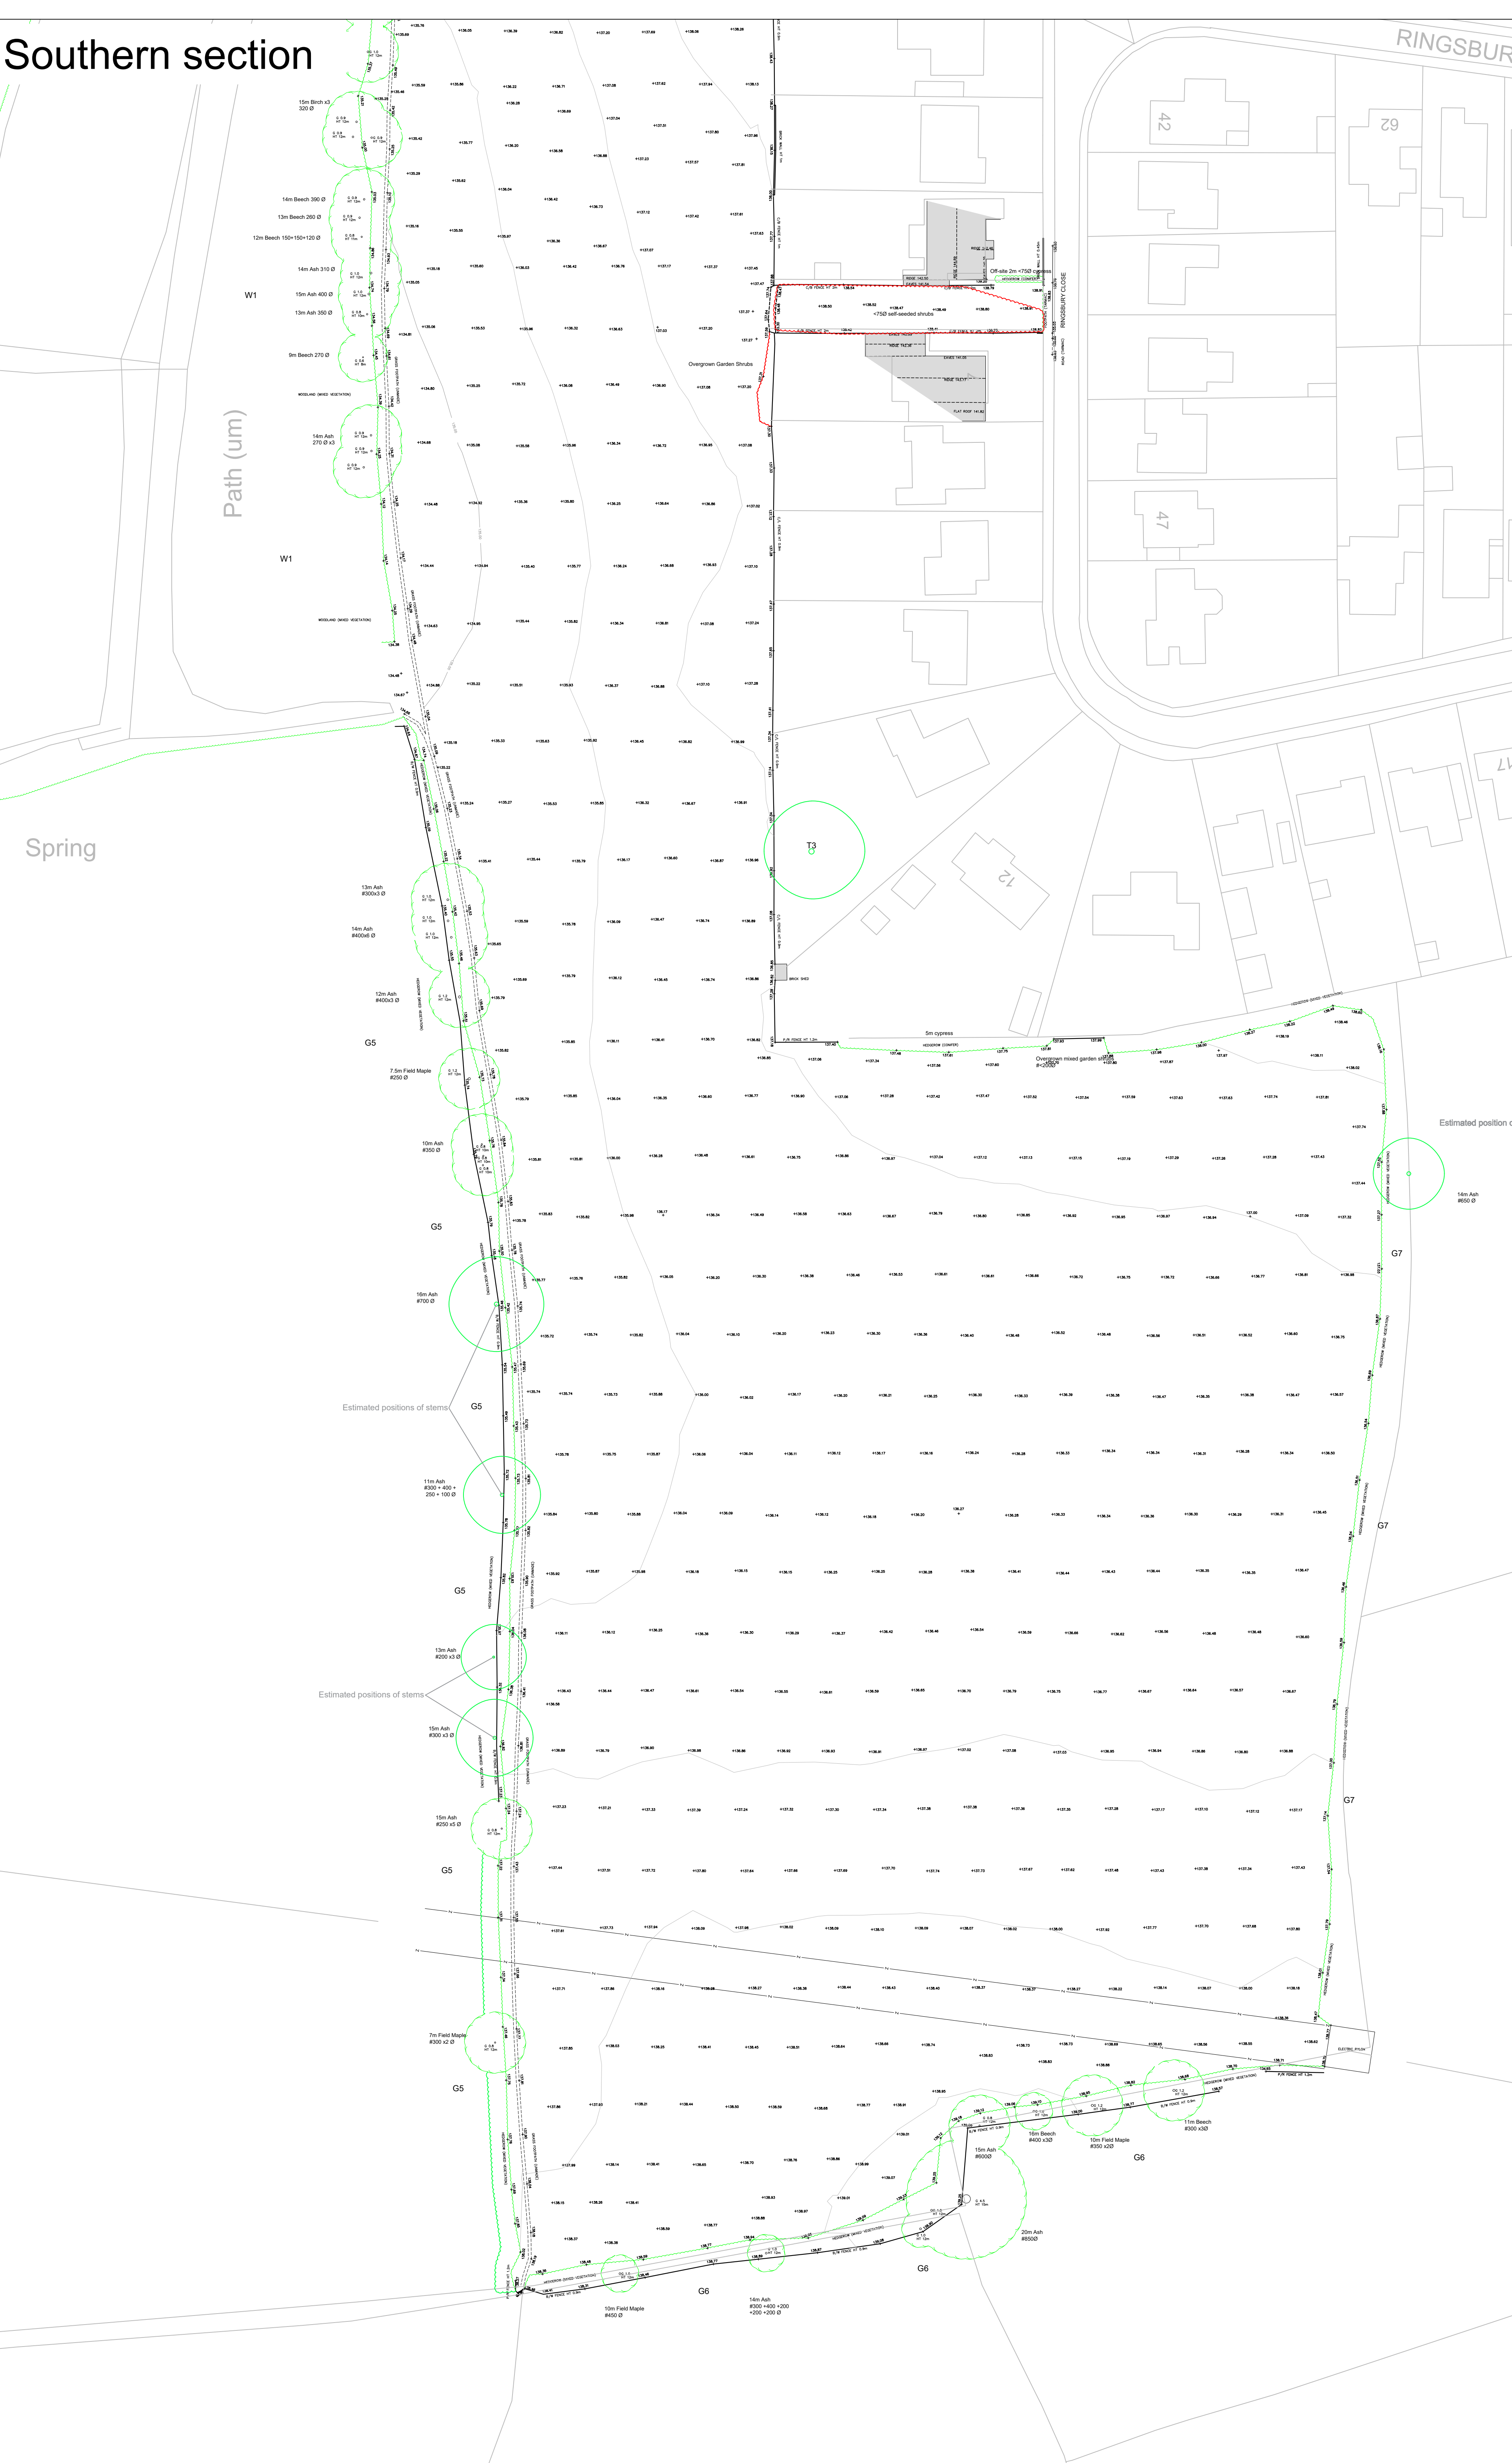
CLIENT: Castlewood Properties Ventures  
PROJECT: South Pavenhill Farm, Purton, Swindon, SN5 4FH  
DRAWING TITLE: Tree survey  
SCALE: 1:500 @ A0  
DRAWN BY: KP  
CHKD BY: CP  
DATE: 18/05/2026  
P: 1464.21.01  
REV: A

**Existing Tree Cover:** Four individual, seven groups of trees, two hedges and one woodland were recorded during our survey, the details of which can be found within Appendix 1 to this report and cross-referenced with drawing P.1464.21.01A *Tree Survey*.
