**The Old Court House. Court Street,  
Sherston. SN16 0LL**

**3 : Proposed Works Details  
REVISION A**

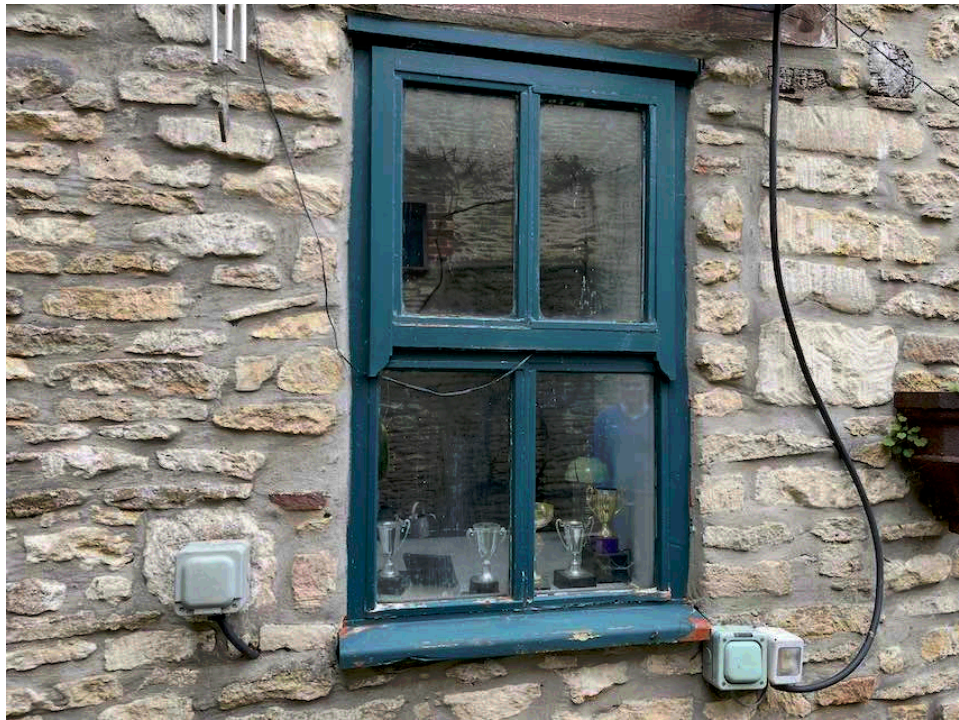
EXISTING WINDOW EXAMPLE ON SOUTH AND WEST ELEVATIONS

2. Carry out like-for-like repairs to windows 1-3 and 5-17

Works to include replacement of rotted sections of beading, cills etc., with new profiles to match existing

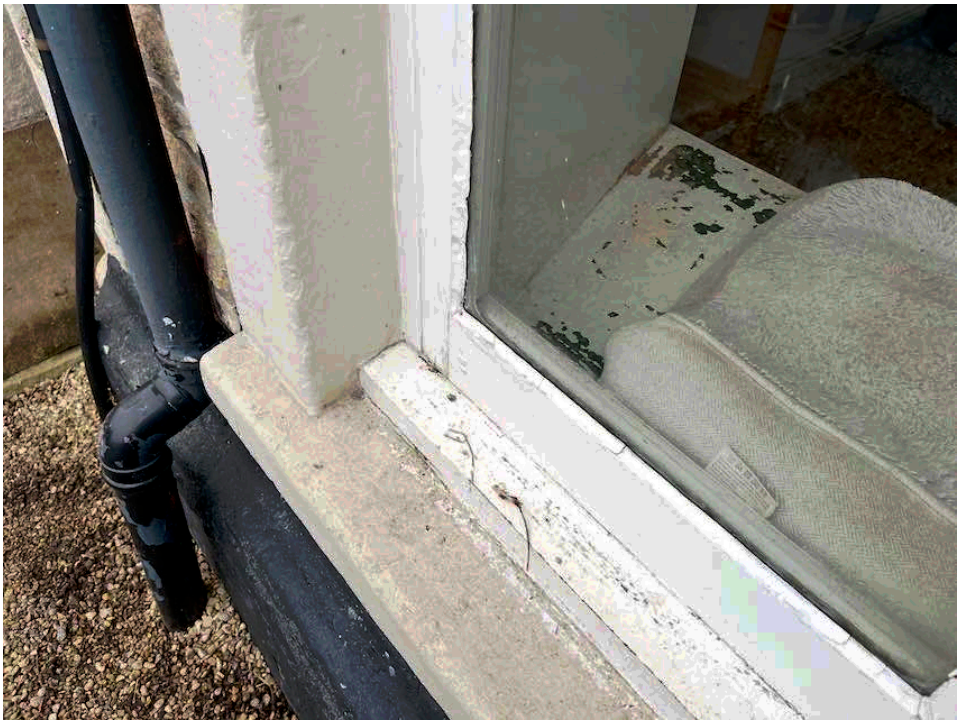
EXISTING WINDOW EXAMPLE ON NORTH AND EAST ELEVATIONS

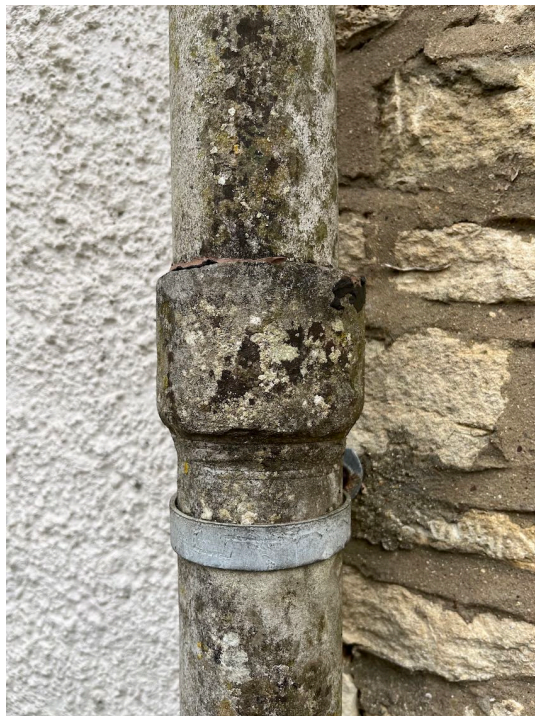
EXISTING ASBESTOS DOWNPIPE

3. Replace asbestos downpipe on East Elevation with Brett Martin Cast Iron Effect downpipe. Carry out repairs to existing rainwater goods

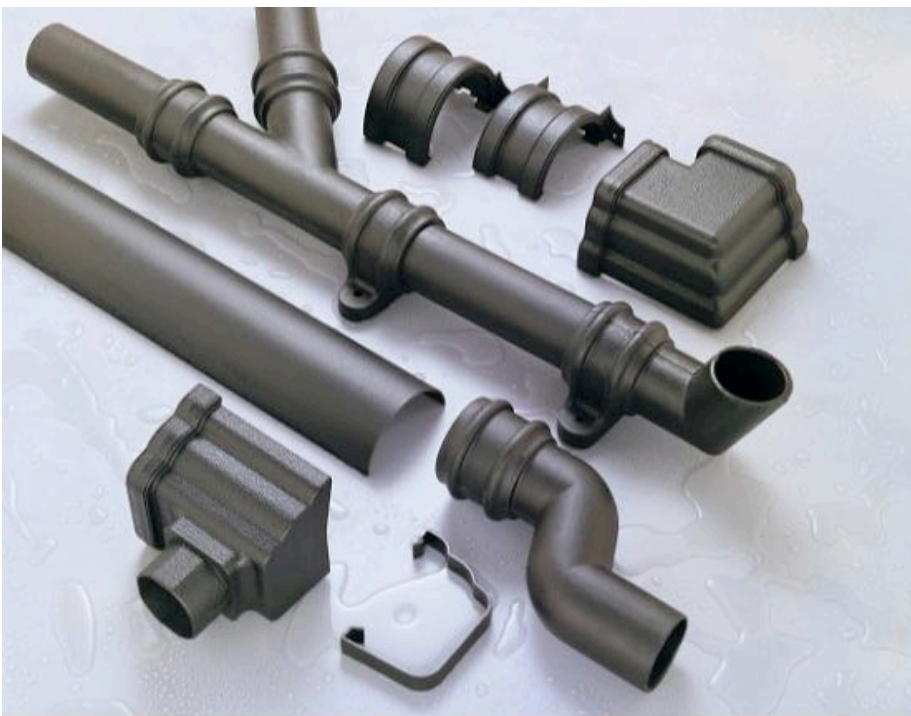
PROPOSED BRETT MARTIN CAST IRON EFFECT DOWNPIPE

See <https://www.brettmartin.com/plumbing-drainage/our-products/product/cascade-cast-iron-effect-rainwater>

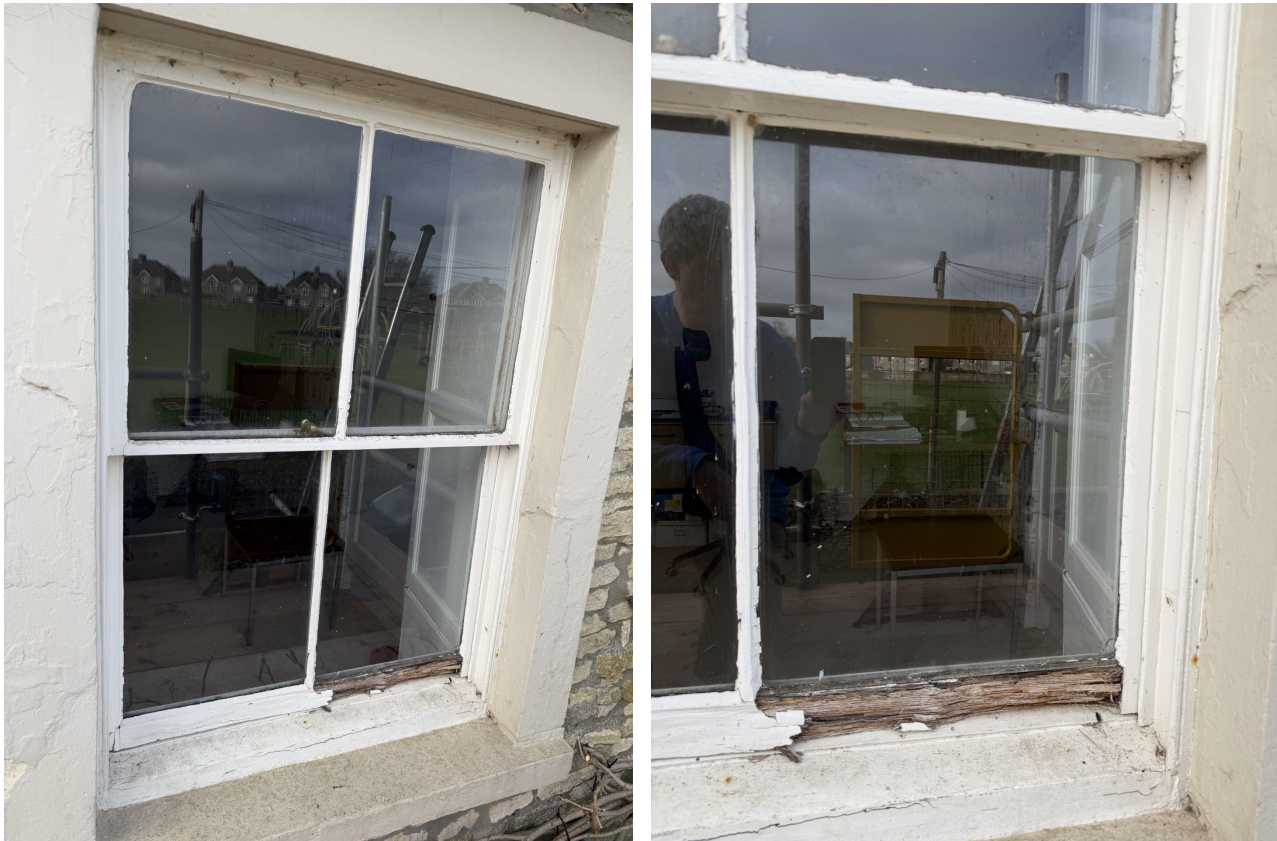
Photographs showing irreparable state of existing lower sash

1. Window 4: Install like-for-like replacement of bottom sash section and carry out like-for-like repairs
