| PROJECT | West Stowell House, West Stowell, Marlborough, SN8 4JU |
| DOCUMENT REF | P-01 |

## DESIGN & ACCESS STATEMENT

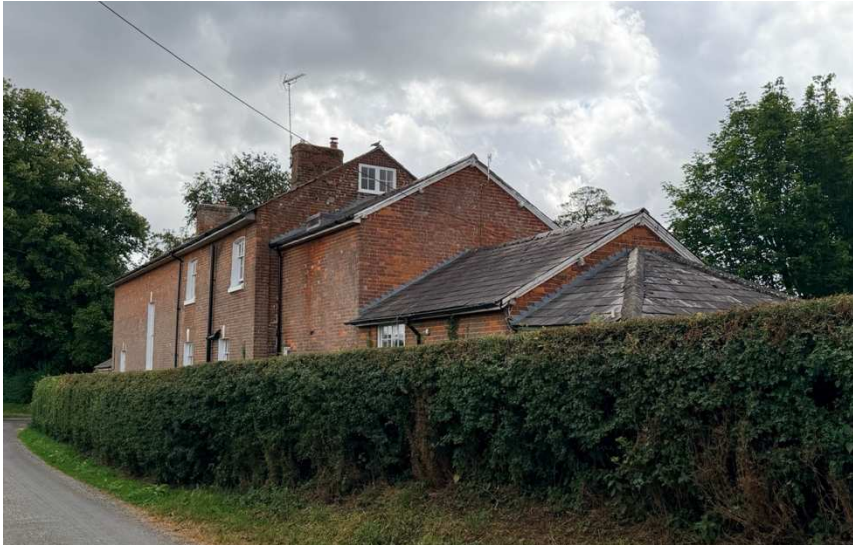
**West Stowell Farmhouse**  
Natural slate roof finish

The natural slate finish chosen for the outbuilding has been proposed to replicate those of other outbuildings in the surrounding area. Please refer to the images of the local outbuildings referenced at the end of this report.

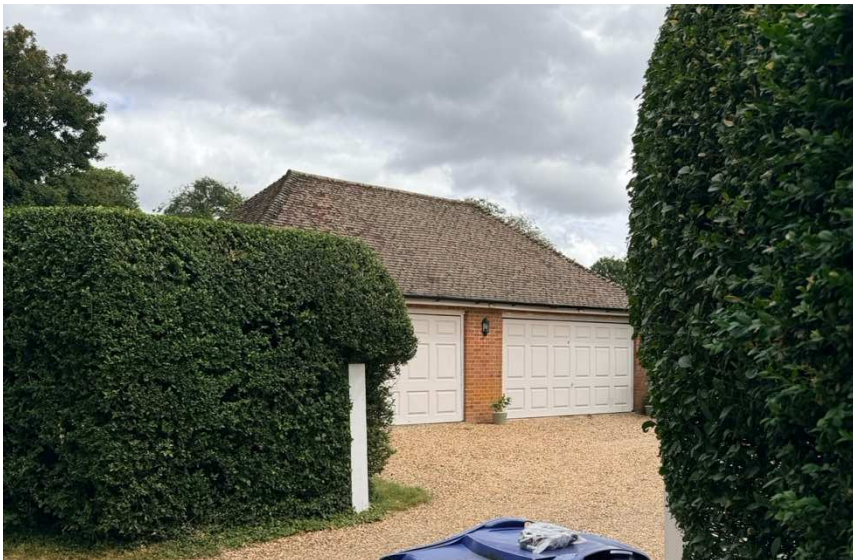
**West Stowell Walk**  
Tiled hipped roof garage

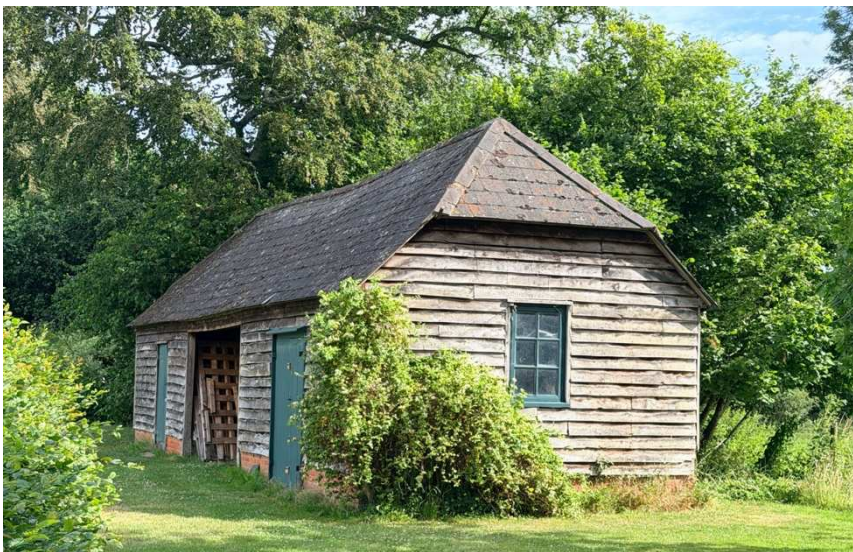
**Storage Barn West Stowell Estate**  
Slate hipped roof outbuilding

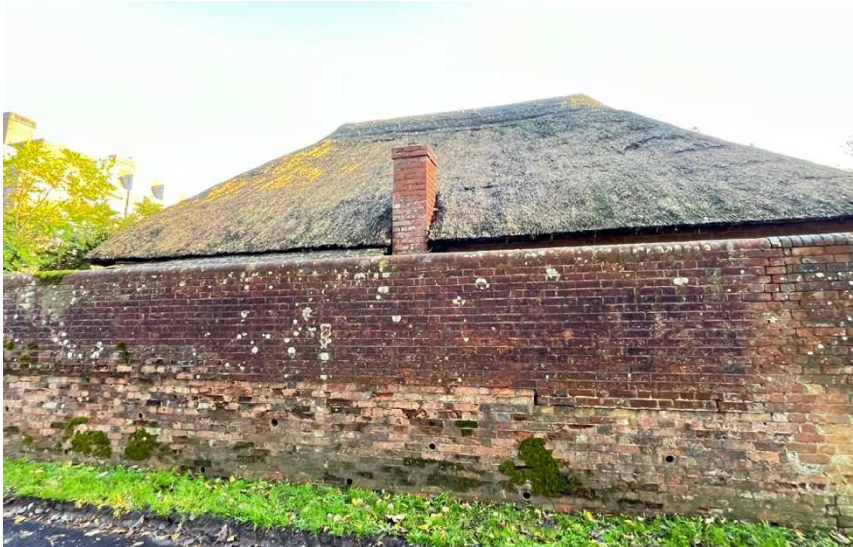
### Existing Outbuilding

Thatch in poor repair

Run off from thatch having detrimental impact on adjacent structure / boundary wall

The proposal seeks to improve the longevity and sustainability of the existing outbuilding by replacing the existing thatch roof finish, which is in poor repair, and through surface run roof is contributing to deterioration of the wider building fabric. The proposed alteration would replace the existing roof material with natural slate and the introduction of rainwater goods; there are no additions or changes to the roof height as part of this proposal.

The proposals seek to retain the existing roof structure leaving the internal finishes and layout unchanged. Following the removal of the thatch, which is in poor repair, the introduction of high-performance insulation will improve the thermal performance of the building and longevity, while maintaining the original buildings overall form, massing and ridge heights. The introduction of rainwater goods will prevent surface run off to mitigate further deterioration to existing structures.

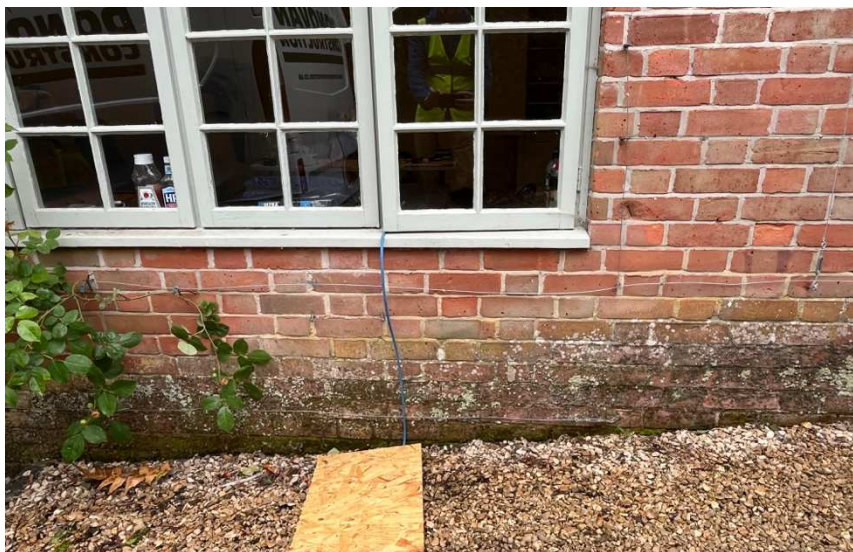
Run off from thatch having detrimental impact on masonry structure leading to issues of moisture and mold both outside and inside the structure.

High-quality powder coated aluminium rainwater goods are proposed to provide proper rainwater drainage and protect the brick building from water damage. The rainwater goods will be connected to existing stormwater arrangements already present on site.

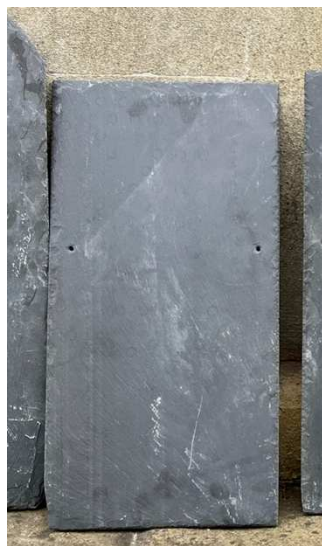
Glendyne Canadian Roofing Slate  
structural composition 98%  
identical to Welsh slate

Glendyne 508×254 Canadian Roof Slate is one of the most premium slates available to the UK with high consistency and durability. The Canadian Glendyne's rock structural composition is 98% identical to Welsh slate, and therefore suitable as an alternative to the Ffestiniog Welsh slate. Glendyne slate is approved for use in the Snowdonia National Park and presents a natural blue/grey hue, very similar to Welsh slates.
