### File Note: River Condition Assessment

**Site address:** Guest Farm, 1A Rixon Gate, Ashton Keynes, Swindon, SN6 6PH

**Ref:** River Condition Assessment

**Proposal:** The demolition of the existing agricultural buildings present on-site and subsequent erection of 4 residential dwellings with associated hard and soft landscaping.

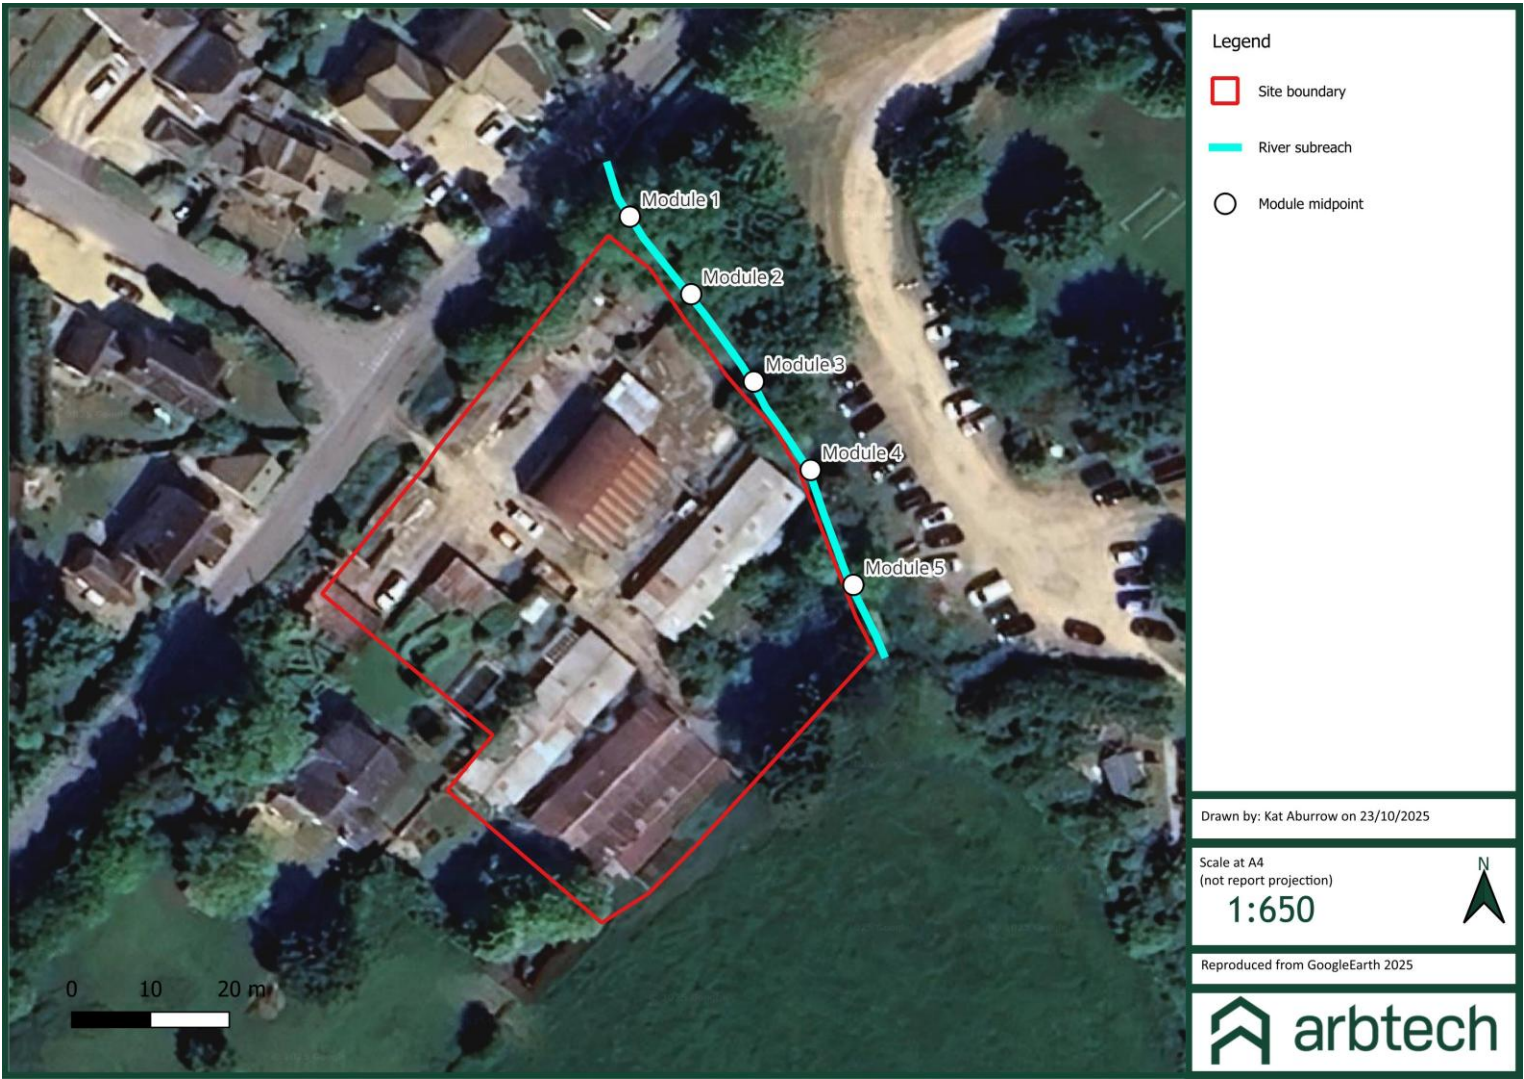
Appendix 2: MoRph Survey Locations

The watercourse subject to the RCA was a 250m stretch of the River Thames which runs adjacent to the western site boundary. For the purposes of this report, the watercourse is referred to as “River Thames”. The extent of the survey is shown on the plan at **Appendix 2**.

The average width of the River Thames (in the surveyed area) is 106m (a large/navigable river) and as such, the length between each module survey was assigned as 50m. One subreach consist of a total of 5 MoRPh modules, which in this case equated to an overall length of 250m. The length of the River Thames that lies within 10m of the site boundary is approximately 128m. As such, the extent of the subreach equates to ~51% of the length of the watercourse within 10m, in excess of the minimum 20% requirement.
