## Purpose and Evidential Relevance of the Photographs

These photographs are submitted to Challenge the Conservation Officer's conclusion that the application site occupies a prominent position and that the proposed dwelling would be harmful in wider elevated views, including those from rising land around the Lansdowne Monument.

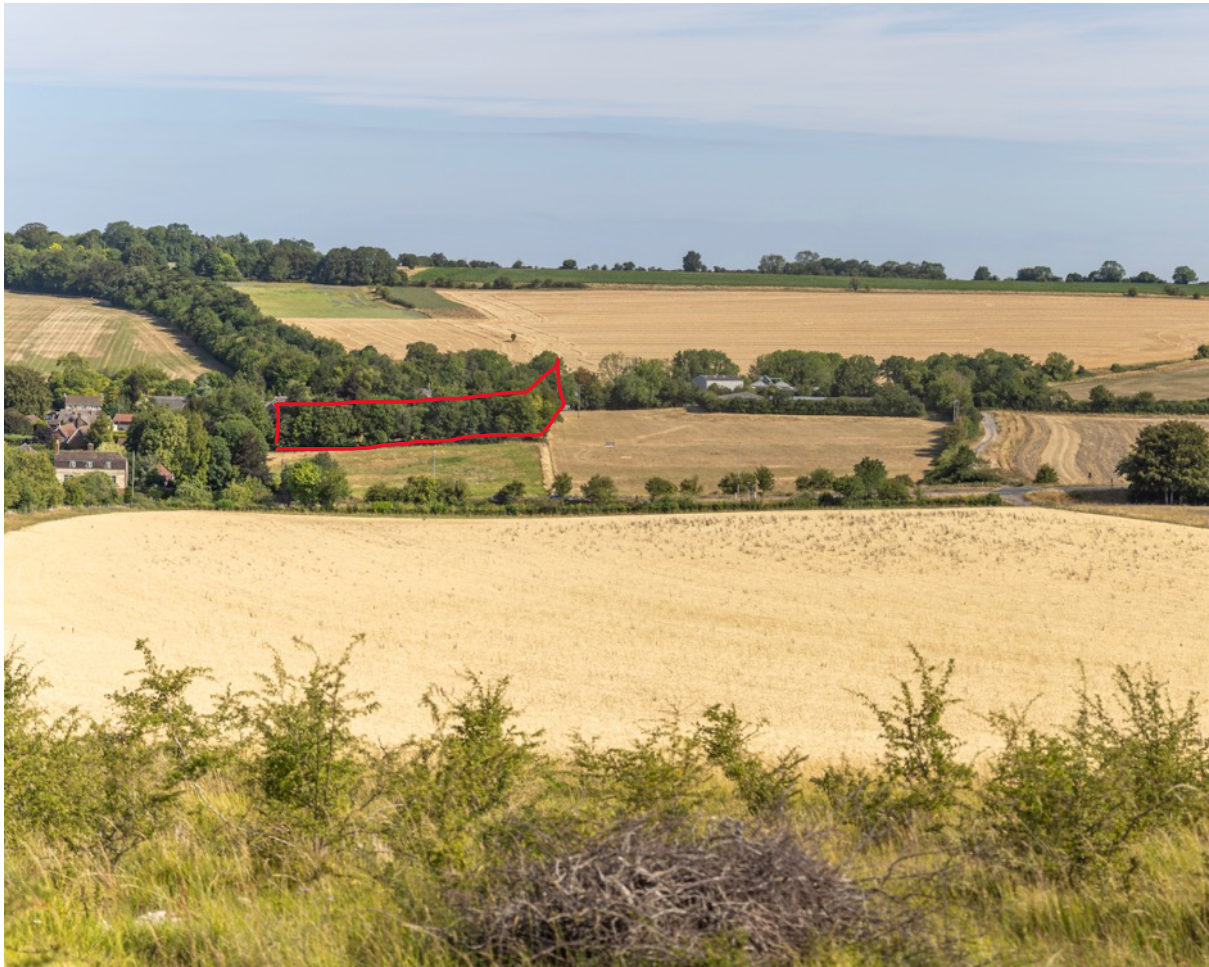
**Viewpoint 1 – approximately 440 metres from the application site.**

The application site is outlined in red for identification. From this viewpoint, it is substantially contained by mature trees and boundary vegetation and is not readily distinguishable as a separate land parcel without annotation. The site forms a limited component of a much broader agricultural, wooded and settlement landscape.

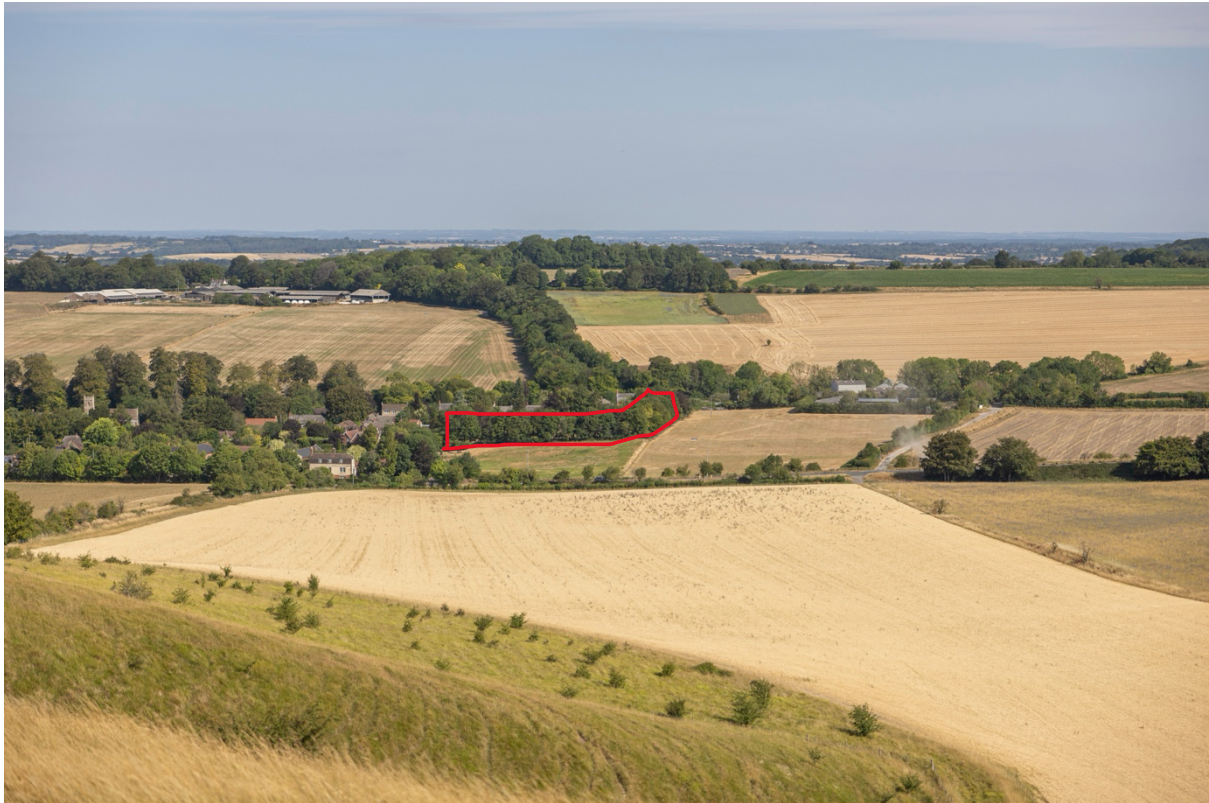
**Viewpoint 2– approximately 1,135 metres from the application site, beside the Lansdowne Monument.**

The application site is outlined in red for identification. From this elevated long-distance viewpoint, the site forms a very limited component of the extensive landscape panorama and is visually absorbed within the established tree and hedgerow structure at the edge of Cherhill. Without annotation, its location and boundaries are not readily discernible.

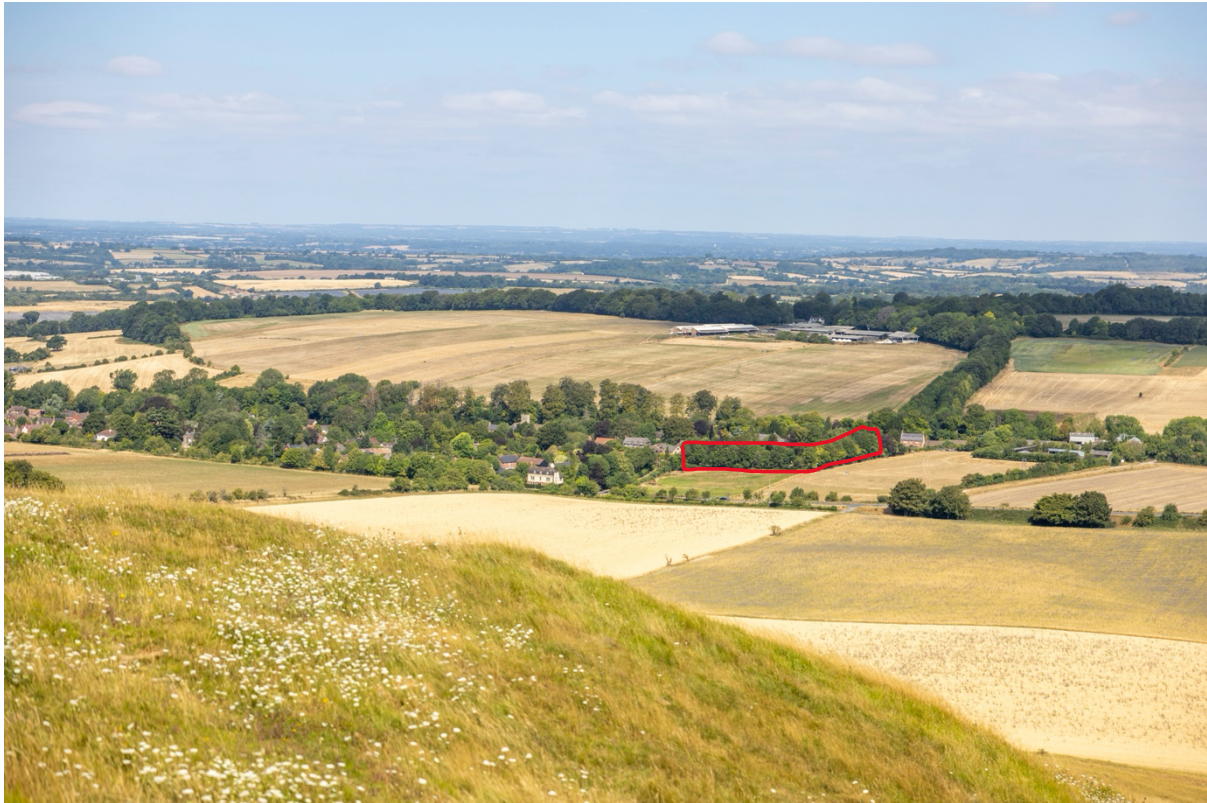
### **Viewpoint 3 – Approximately 1,133 Metres from the Application Site, Beside the Cherhill White Horse**

This photograph directly challenges the assertion that the proposal would be visually prominent or harmful in far-reaching views from Cherhill Down. The red outline identifies the entire application site of approximately 3,358m<sup>2</sup>—not the proposed dwelling. The dwelling would occupy approximately 170m<sup>2</sup>, representing only 5.1% of the outlined area. Even with the whole site deliberately marked, it remains a minor and visually subordinate element within an extensive panorama dominated by agricultural fields, woodland, mature hedgerows and established village development. Without the red outline, the site is not readily identifiable.

The proposed dwelling would be a reduced, one-and-a-half-storey cottage-style building, lowered into the site and contained by existing and strengthened landscaping. There is no objective basis within this view for describing that limited development as dominant, incongruous or harmful to the wider landscape. While this is a summer baseline photograph rather than a photomontage of the completed dwelling, it provides clear evidence of the site's scale, position and landscape containment. If harm from this viewpoint is maintained, the Council should identify precisely how a 170m<sup>2</sup> dwelling occupying only 5.1% of this visually contained site would materially affect the character or significance of the expansive landscape shown. The photographic evidence does not support the conclusion that the application site is visually prominent within this wider landscape view.
