**Tree Survey & Arboricultural Impact Assessment**

**Tisbury Motors, High Street, Tisbury SP3 6HF**

August 2026 V2.0

**Reference:** 26/07/178/NH

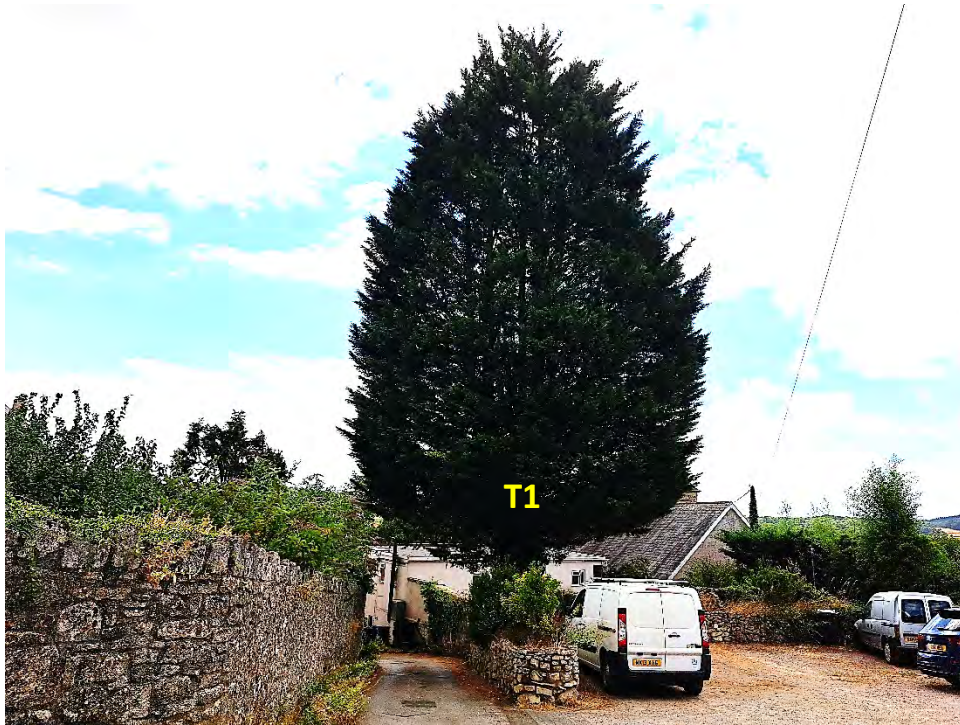
Photo 1 (above): Leyland cypress T1 growing on a raised border

T1 is growing on a raised border and immediately adjacent to a retaining stone wall.

Leyland cypress are fast growing conifers often increasing in height by 60cm to 90cm a year, with the potential to reach 40.0m in height.

In the absence of development it is reasonably likely and foreseeable that T1 will cause structural damage to the immediately adjacent retaining stone walls.

In brief, T1 is the wrong tree in the wrong place and unsuitable for retention regardless of development.

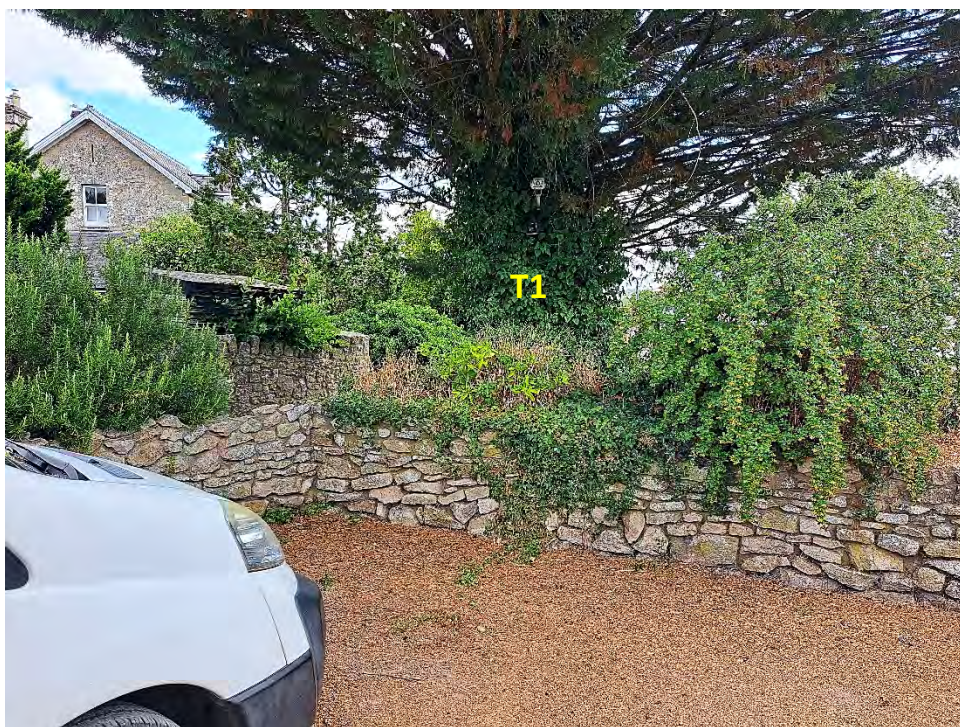
Photo 2 (above): Leyland cypress T1 growing on a raised border

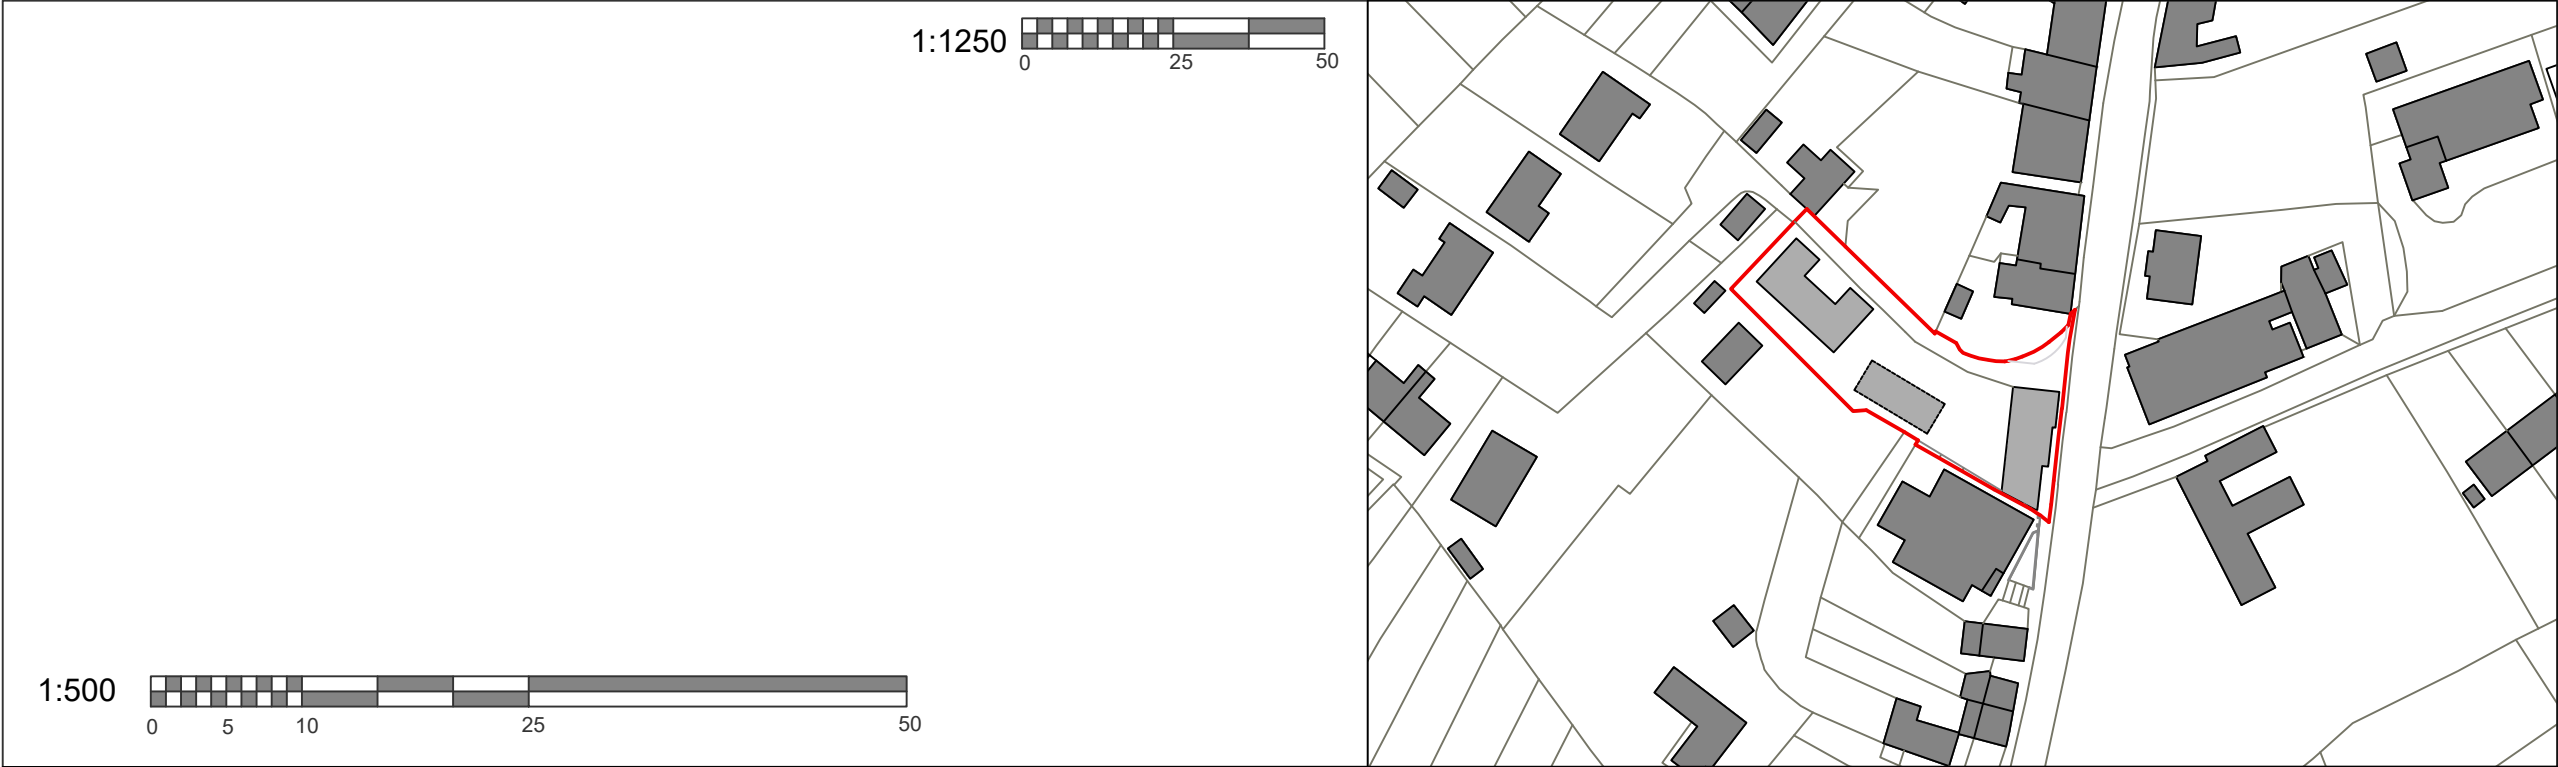
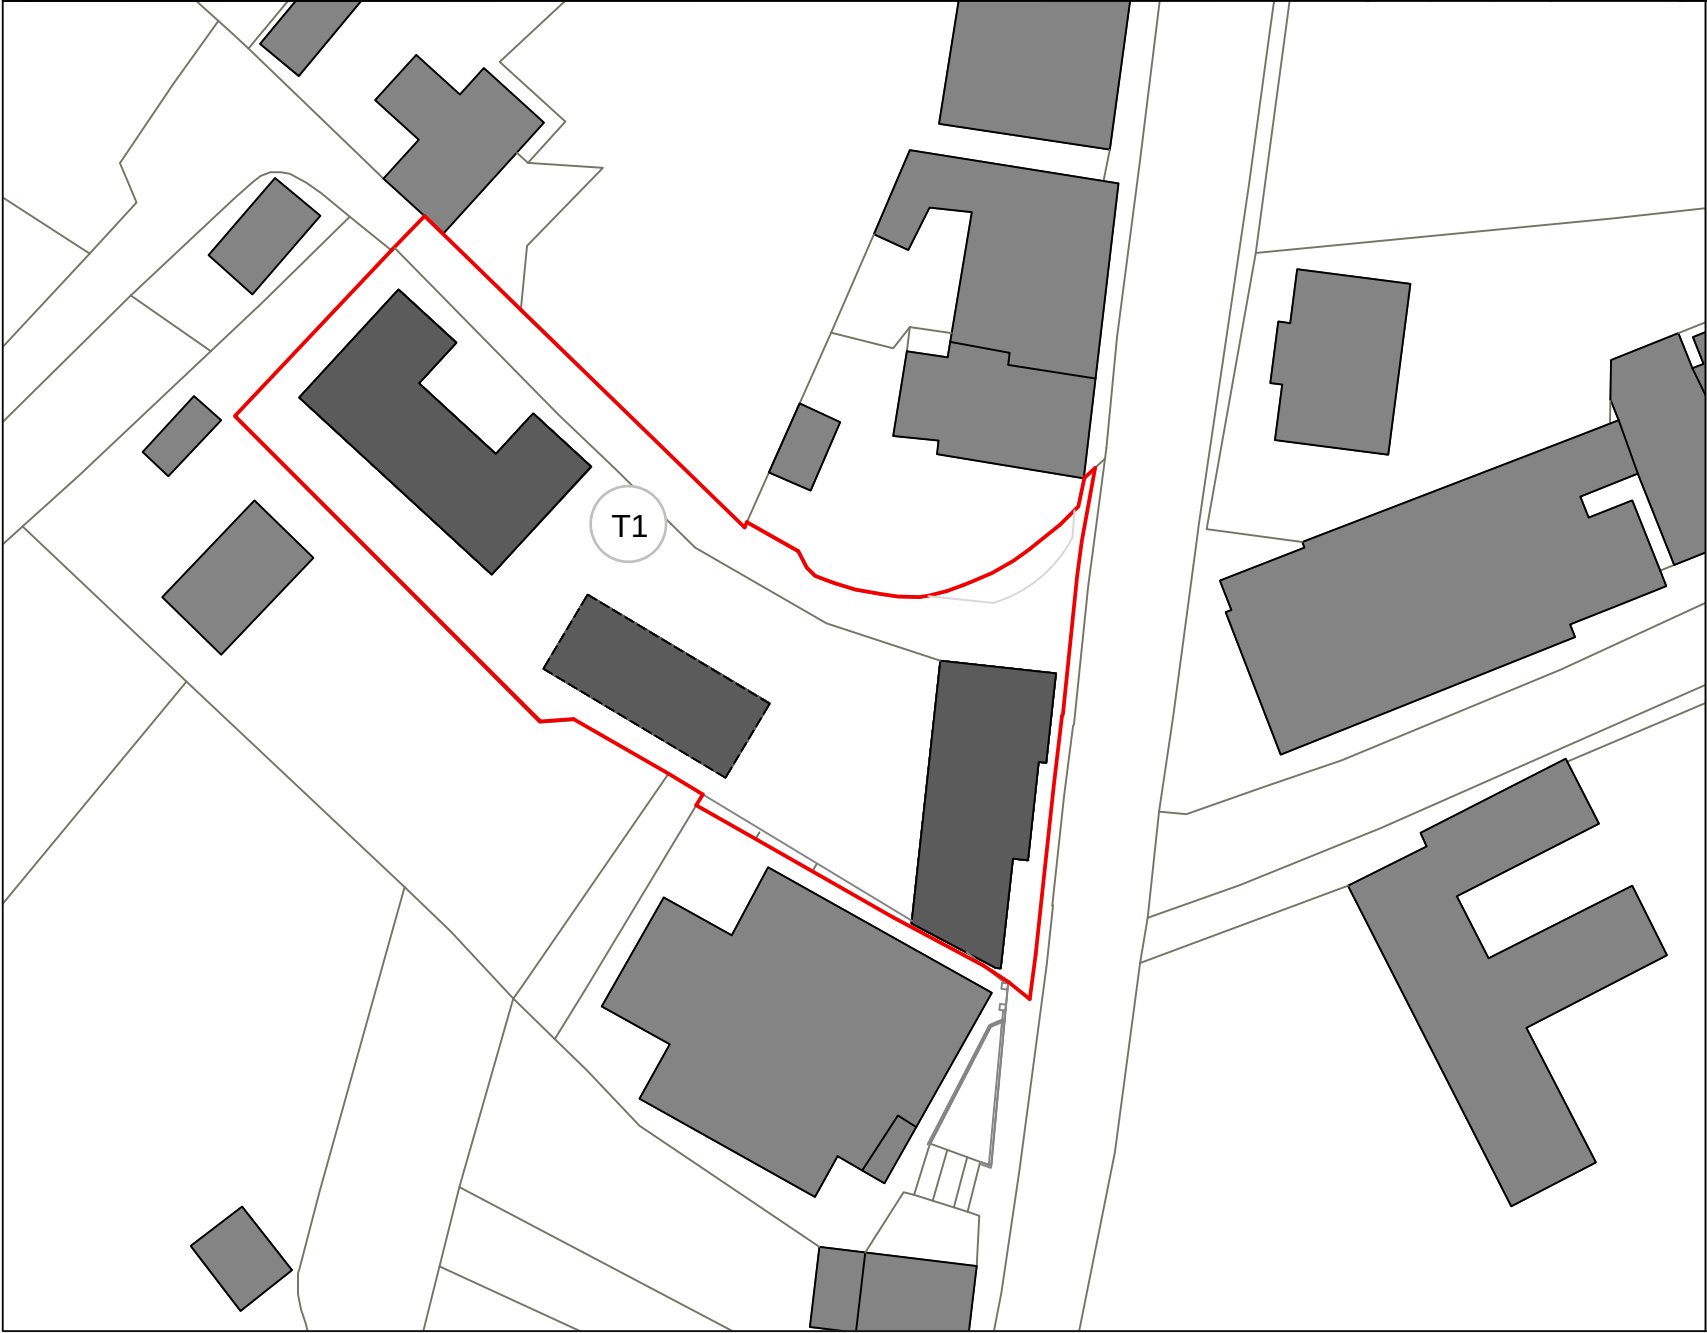
Title: Tree Constraints Plan ref: TCPTM

The purpose of this plan is to illustrate issues associated with the trees present on and immediately adjacent to the site.

I have inspected all the trees of material consideration within and immediately adjacent to the proposed development site. These trees are listed at Appendix 1 as T1 and annotated on the Tree Constraints Plan at Appendix 4.
