## **Window Restoration and Renewal**

**32 The Halve, Trowbridge BA14 8SA**

**Reference Listed Building Consent Query – ENQ/2026/00995**

Grade II Listed – ref 1021605

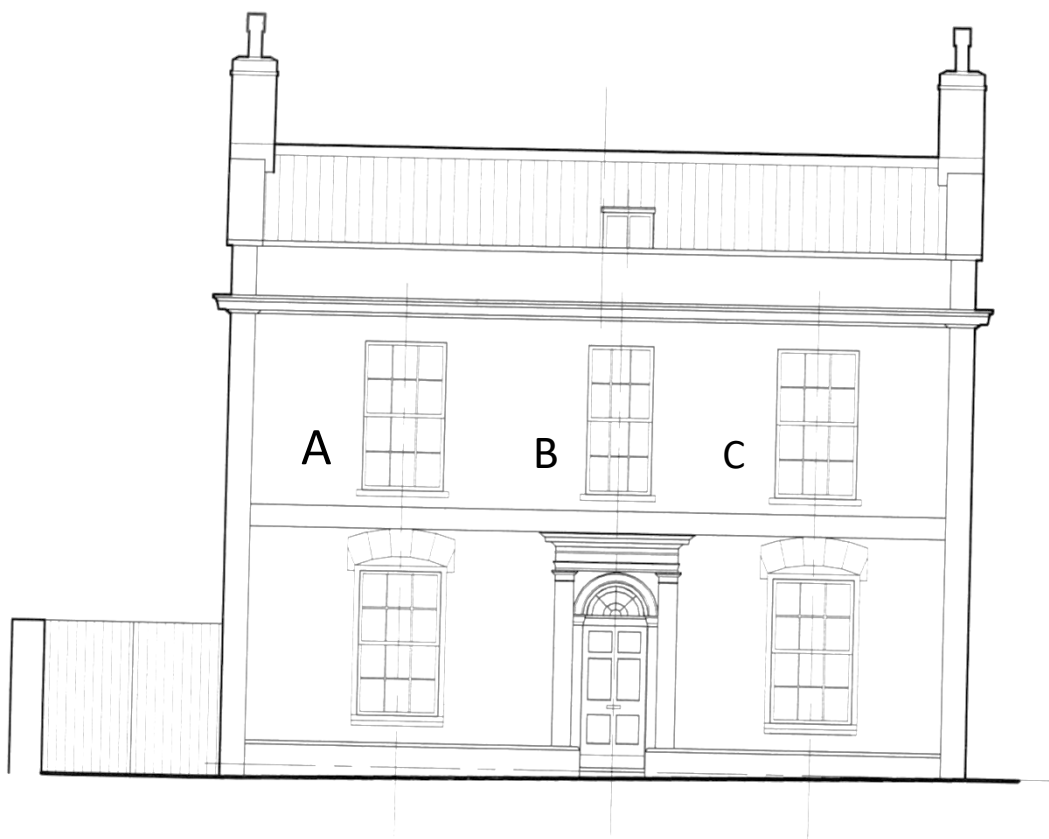
Restoration and part renewal of the 3 first floor sash windows marked on front elevation diagram as A, B and C.

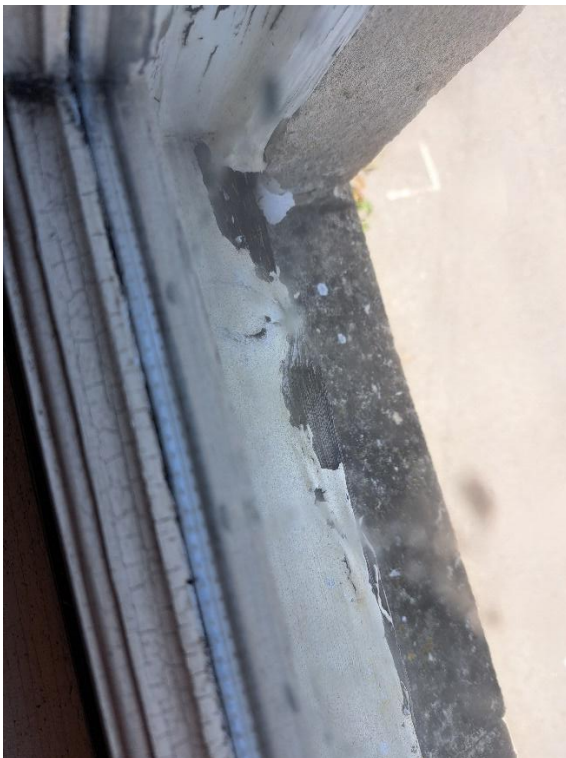
**Example of sill rot in window C**

CTWS advised that the frames of all three windows will need restoration including cutting back of rotted wood and scarfing in of high-quality new timber. Use of specialist care resin to provide a high-quality seal between new and existing wood.

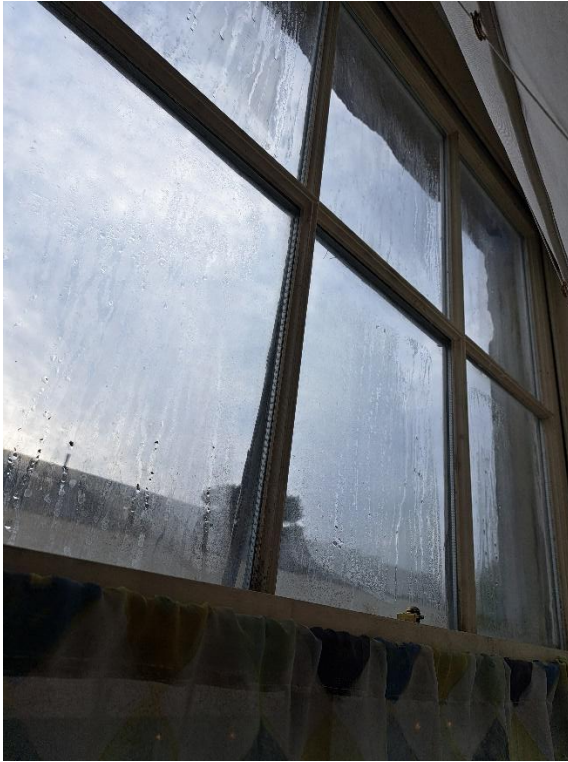
Example of failed secondary glazing unit, also shows example of glazing bar loss. Window A.

They have advised that the repair of the sashes themselves is no longer viable and have quoted like for like replacement of all six existing soft wood sashes with hardwood, double glazed replacements. These would replicate the existing design, profiles and operation exactly.

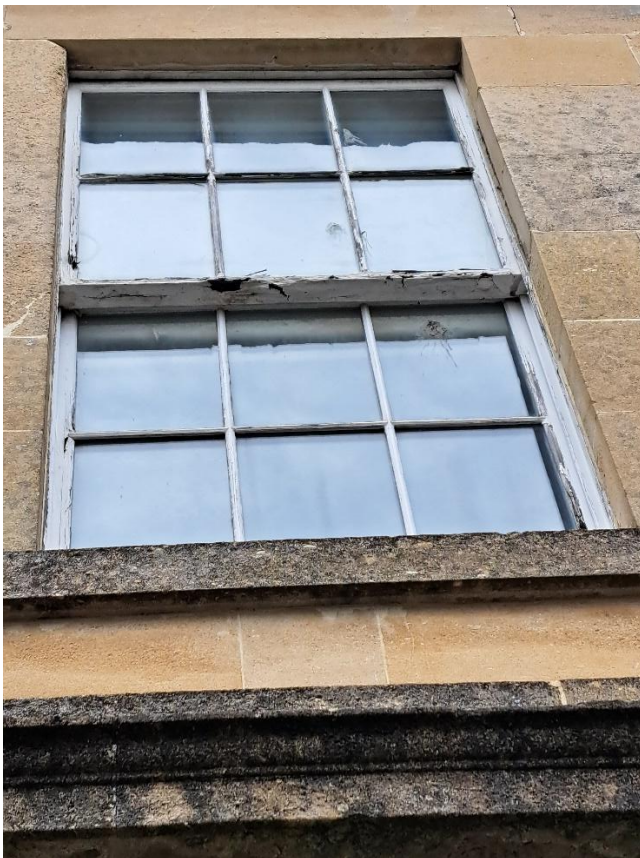
Example of sash rot Window B.
