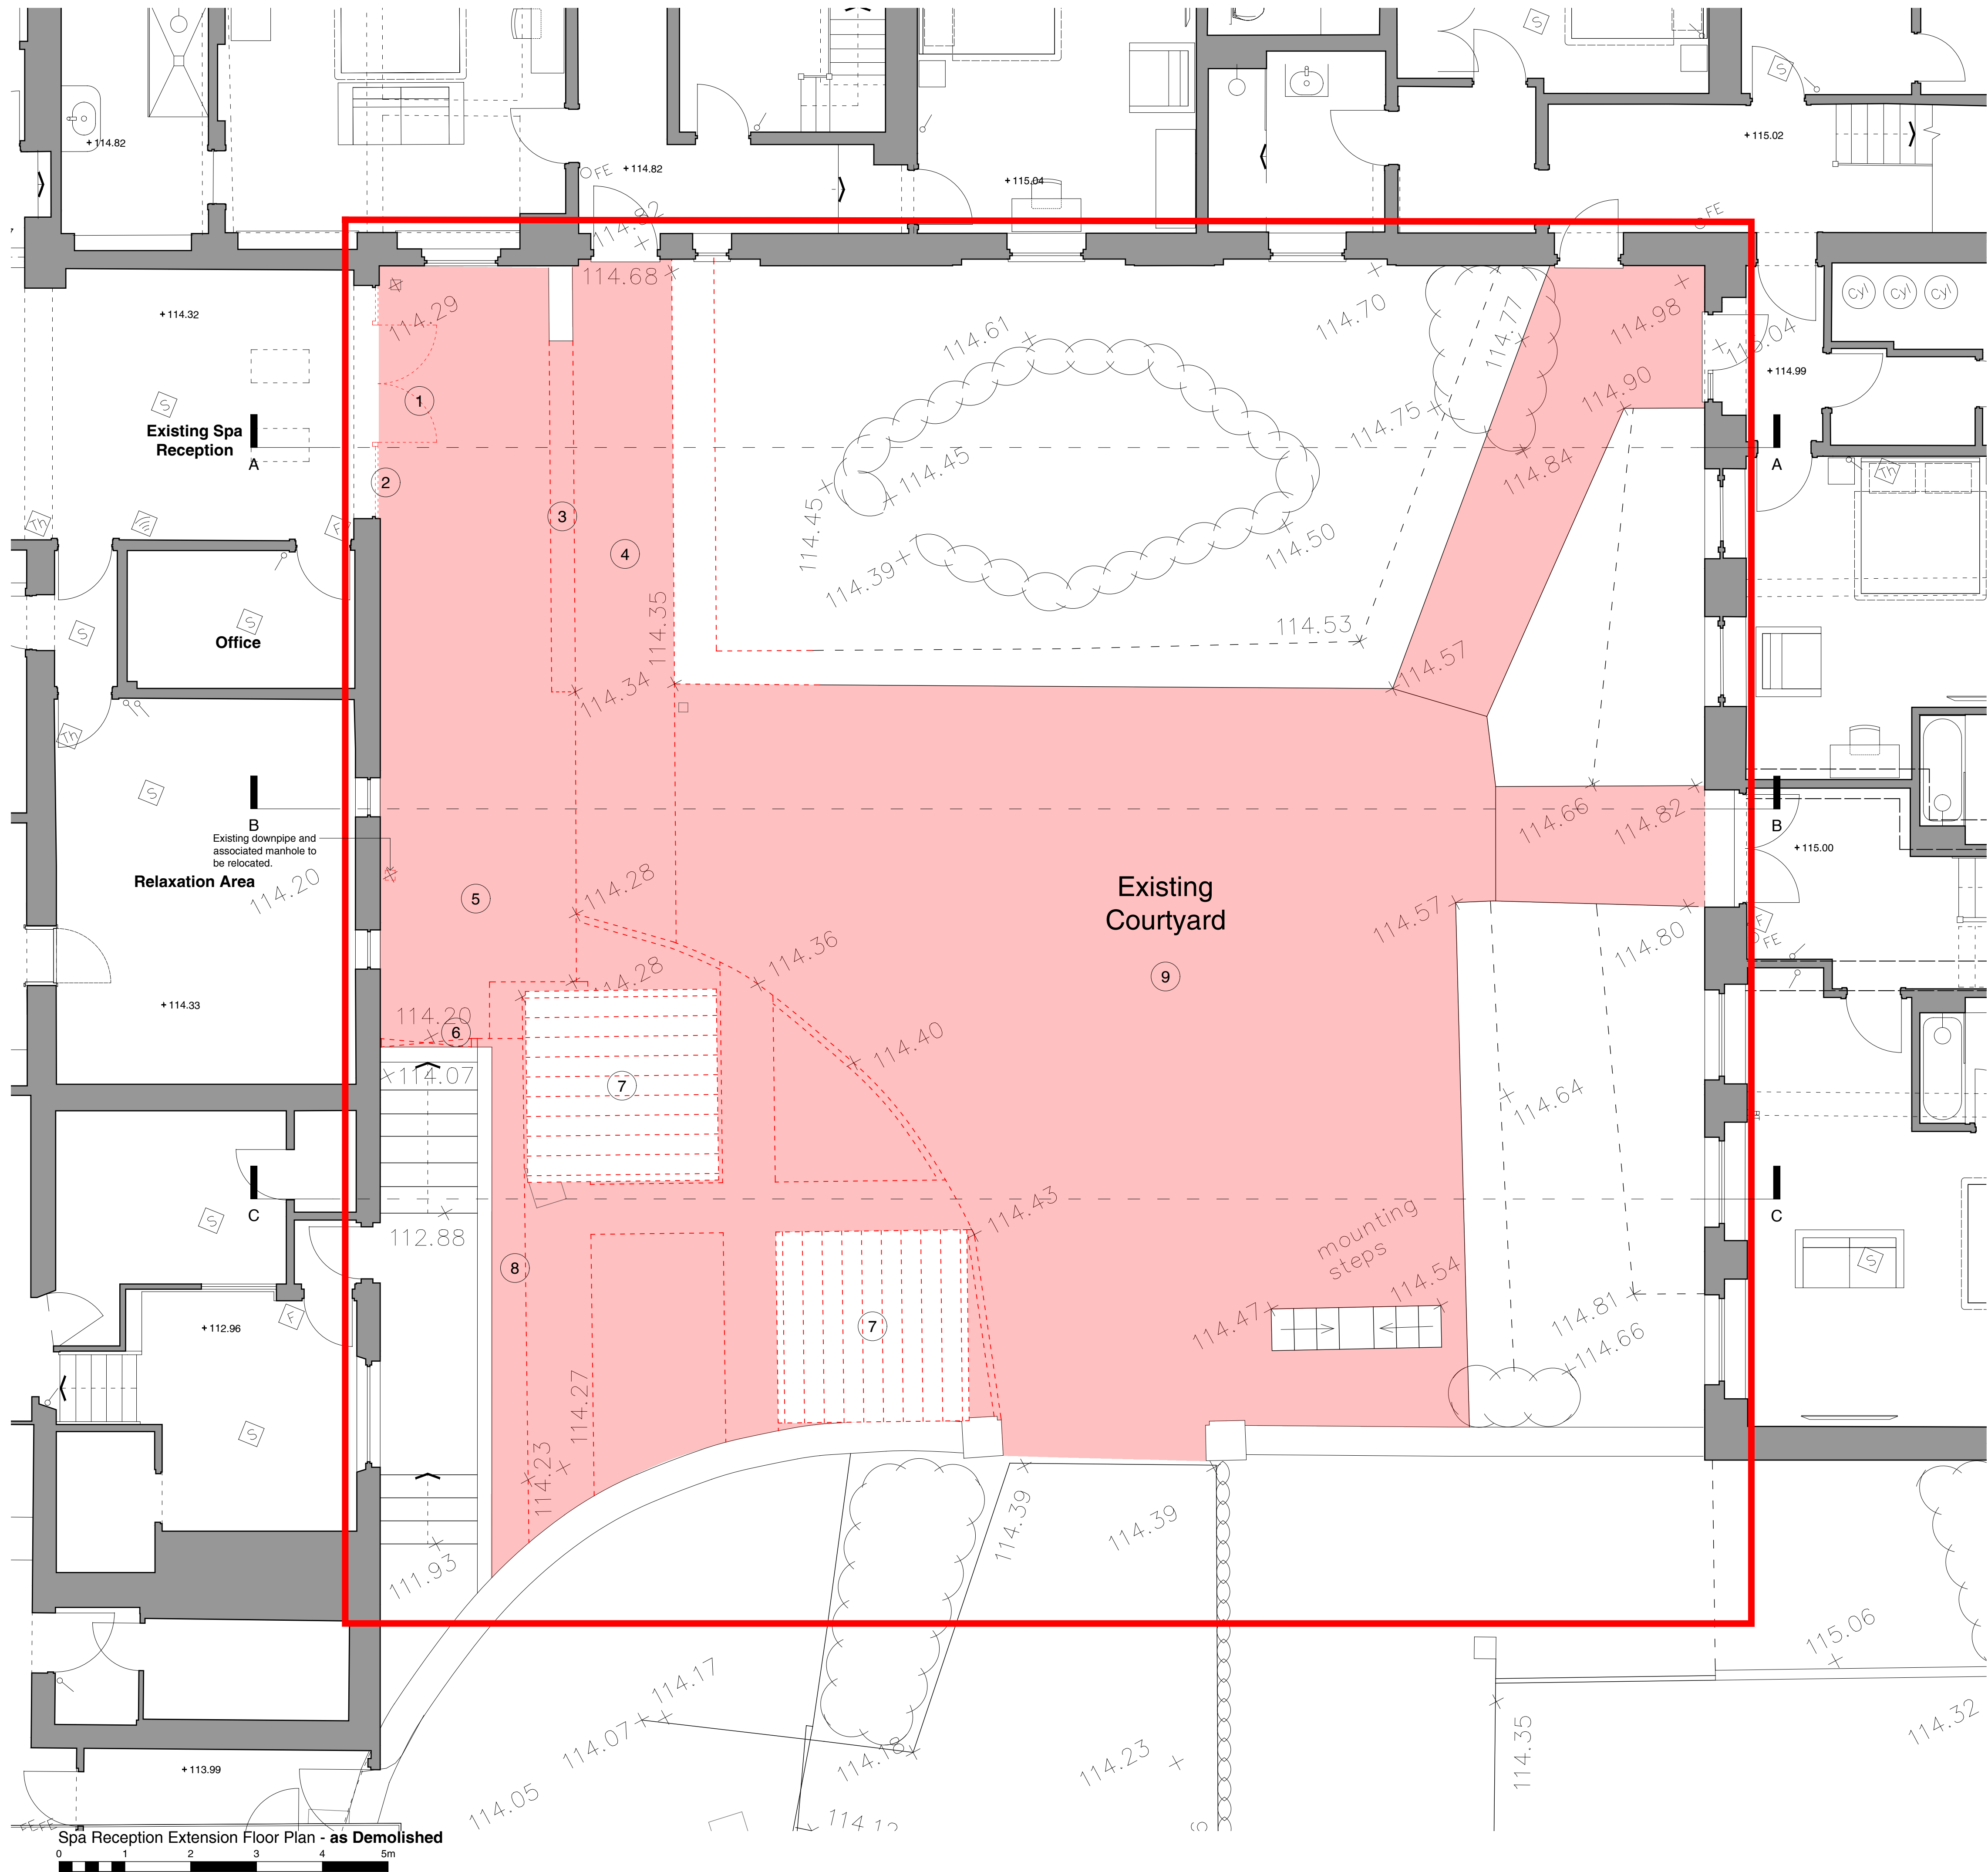
- 1 Existing double doors to be removed to form new opening to Spa reception.
- 2 Existing sidelights to be removed and walls prepared for new plaster, skim plaster and paint.
- 3 Existing low-level wall to be demolished.
- 4 Existing ramped access to be removed and repositioned
- 5 Existing manhole to be relocated.
- 6 Existing close boarded fence to be removed
- 7 Existing Cabana structures to be removed
- 8 Close boarded fence to be removed
- 9 Existing surface to be removed
