## R18082 Bath Road, Melksham - Hedgerow assessment

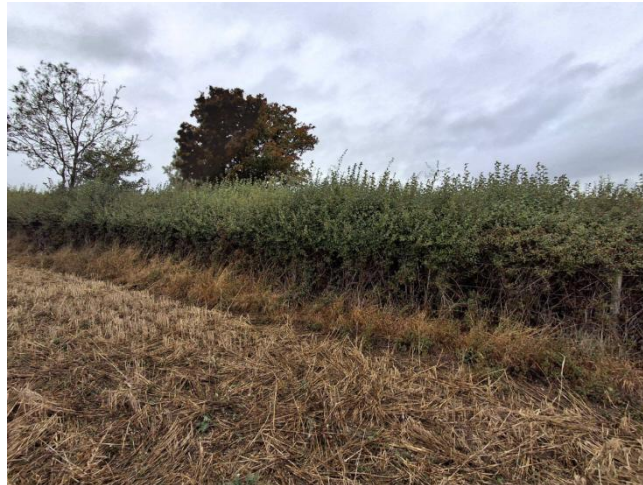
### Hedgerow 1 (H1) – 6m section for removal

Grid Reference: ST 92506 62084

| Ref. | Type | Description | Removal notice required | Important hedgerow (ecology) |
|---|---|---|---|---|
| H1 | Shrubby hedgerow | Species-rich shrubby hedgerow with trees.<br>Woody species: Blackthorn, elm, field maple, hazel with ash standards.<br>Features (5): Schedule 5 species (bats), Bank, gaps under 10% of length, length >100m with standard trees, parallel hedgerow and ditch. 3 connection points | Yes | Yes |

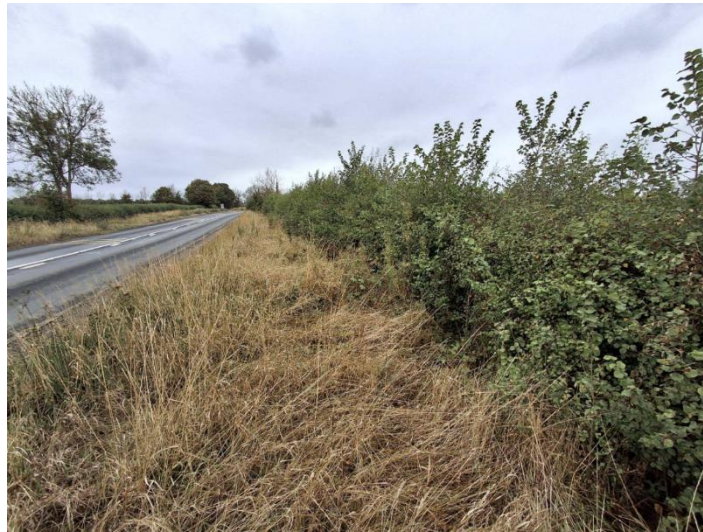
## Hedgerow 2 (H2) – 6m section for removal

Grid Reference: ST 92492 62107

| Ref. | Type | Description | Removal notice required | Important hedgerow (ecology) |
|---|---|---|---|---|
| H2 | Shrubby hedgerow | Species-rich shrubby hedgerow with trees.<br>Woody species: Hazel, hawthorn, blackthorn with ash standards.<br>Features (5): Schedule 5 species (bats), Bank, gaps under 10% of length, length >100m with standard trees, parallel hedgerow and ditch. 3 connection points | Yes | Yes |

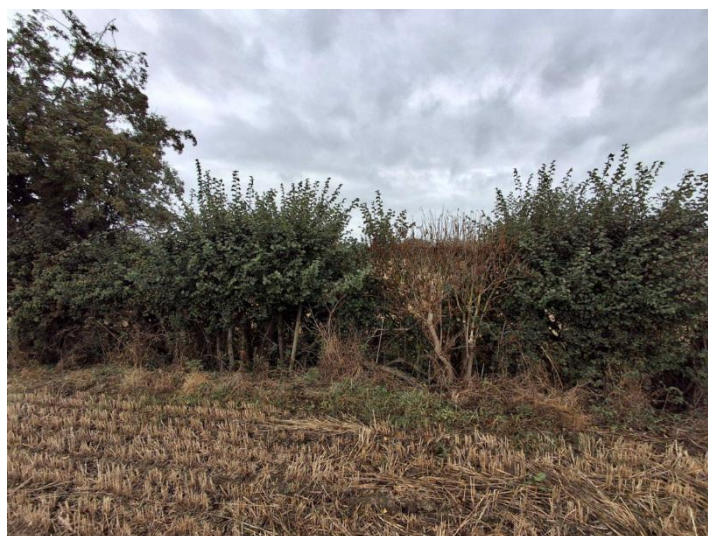
### Hedgerow 3 (H3) – 6m section for removal

Grid Reference: ST 92491 61976

| Ref. | Type | Description | Removal notice required | Important hedgerow (ecology) |
|---|---|---|---|---|
| H3 | Shrubby hedgerow | Species-poor shrubby hedgerow with trees.<br>Woody species: Hawthorn, field maple, hazel with occasional hawthorn standards.<br>Features (4): Schedule 5 species (bats), gaps under 10% of length, length >100m with standard trees, ditch, 4 connection points | Yes | No |
