## Appendix D Site Walkover Plan and Photographs

| <b>Project:</b> | Flaxlands Solar Farm | <b>Date:</b> 11/11/2024 |
| <b>Job Number:</b> | 60727989 | <b>Undertaken by:</b> LR |
| <b>Site Location:</b> | Wootton Bassett, Swindon | |

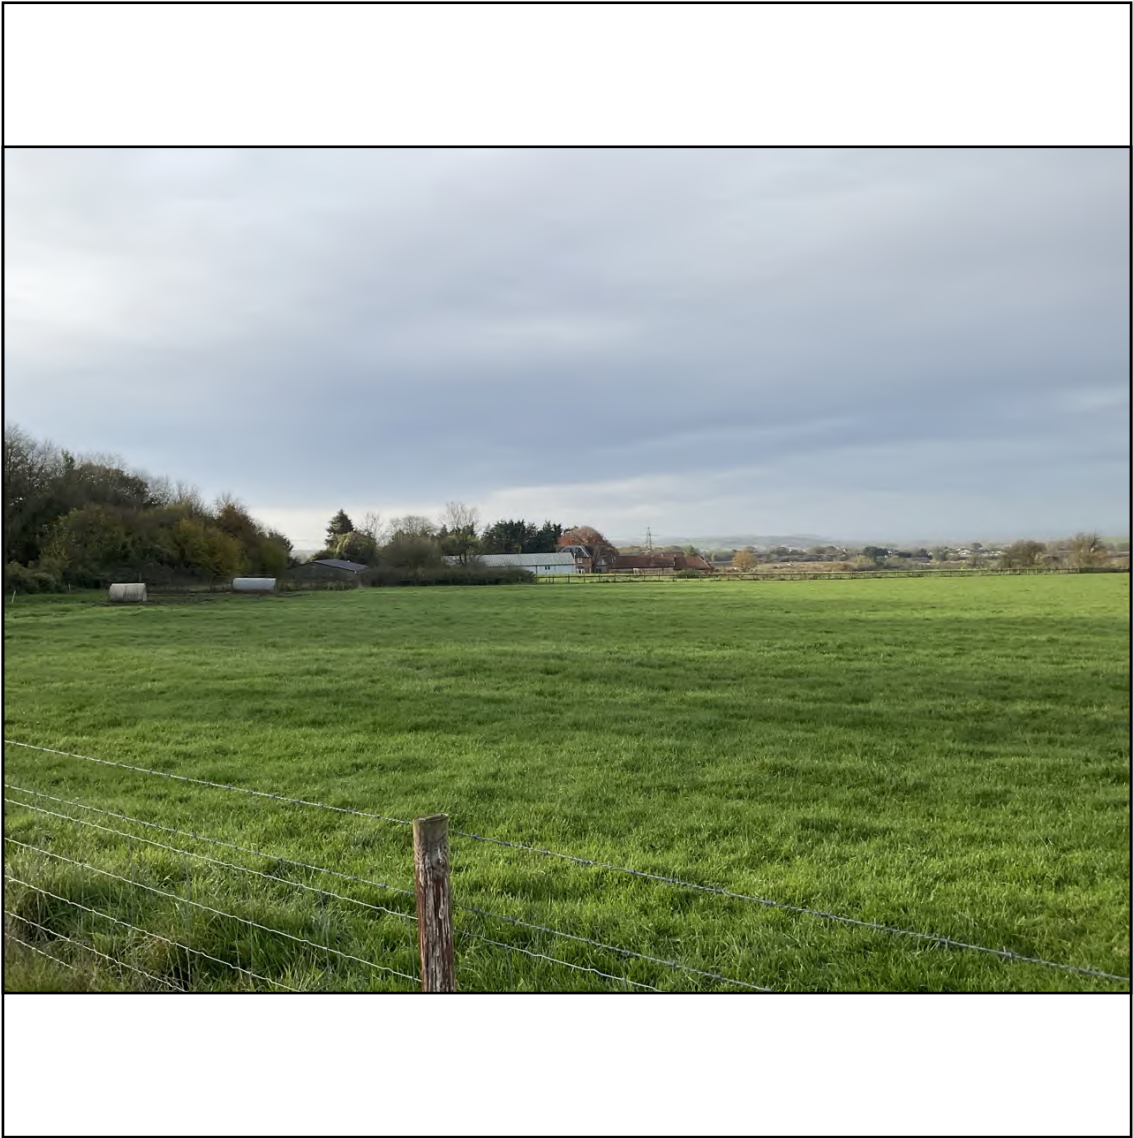
| Feature Description : | Viewpoint looking southwest from track |

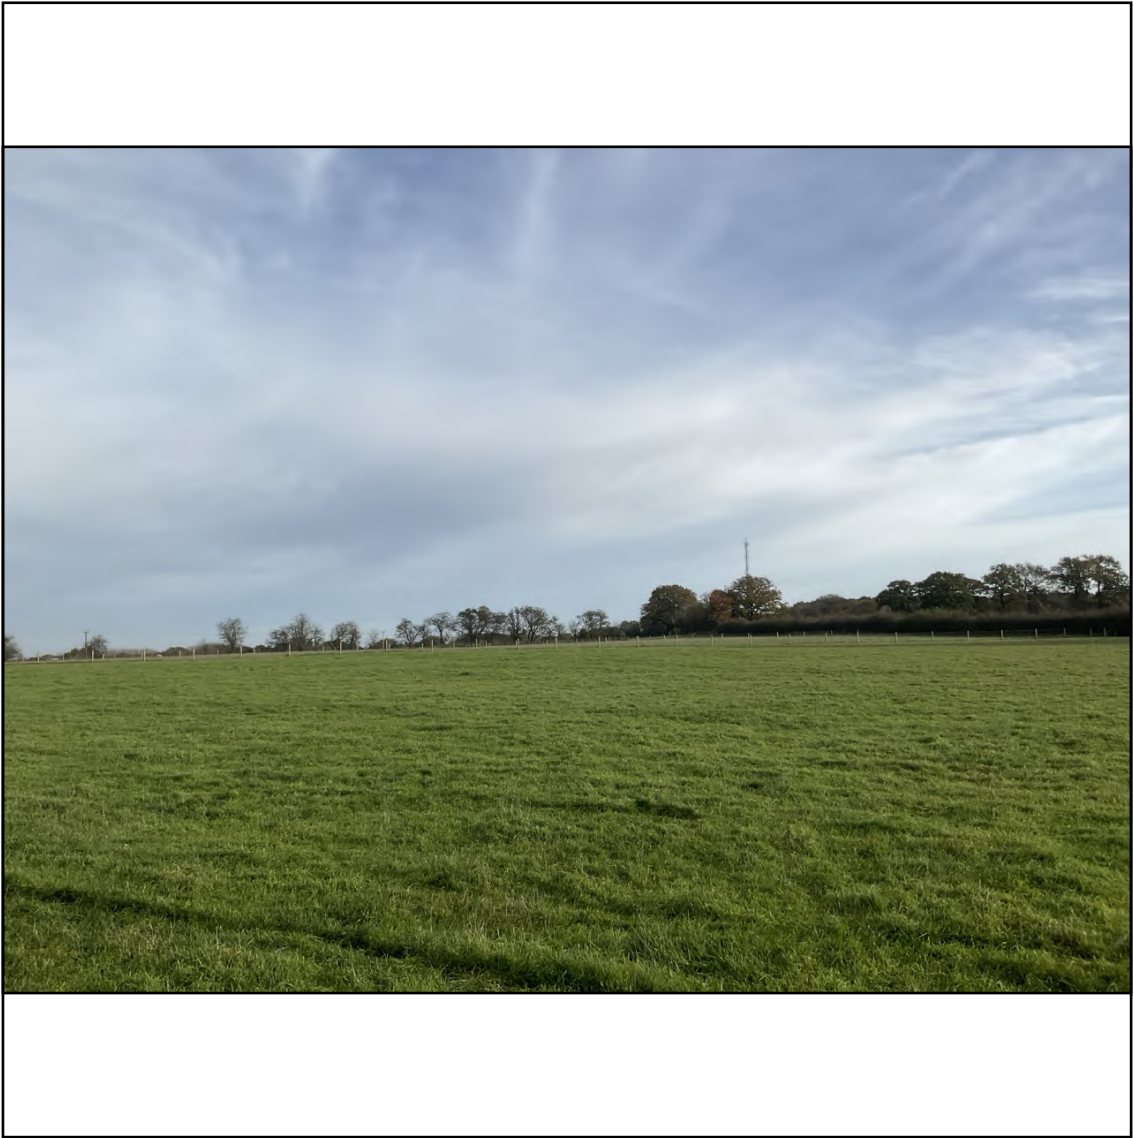
| Feature Description : | Looking northeast |

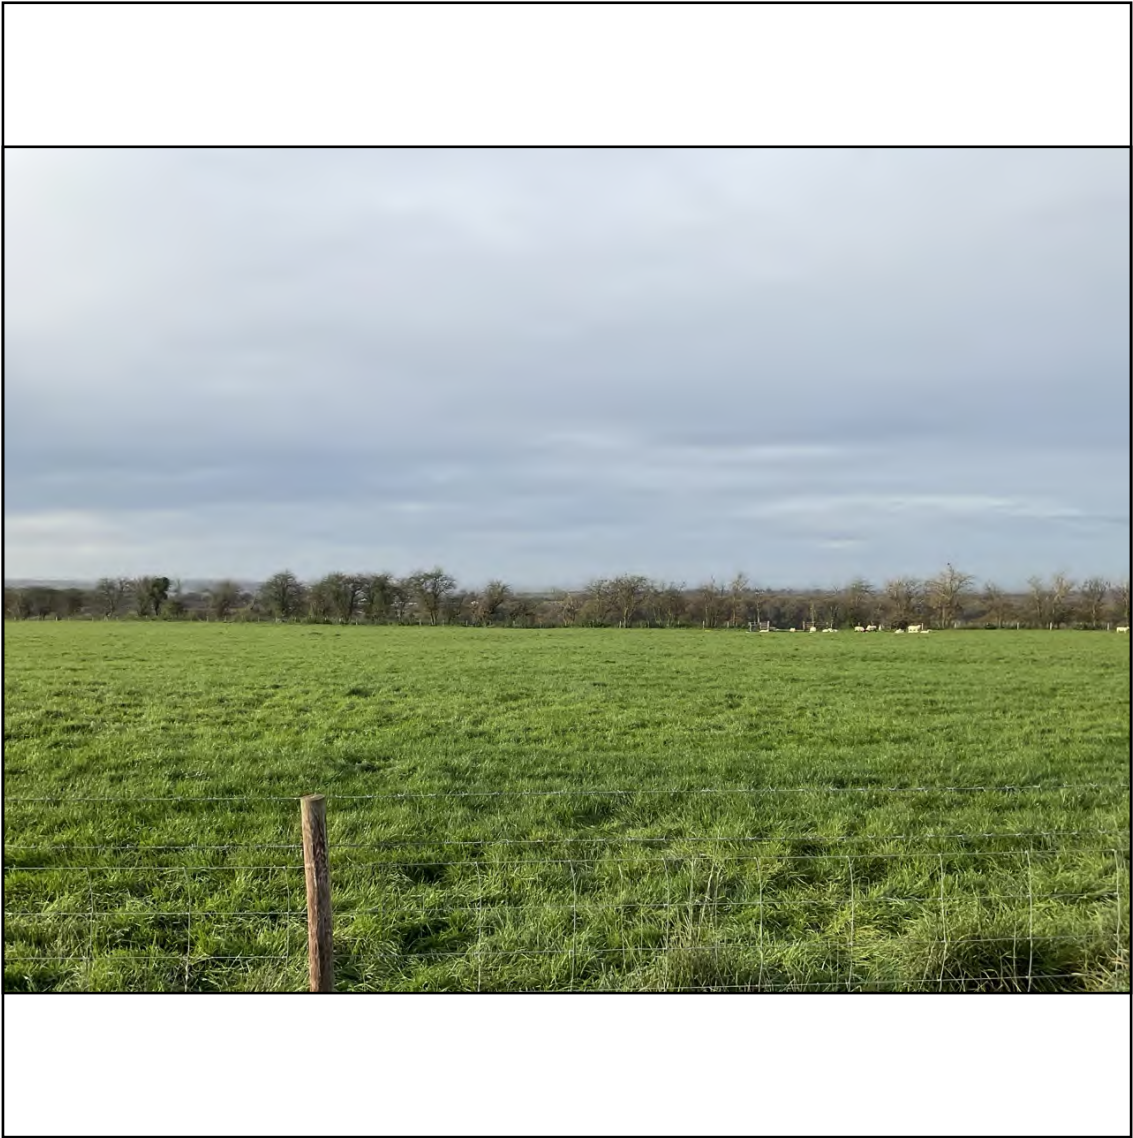
| Feature Description : | Looking west |

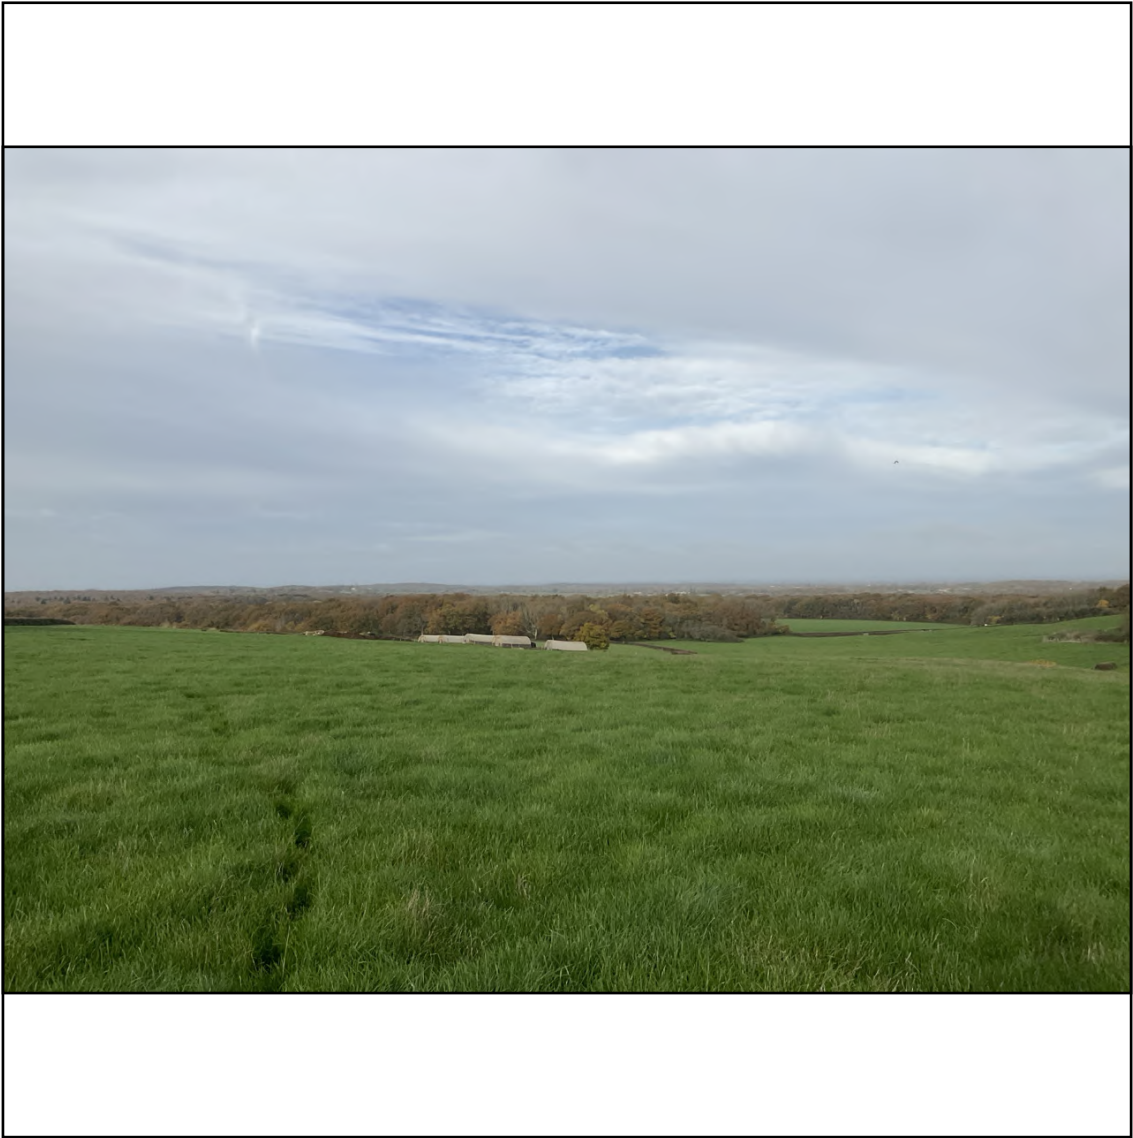
| Feature Description : | Slope |

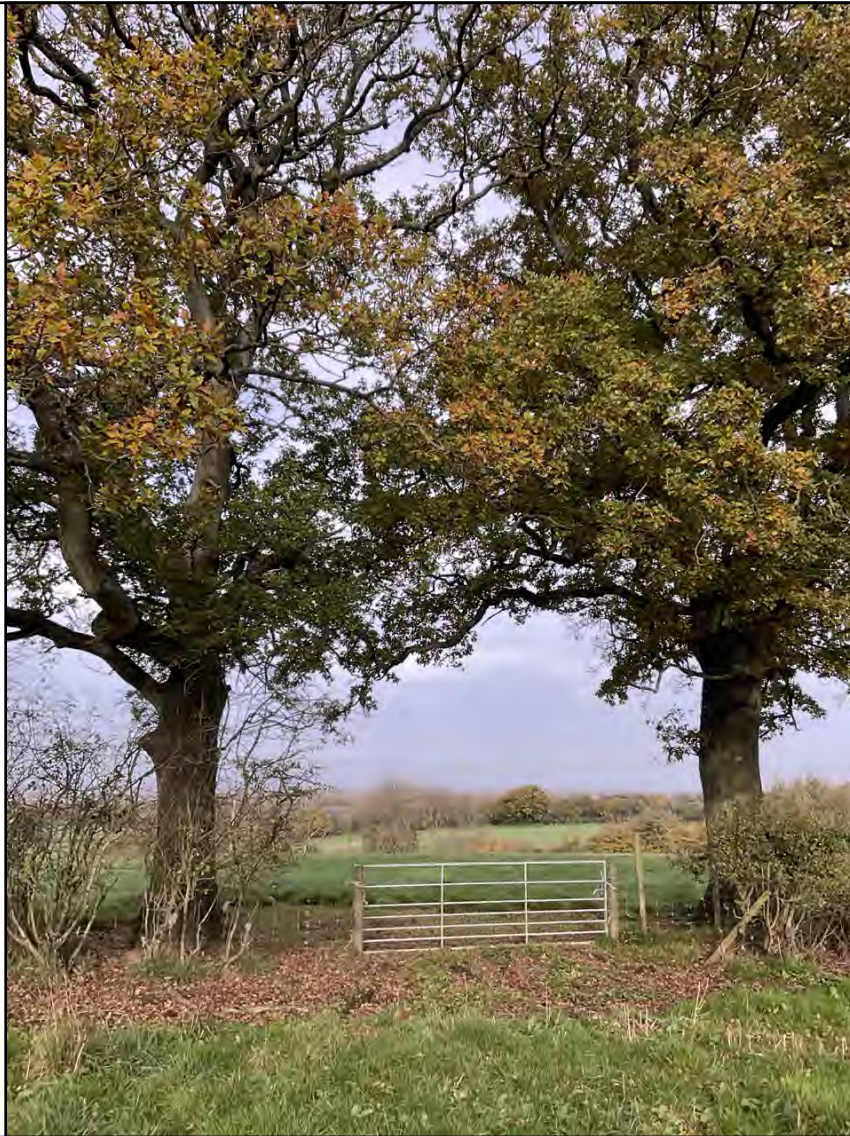
| Feature Description : | Access |

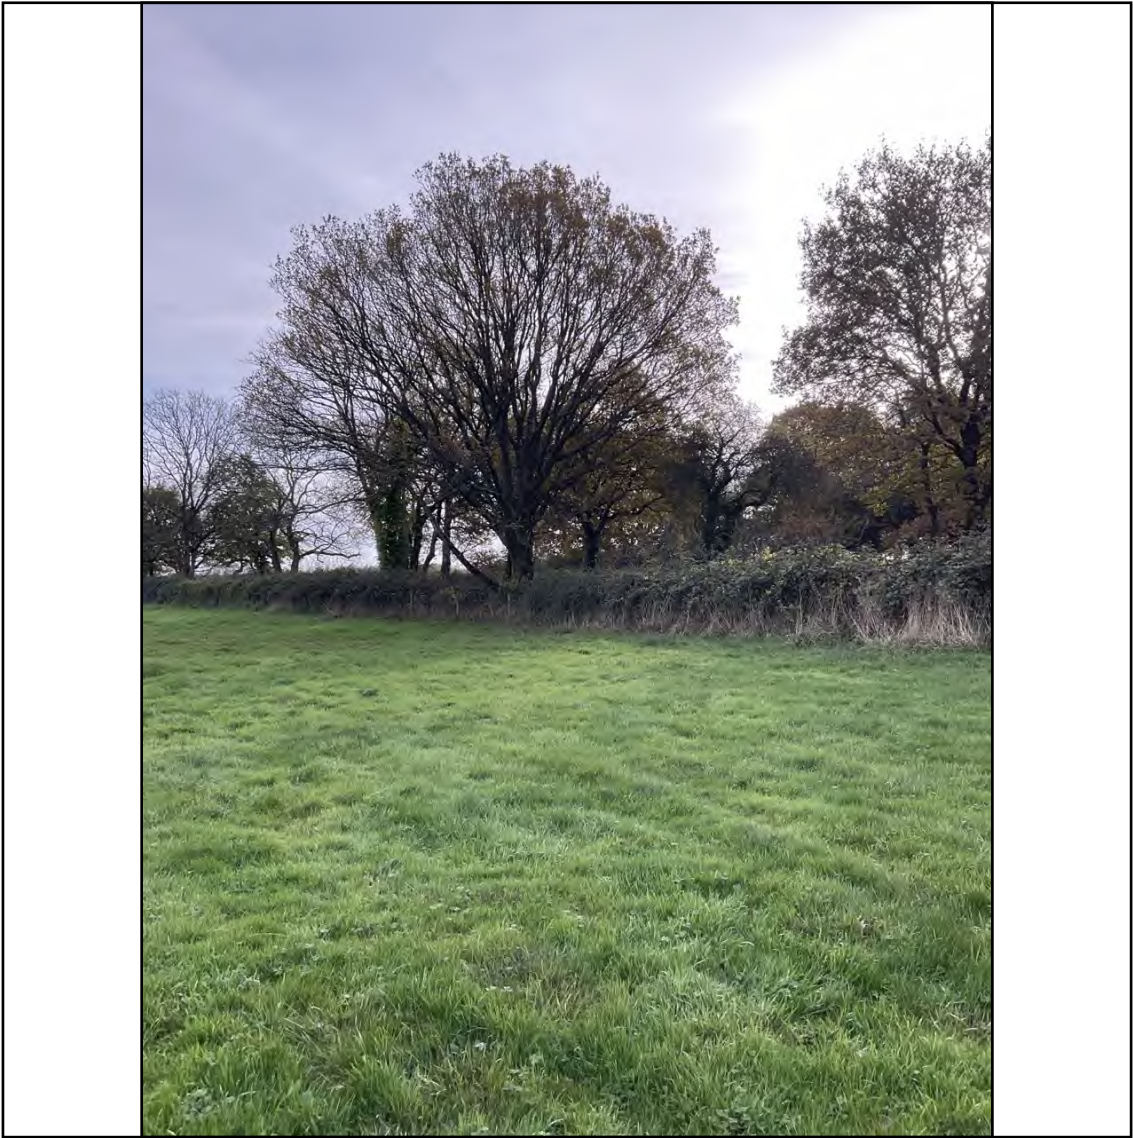
| Feature Description : | General area |

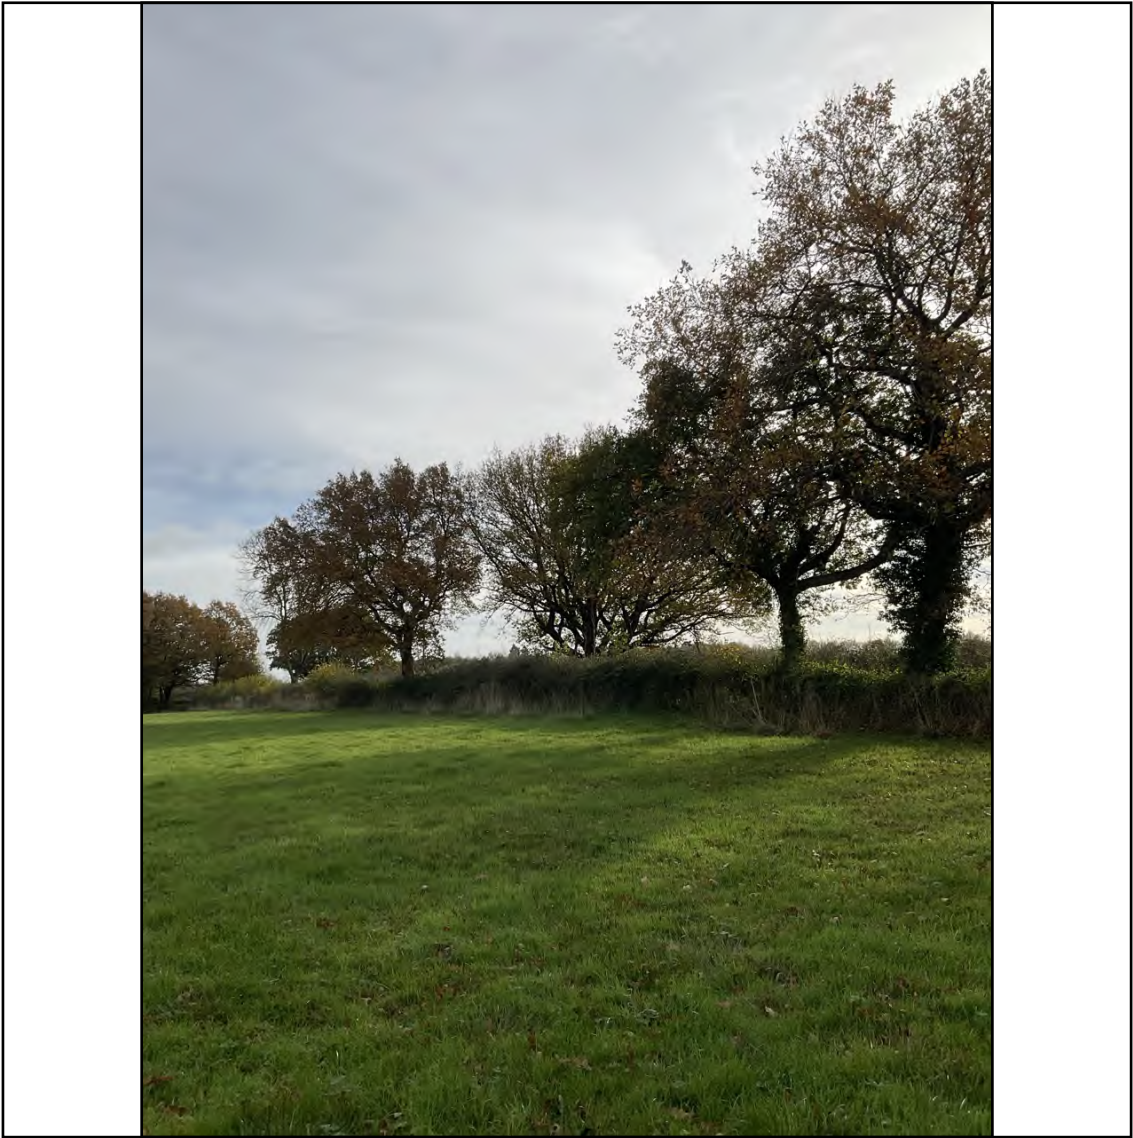
| Feature Description : | General area and oh lines |

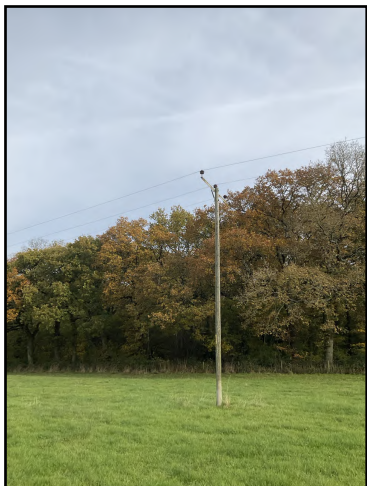
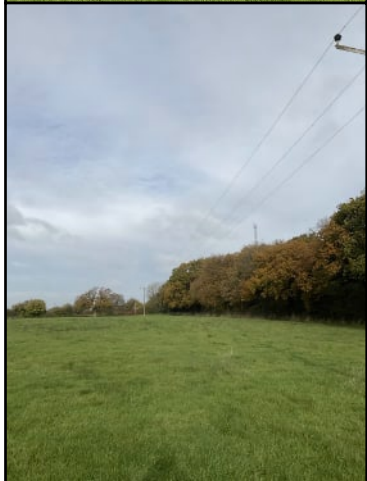
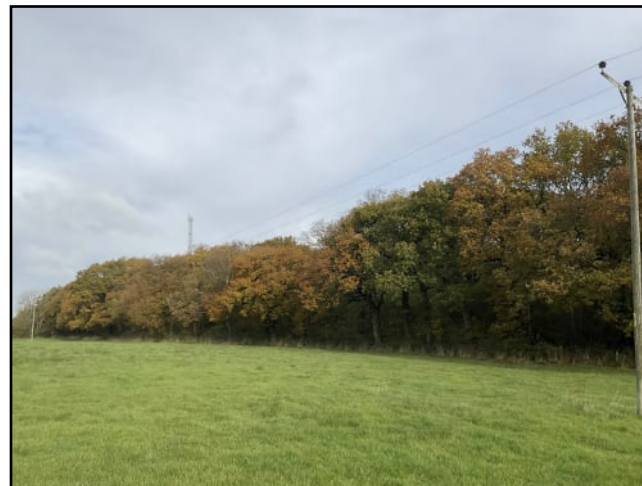
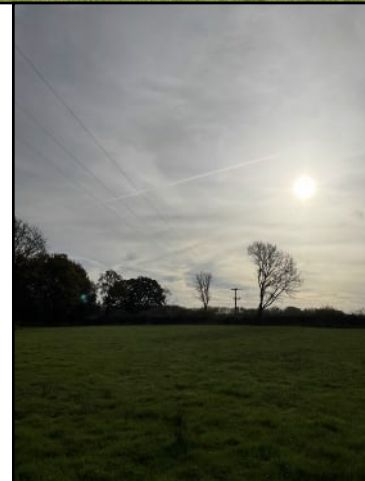
29

| Feature Description : | Sloping topography into depression approx 5mx5m |

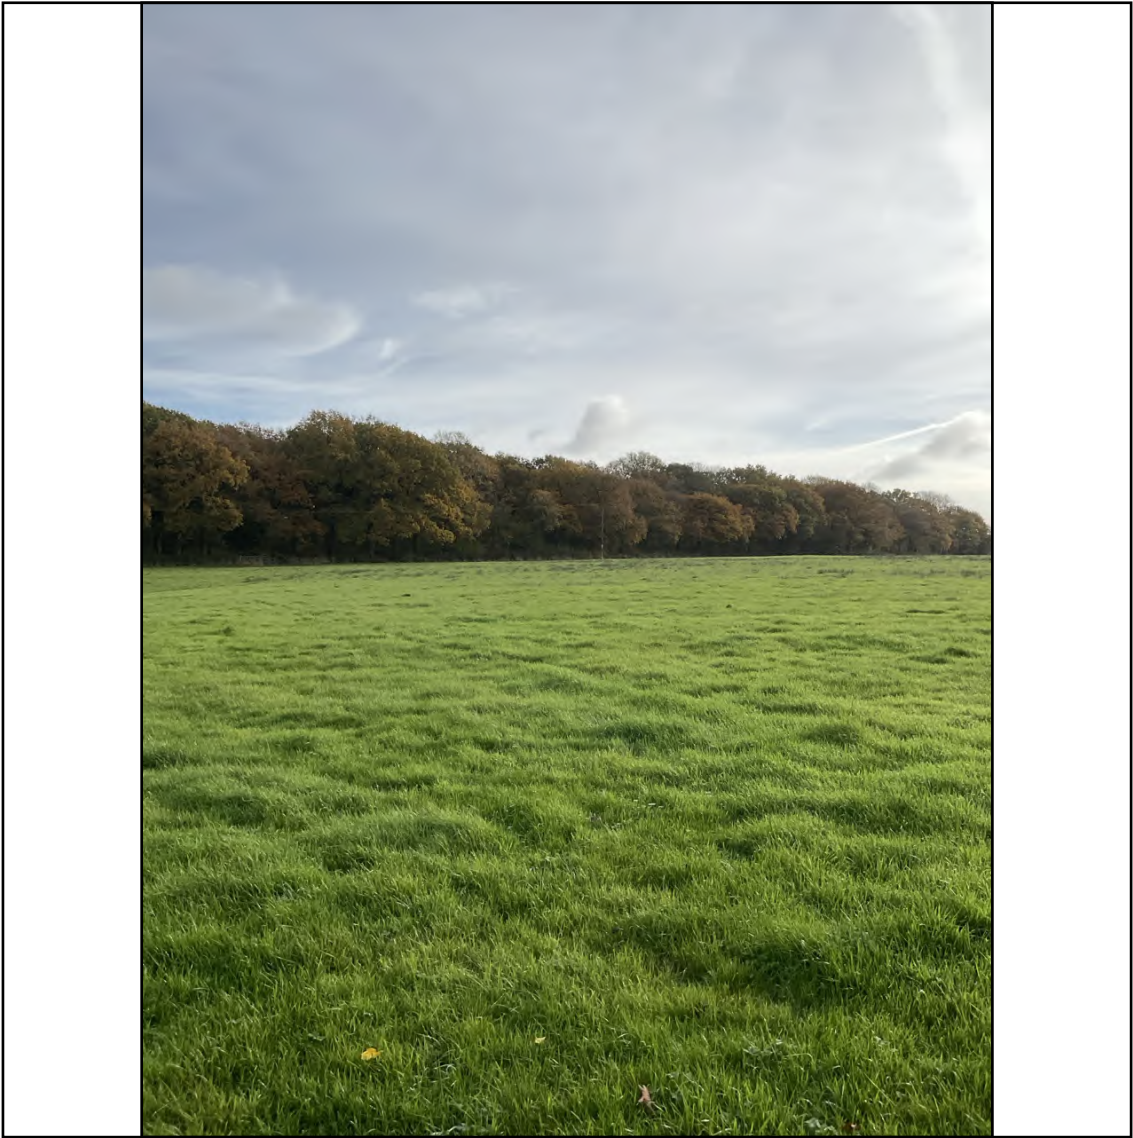
| Feature Description : | General view |

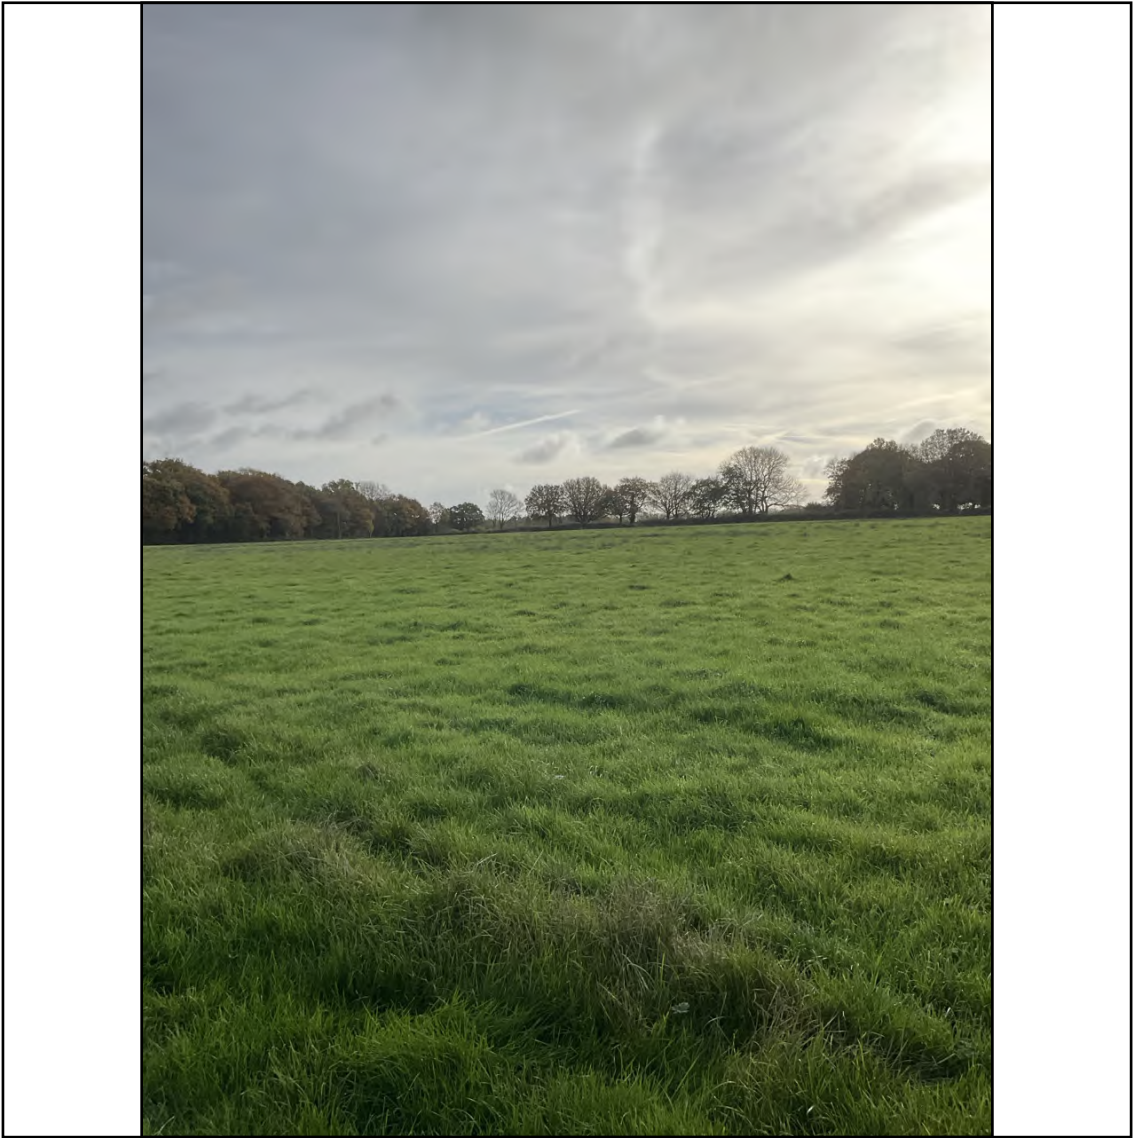
| Feature Description : | General view |

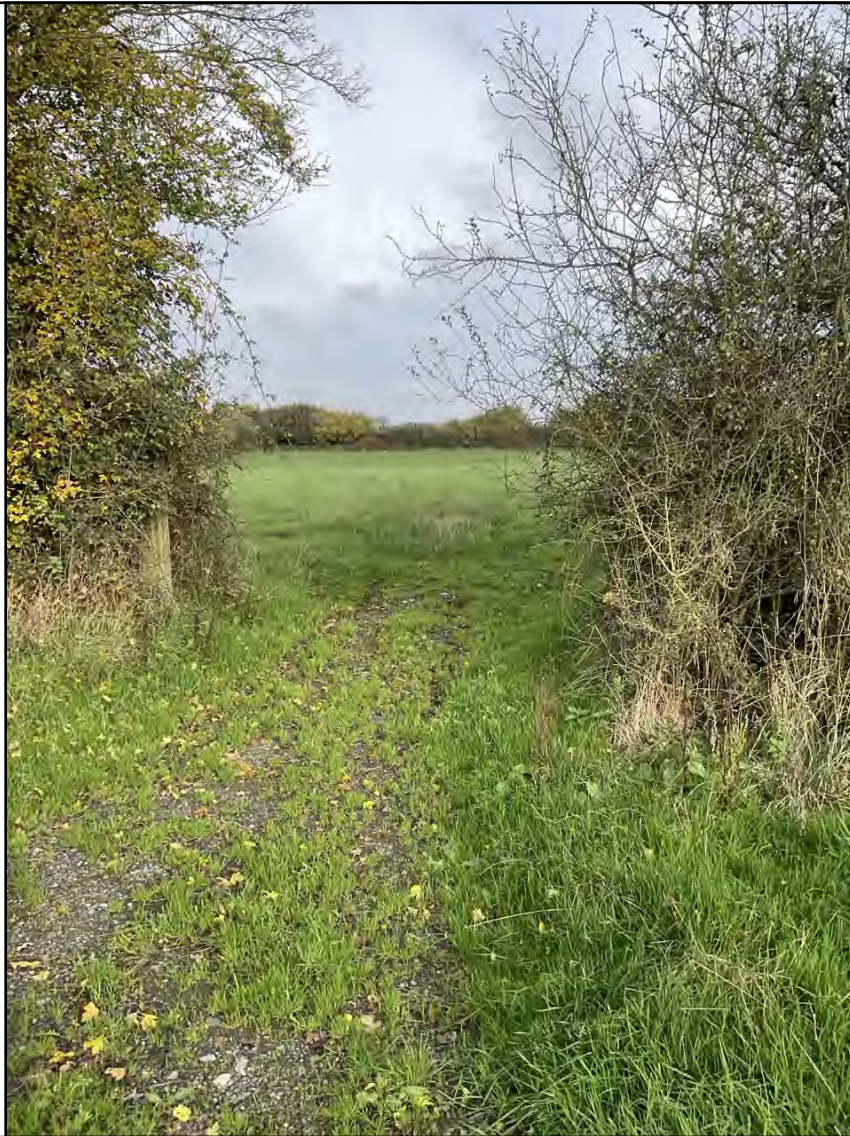
| Feature Description : | Gateway |

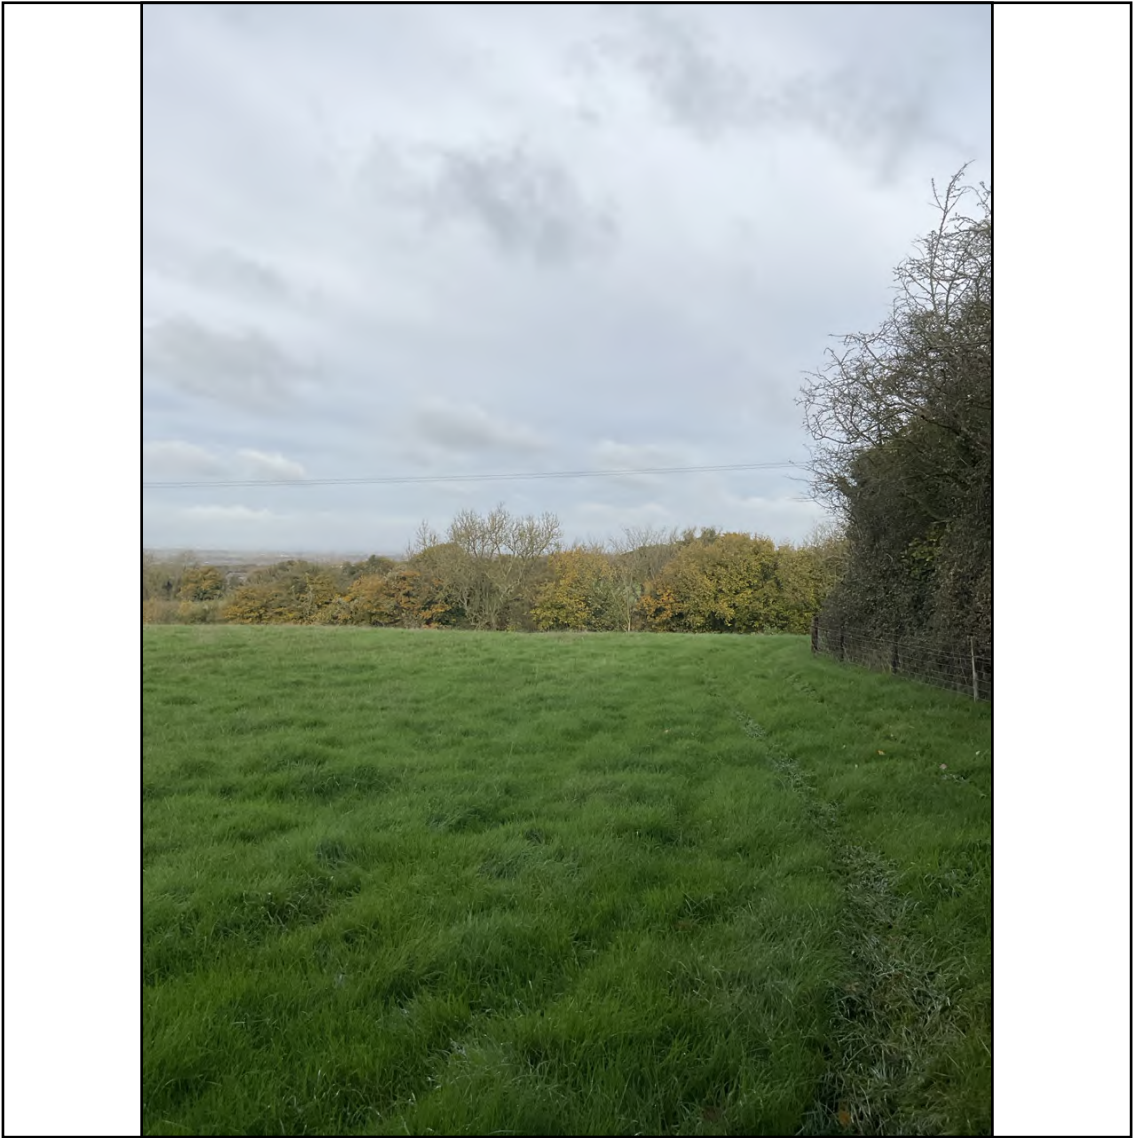
| Feature Description : | General view |

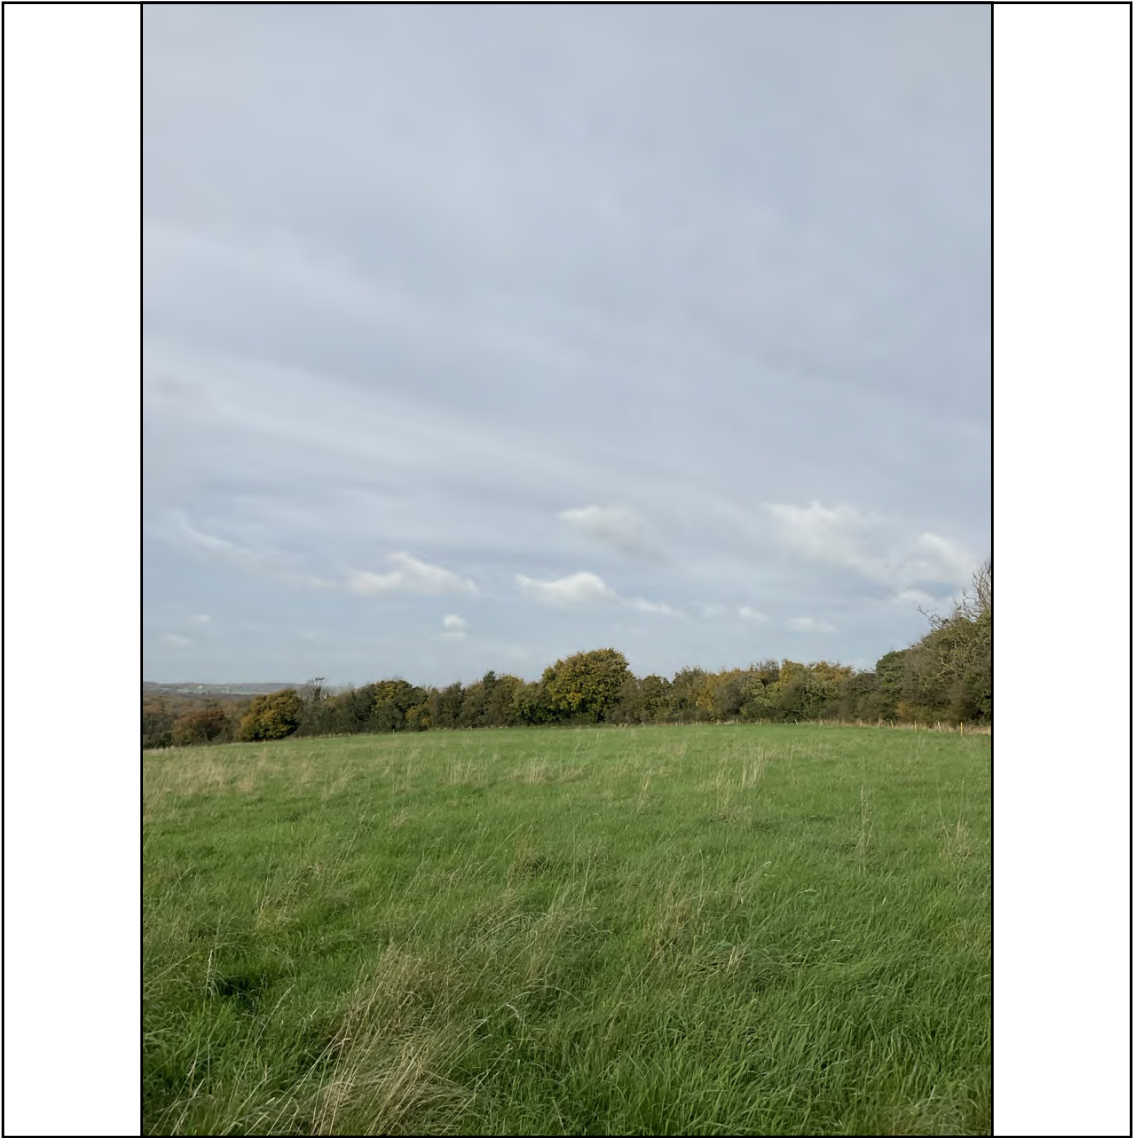
| Feature Description : | General view |

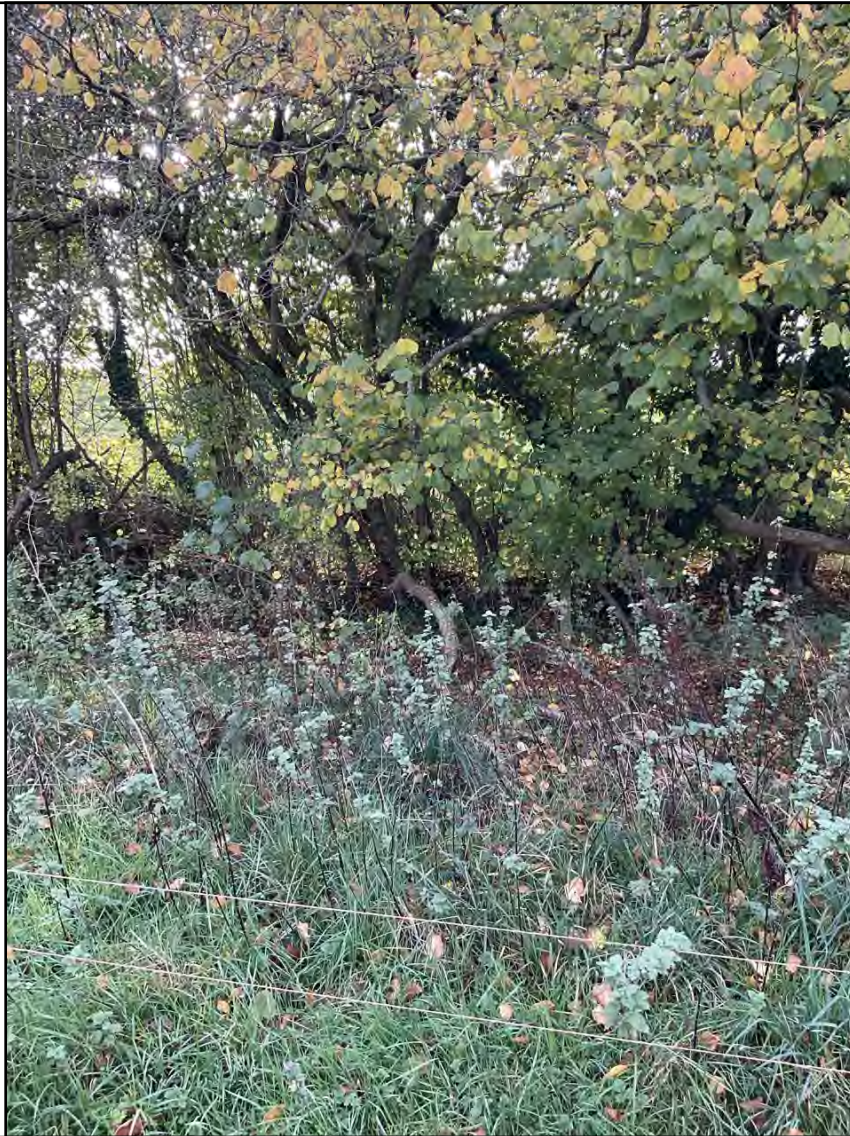
| Feature Description : | Slope |

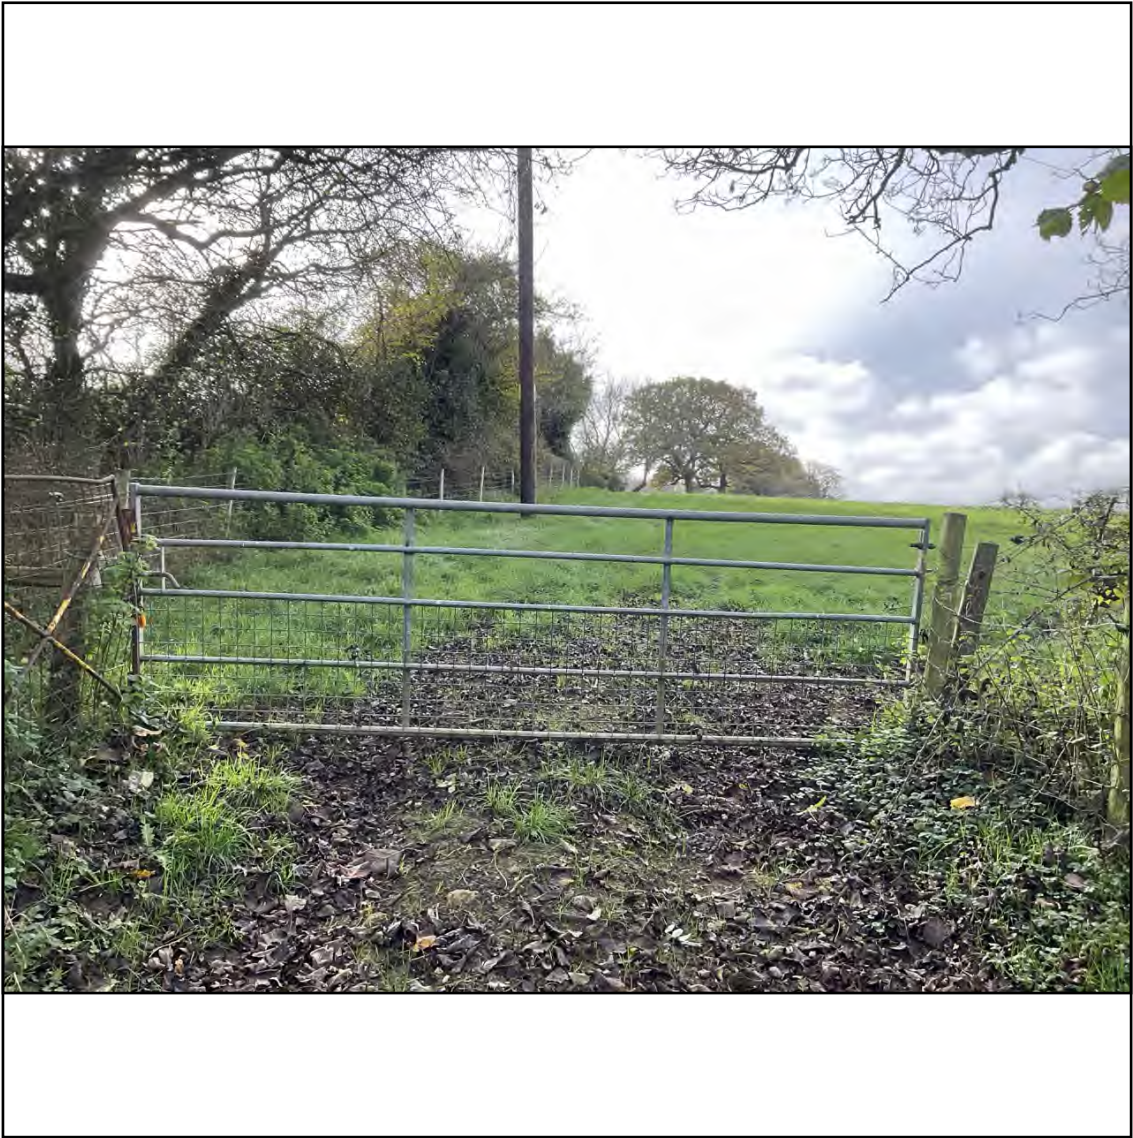
| Feature Description : | Gate entry |

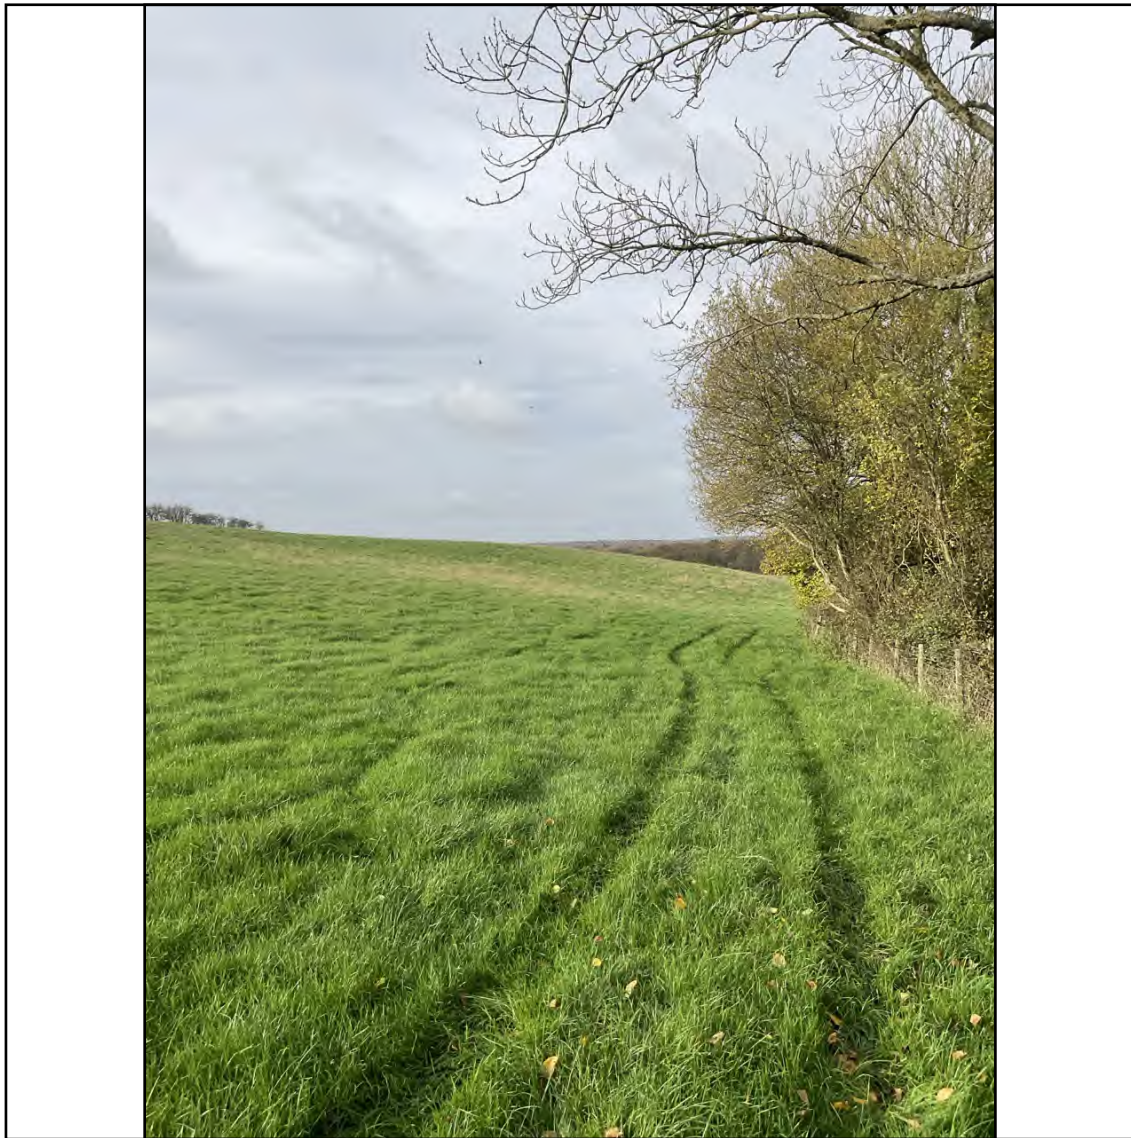
| Feature Description : | Approx 10m elevation |

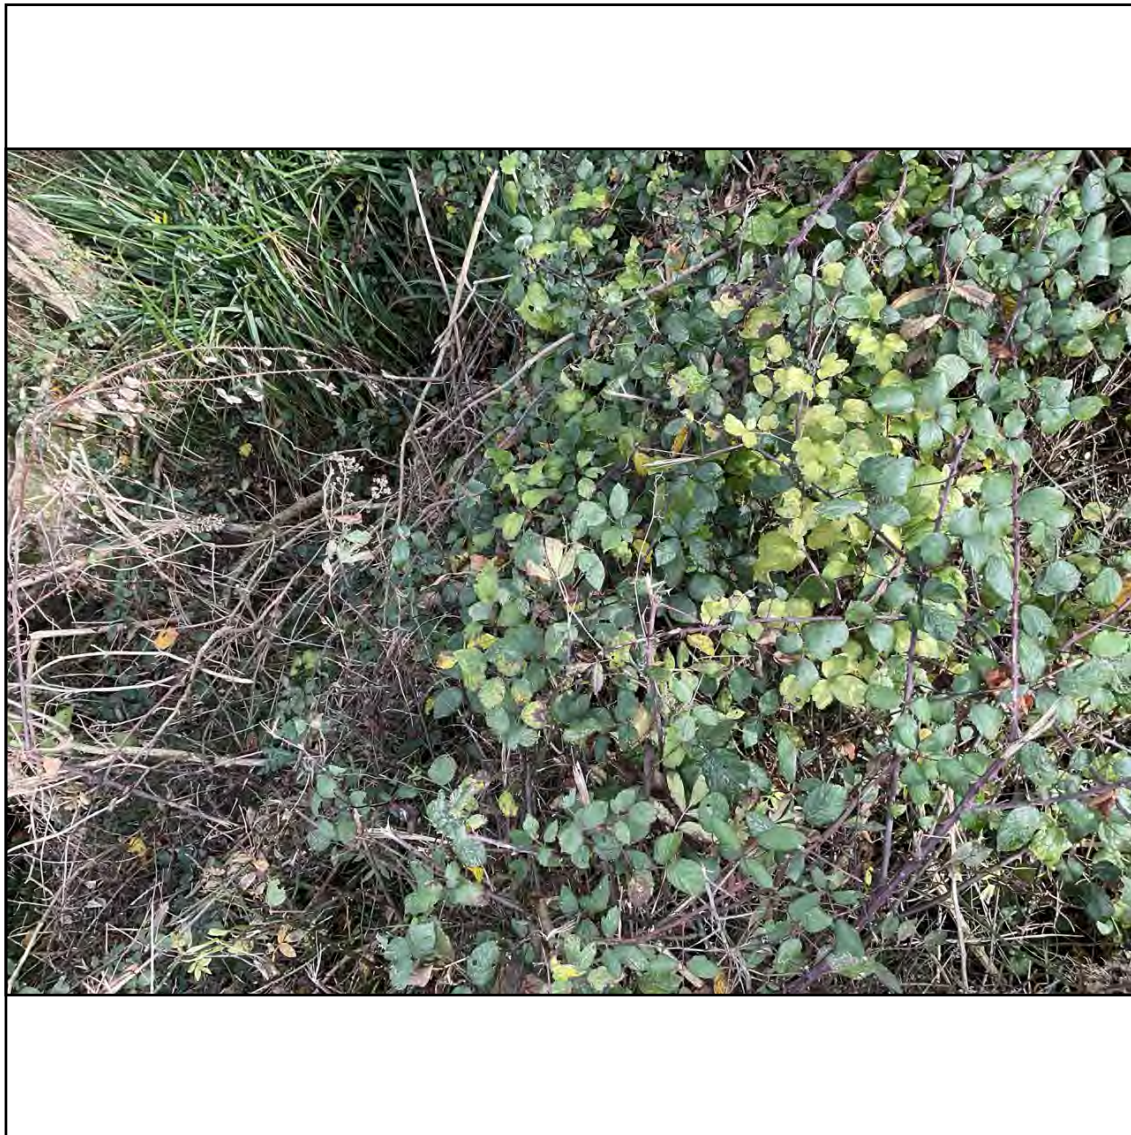
| OBJECTID : | 42 |

| Feature : | Surface water and marshy or soft ground (Rivers / streams / width / depth / |
| Feature Description : | Stream not visibl |

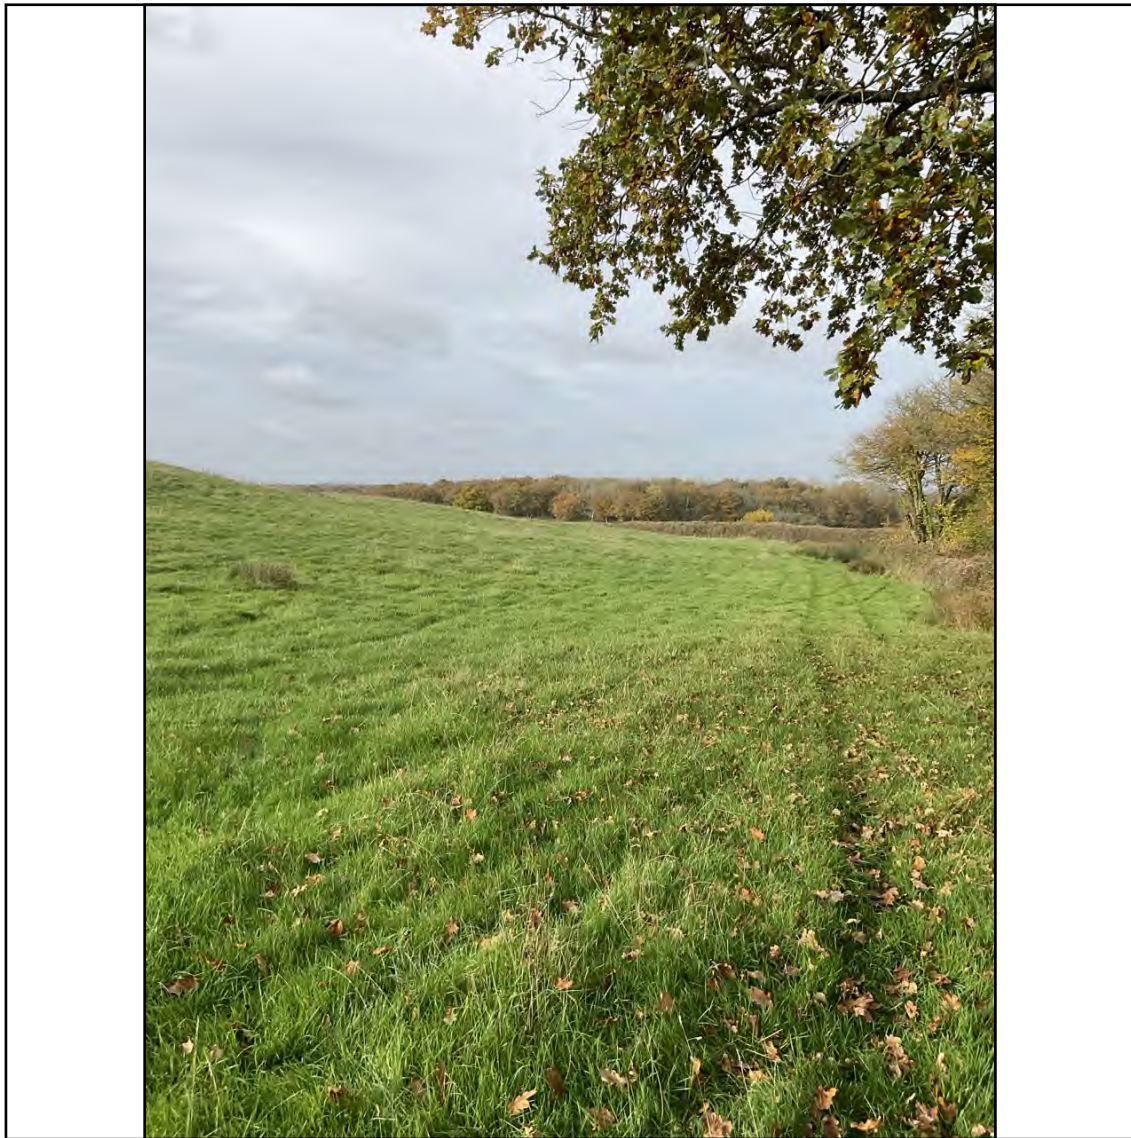
| OBJECTID : | 43 |

| Feature Description : | General view |

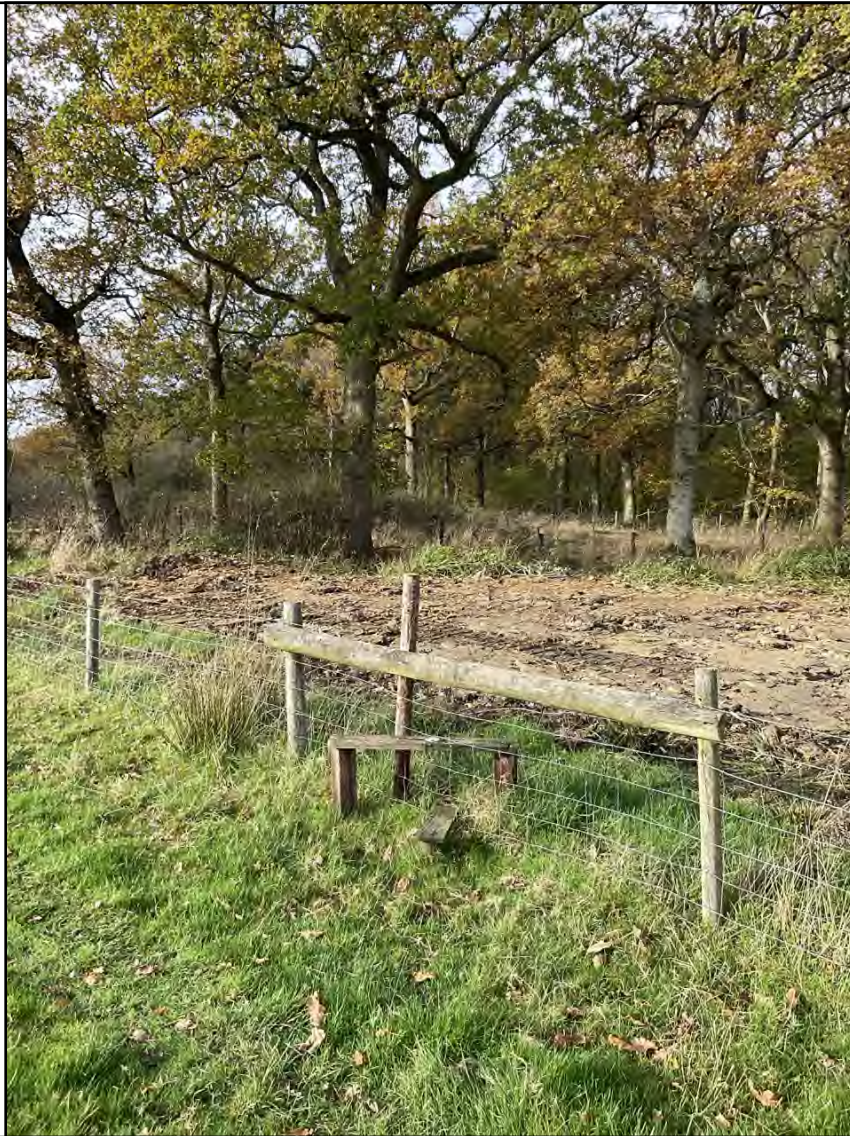
| Feature Description : | Pond |
