## Appendix D Site Walkover Plan and Photographs

| <b>Project:</b> | Flaxlands Solar Farm | <b>Date:</b> 11/11/2024 |
| <b>Job Number:</b> | 60727989 | <b>Undertaken by:</b> LR |
| <b>Site Location:</b> | Wootton Bassett, Swindon | |

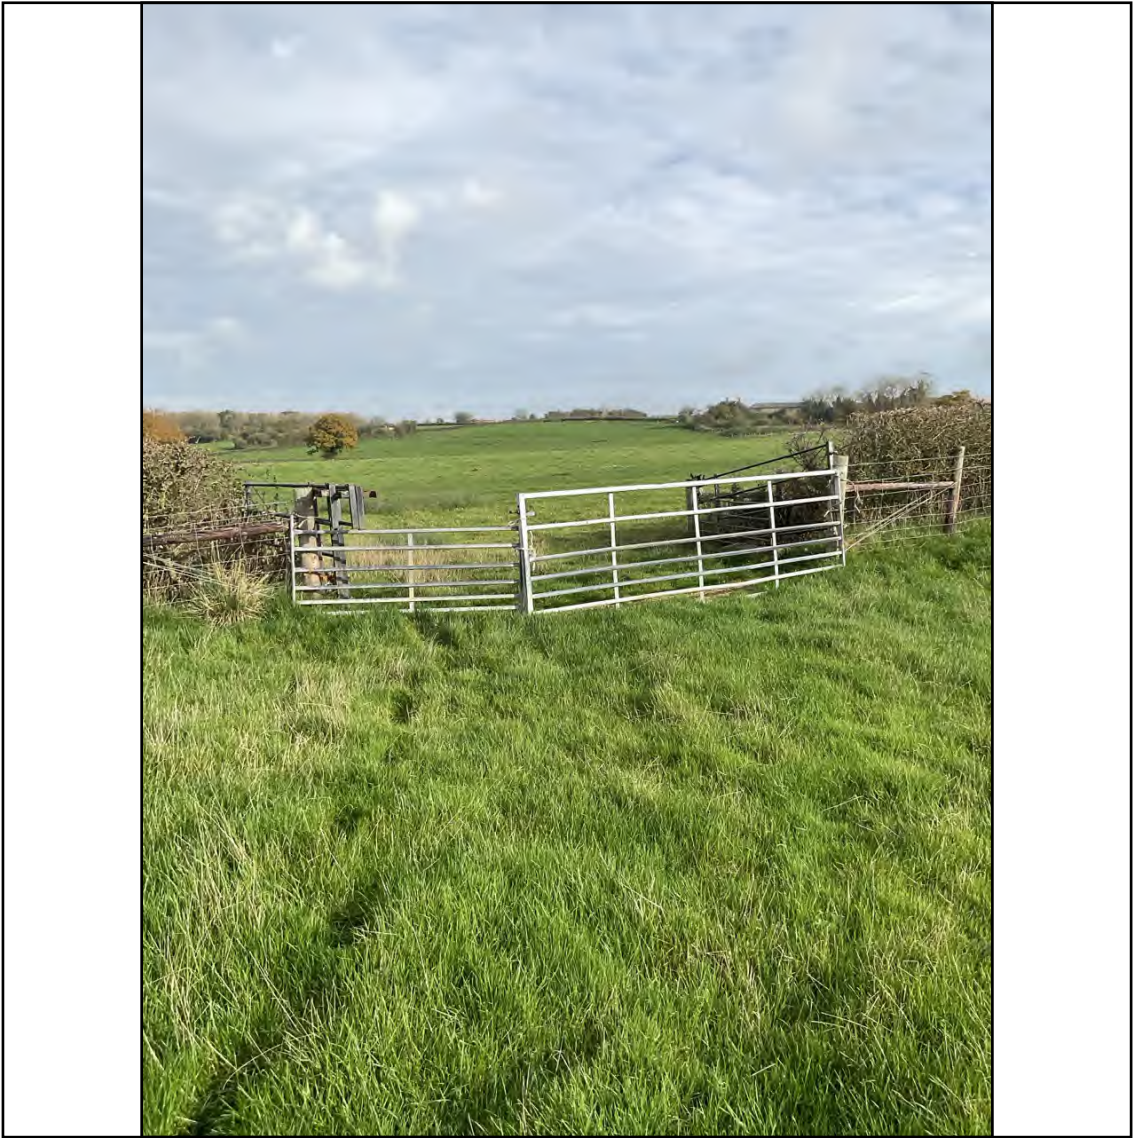
| Feature Description : | Gate |

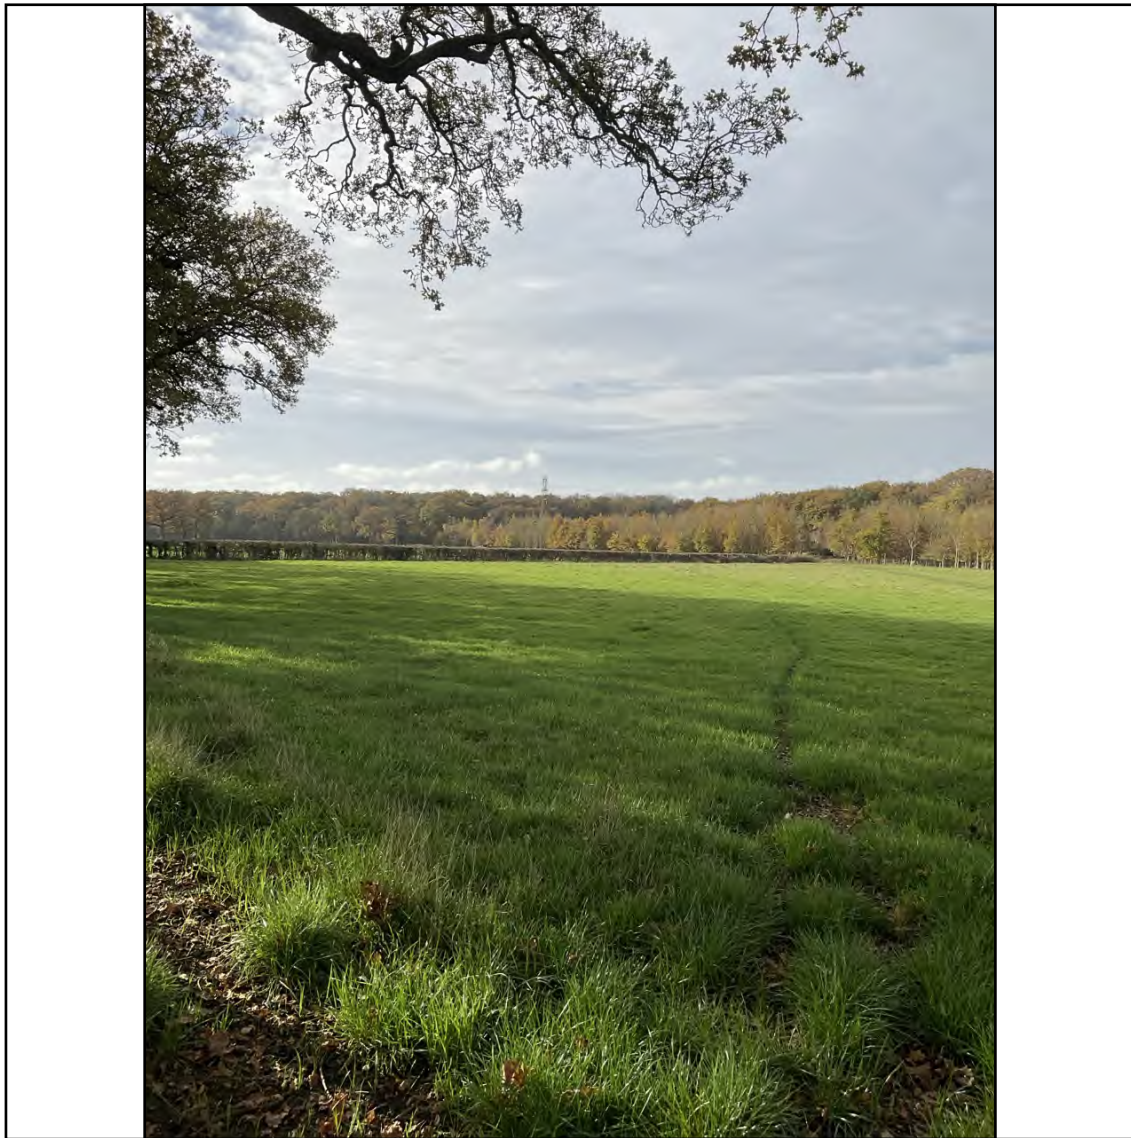
| Feature Description : | General view |

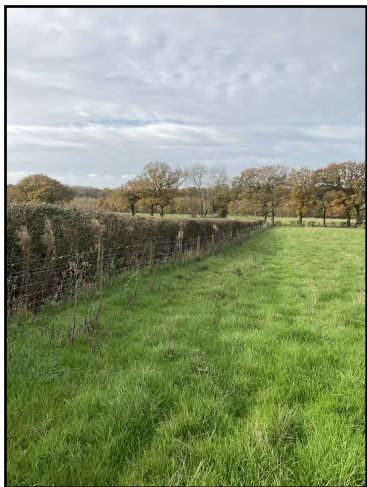
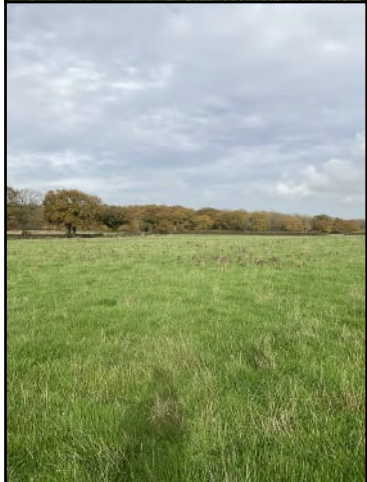
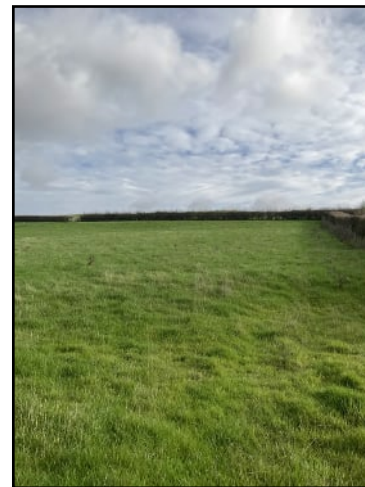
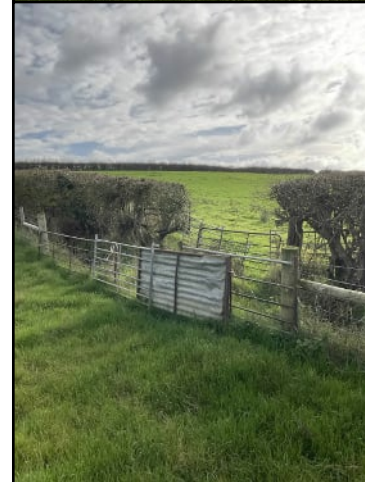
59

| List of DTS Features to be checked during site visit | Feature and Information | Site Photograph Number |
|---|---|---|
| <b>Access/ GI feasibility</b> | <p>Overall access for GI will be good, allowing for movement of equipment and machinery through the double gate access points within the fields.</p> <p>Water supply on site will need to be confirmed, some clay pipes and water pipes were observed during the walkover as were water tanks.</p> <p>Some slopes within the site are significantly steep and therefore there may be issues with accessing these with the rig, routes would need to be planned in advance and weather considered.</p> <p>The ground was very wet underfoot on a dry day with evidence of farm vehicles churning up significant ruts within the ground. Risk of vehicles becoming stuck or skidding down steep slopes in wet weather.</p> | 1,3,51,55,56,34,40,59 |

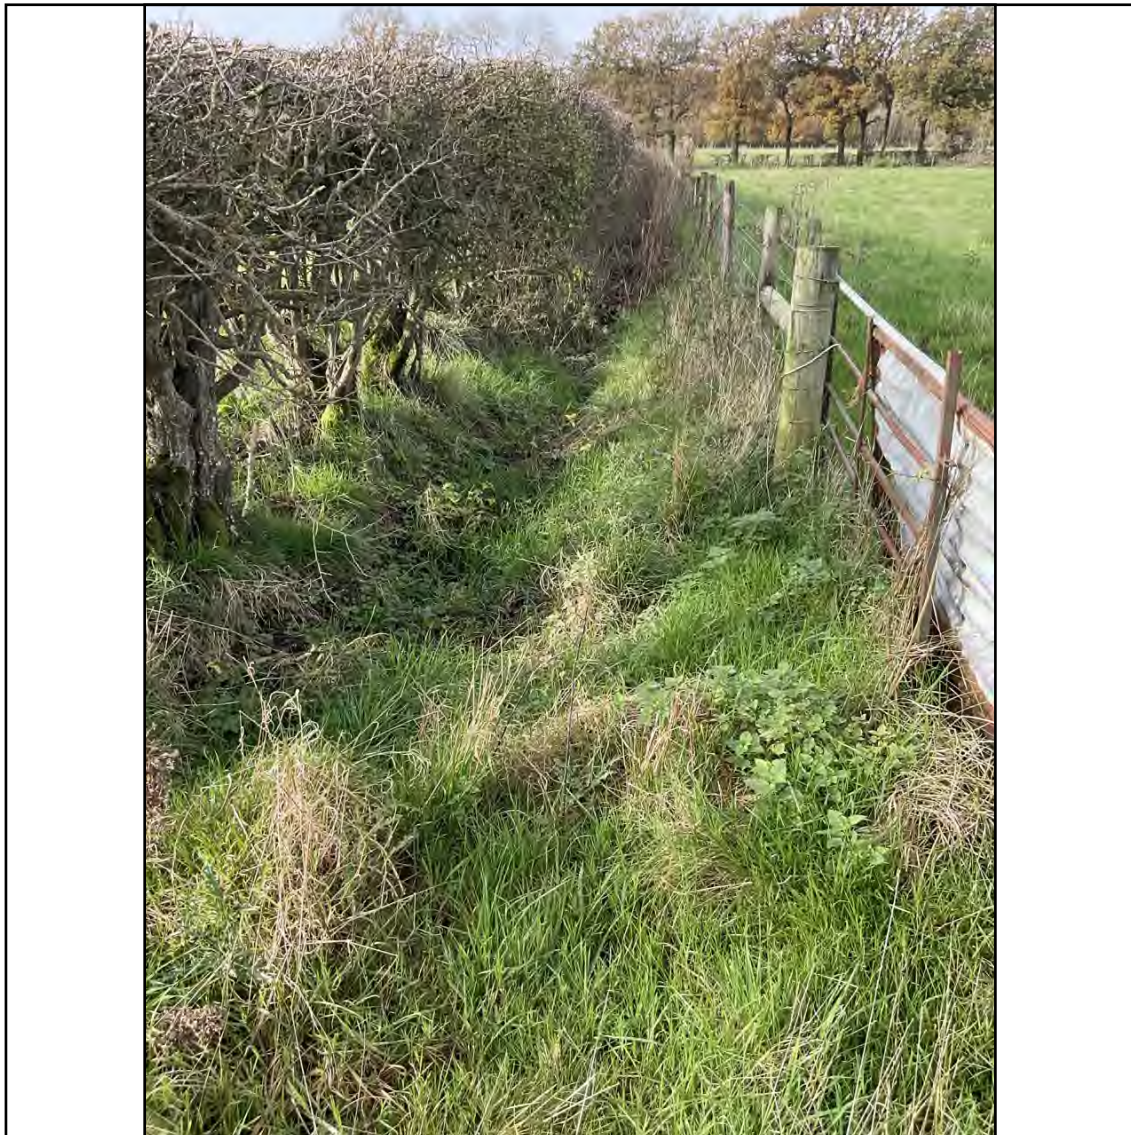
| Feature Description : | Stream |

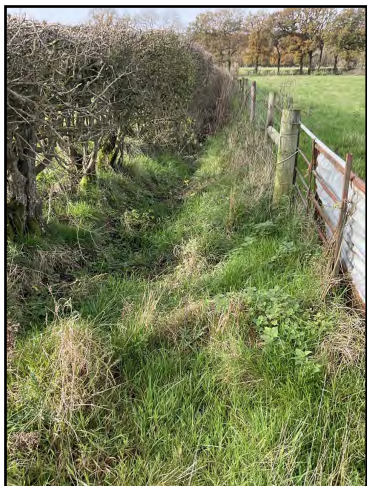
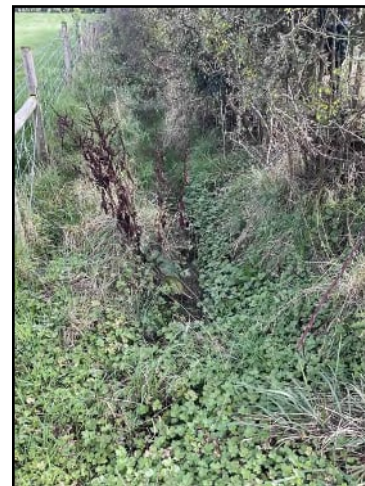
60

| List of DTS Features to be checked during site visit | Feature and Information | Site Photograph Number |
|---|---|---|
| <b>Ground Conditions</b> | The site was wet underfoot in most locations despite topography change. | 10,42, 53,60,64,70,81,88 |

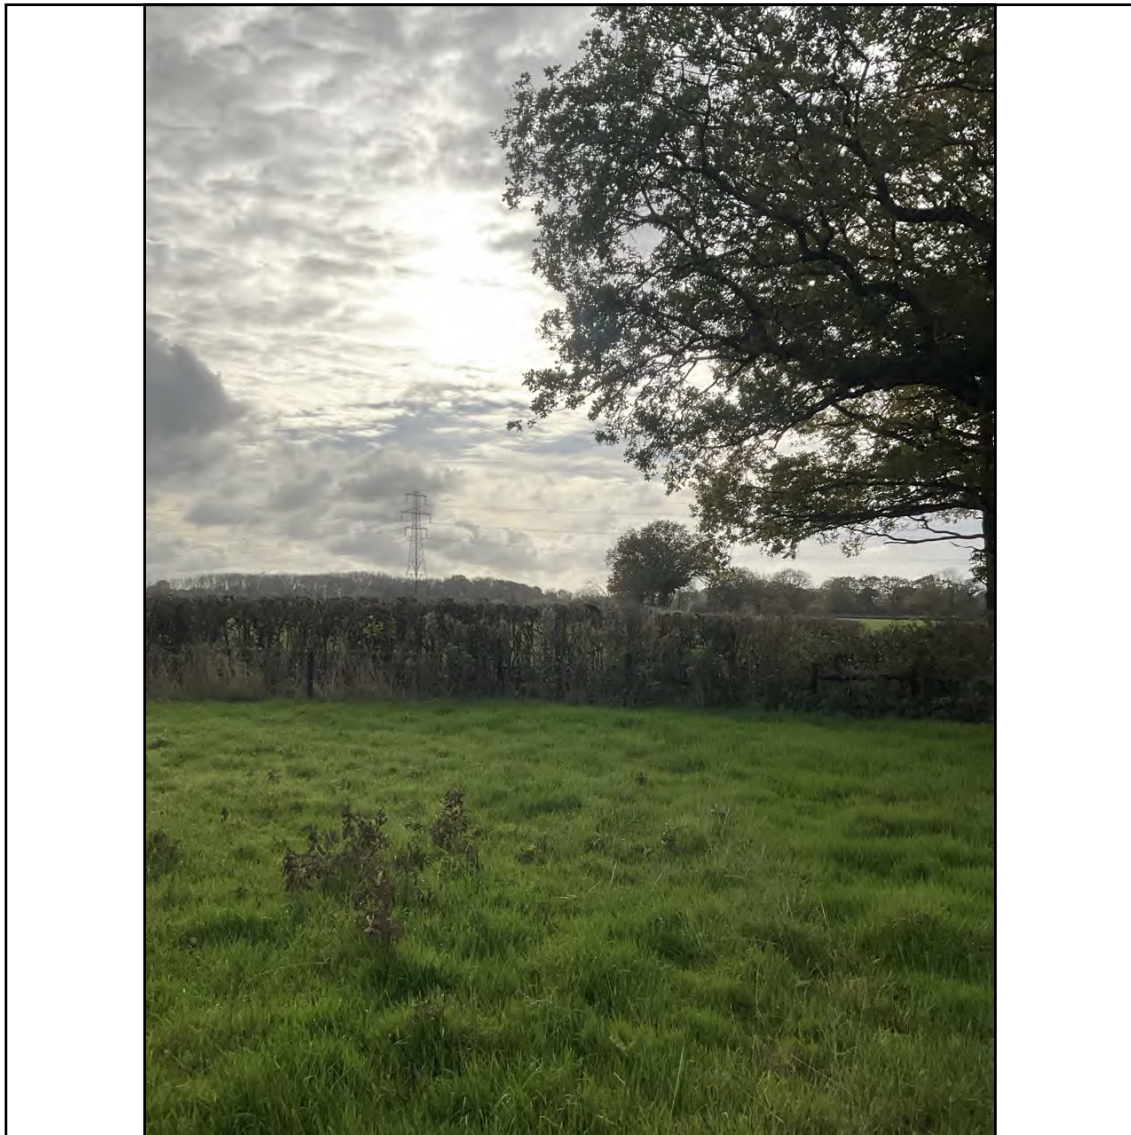
| Feature Description : | General view towards the western extent of the farm where de-vegation works being undertaken |
