## **STRUCTURAL APPRAISAL**

**THE CARPENTERS ARMS, LACOCK, WILTS, SN15 2LB**

**MR ADRIAN GOTT**

**Project** : 2022.270  
**Date** : February 2024  
**Engineer** : G.Schofield C Eng, MI Struct E, MICE, MIEI  
**Issue No: 1** : 21.02.2024

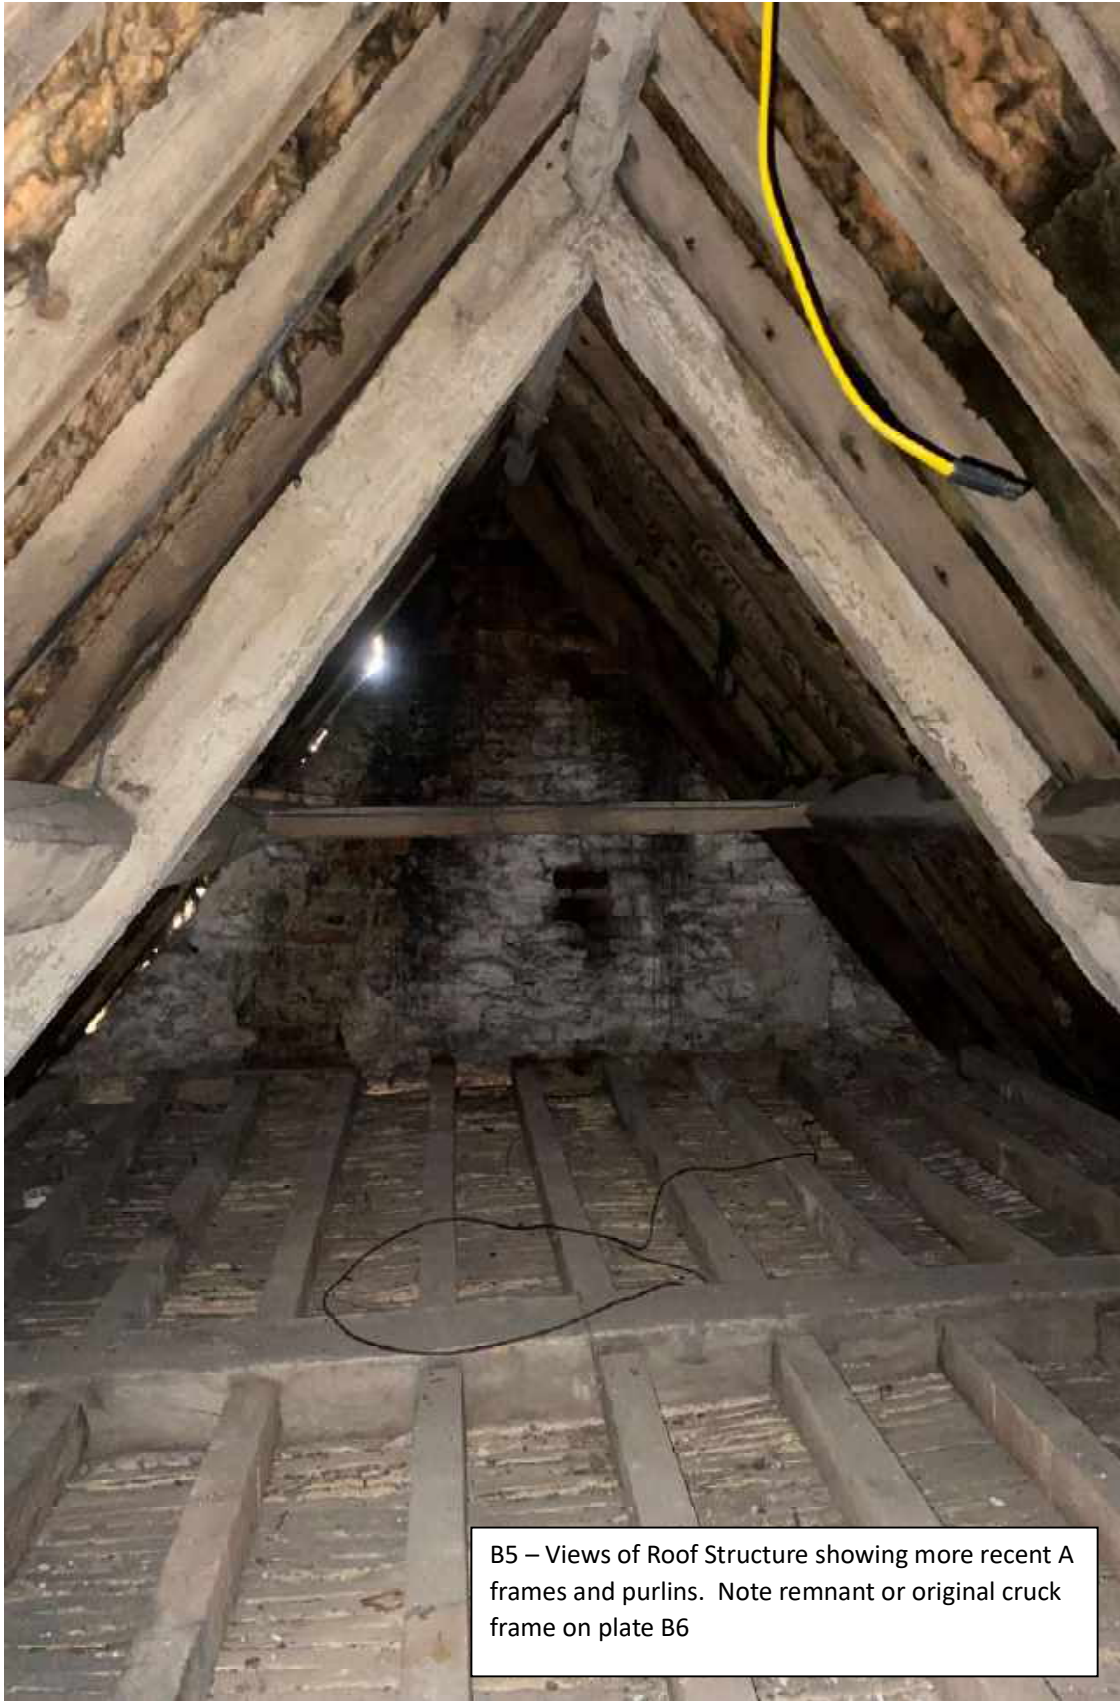
Construction comprises stone slated roof on the original timber rafters. The principle structural members of purlins and 'A' frames are replacements to the original support members. However, by reference to photographs B5 and B6 remnants of a part cruck frame are still present and has been made use of in the restructuring of the roof.

B5 – Views of Roof Structure showing more recent A frames and purlins. Note remnant or original cruck frame on plate B6

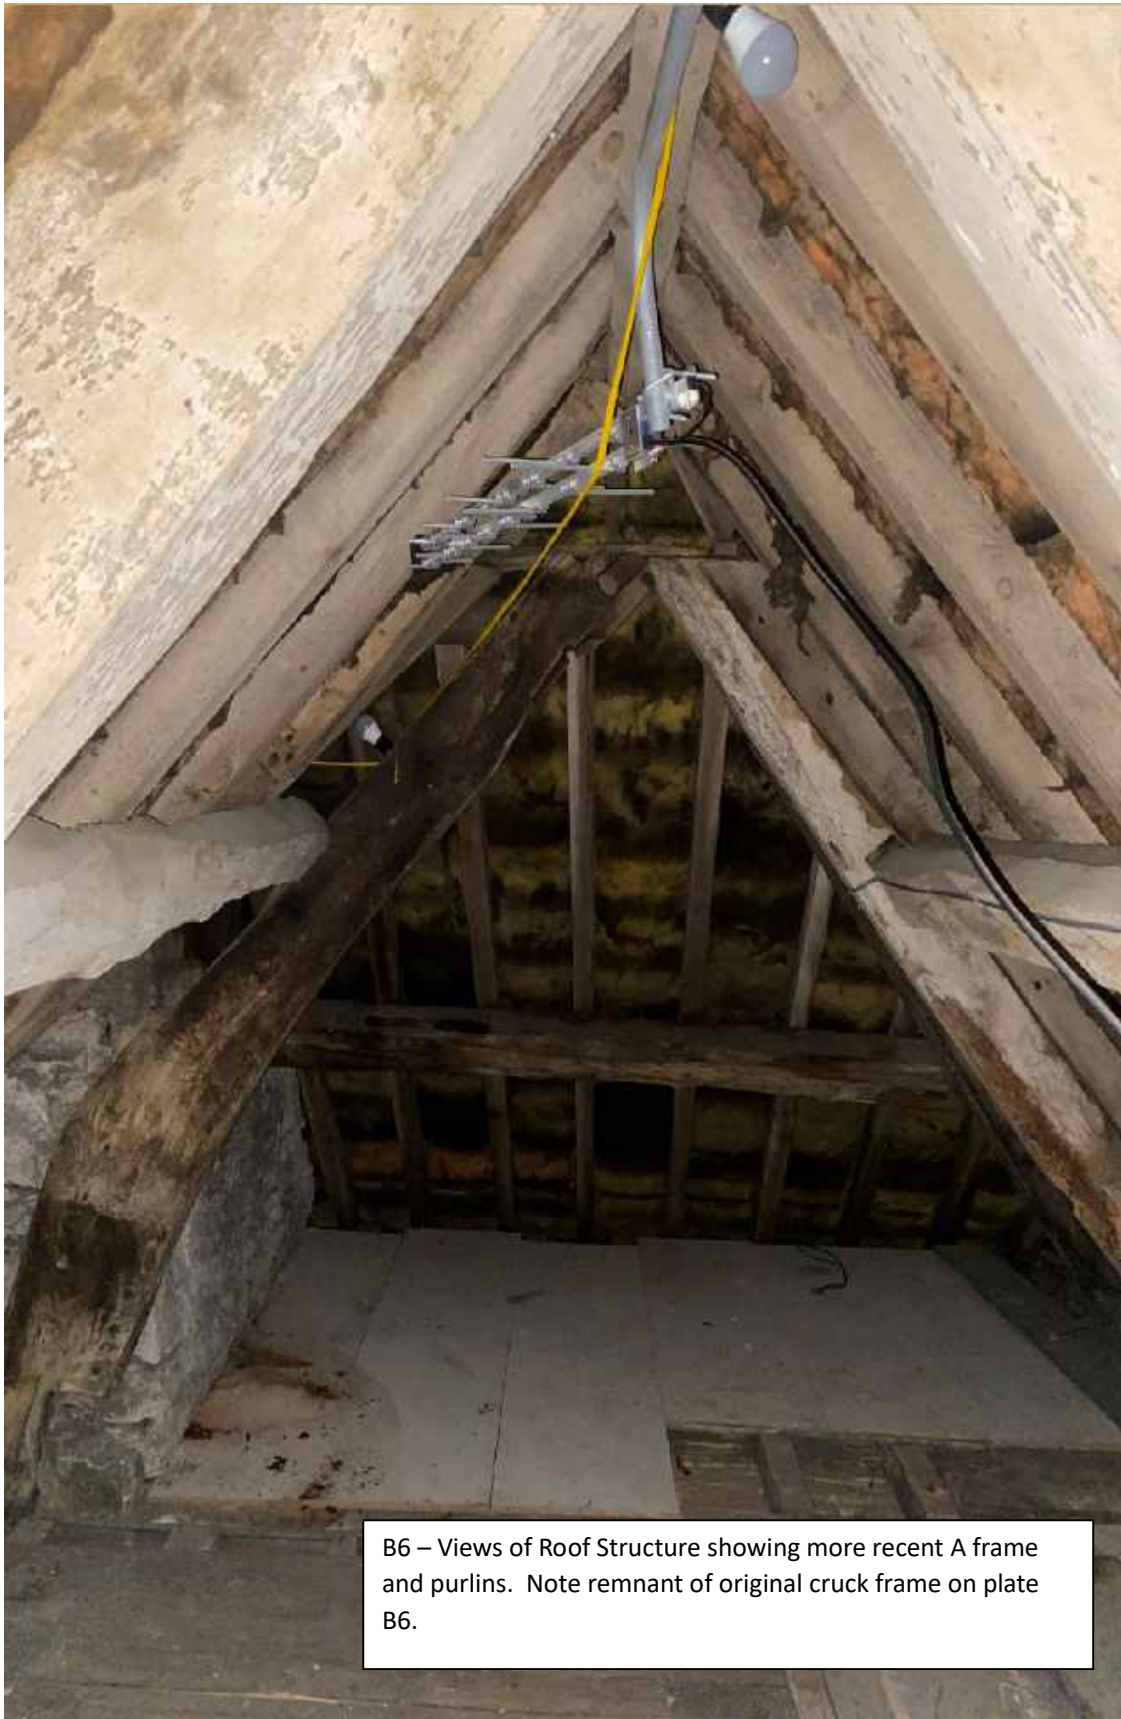
B6 – Views of Roof Structure showing more recent A frame and purlins. Note remnant of original cruck frame on plate B6.

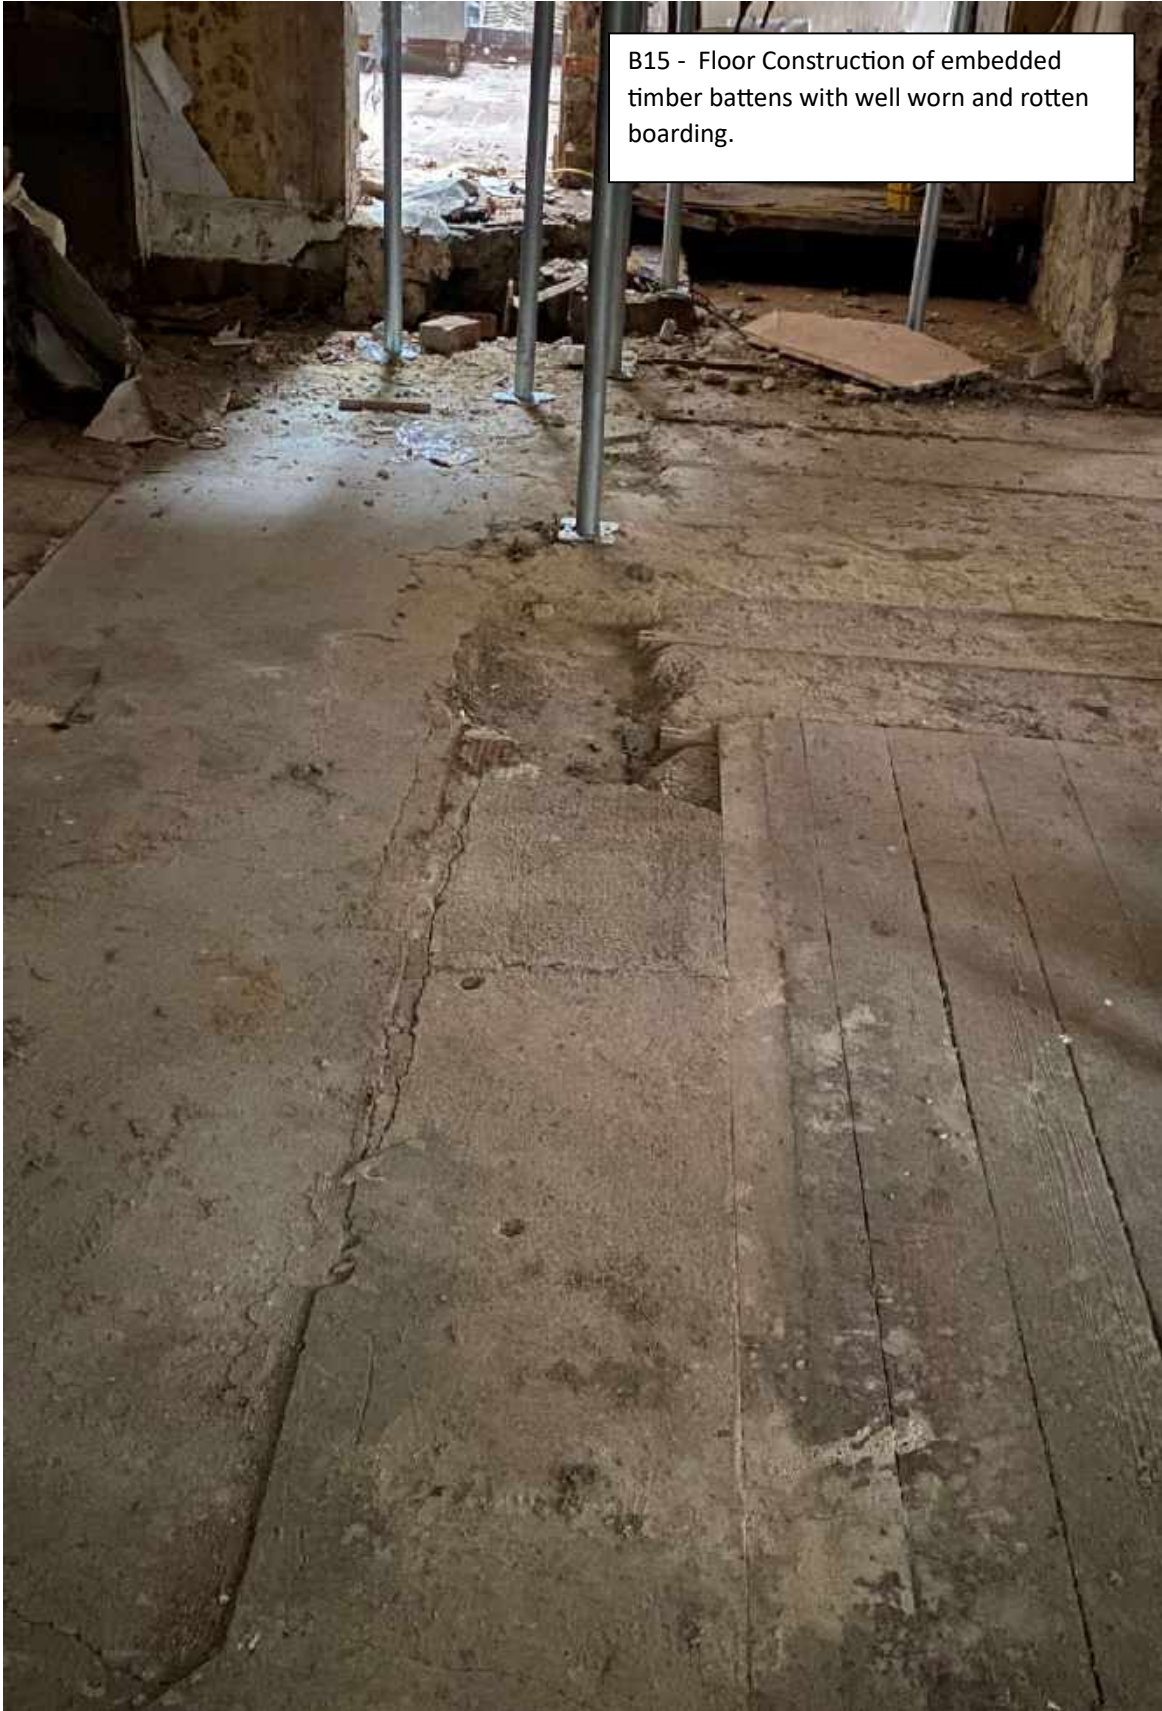
The timbers however are in poor condition and exhibit evidence of wet rot and deterioration from foot traffic. Quite a few areas have had the boards removed and replaced with a screed.

B16 - Floor Construction of embedded  
timber battens with well worn and rotten  
boarding.

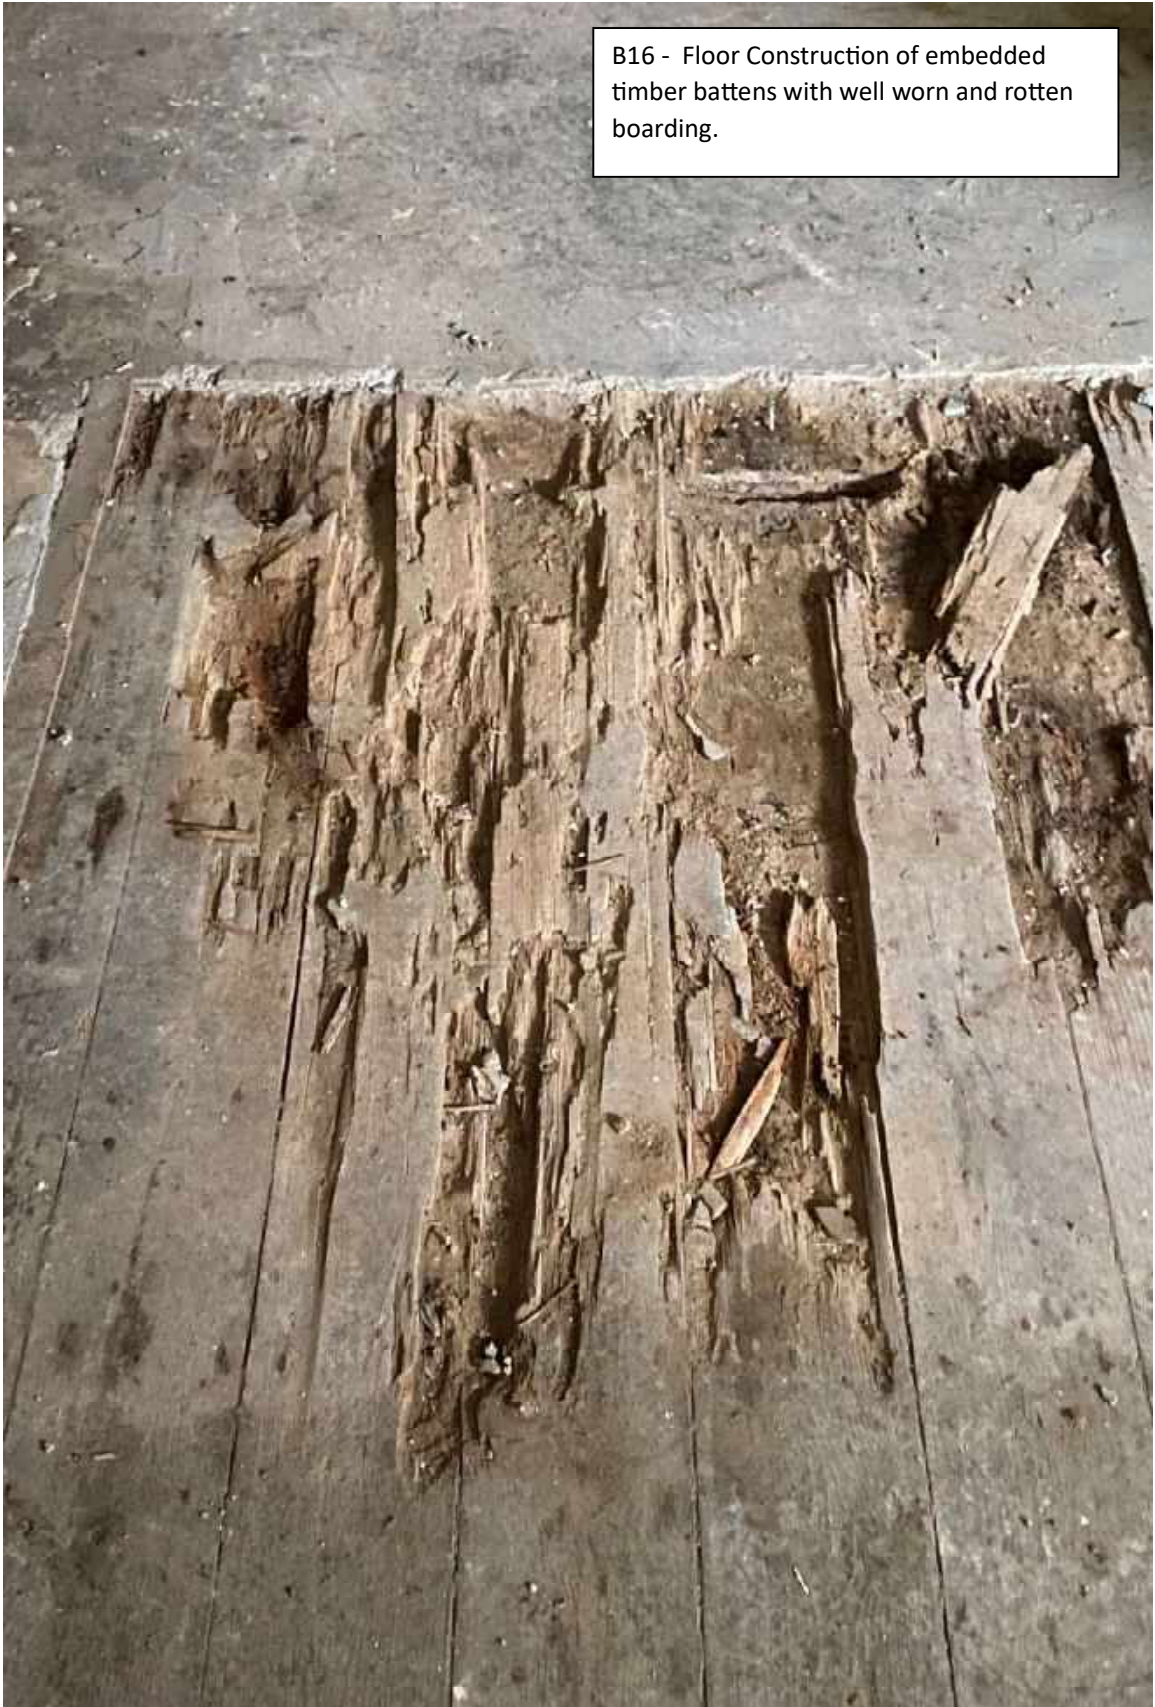
B17 - Floor Construction of embedded timber battens with well worn and rotten boarding.

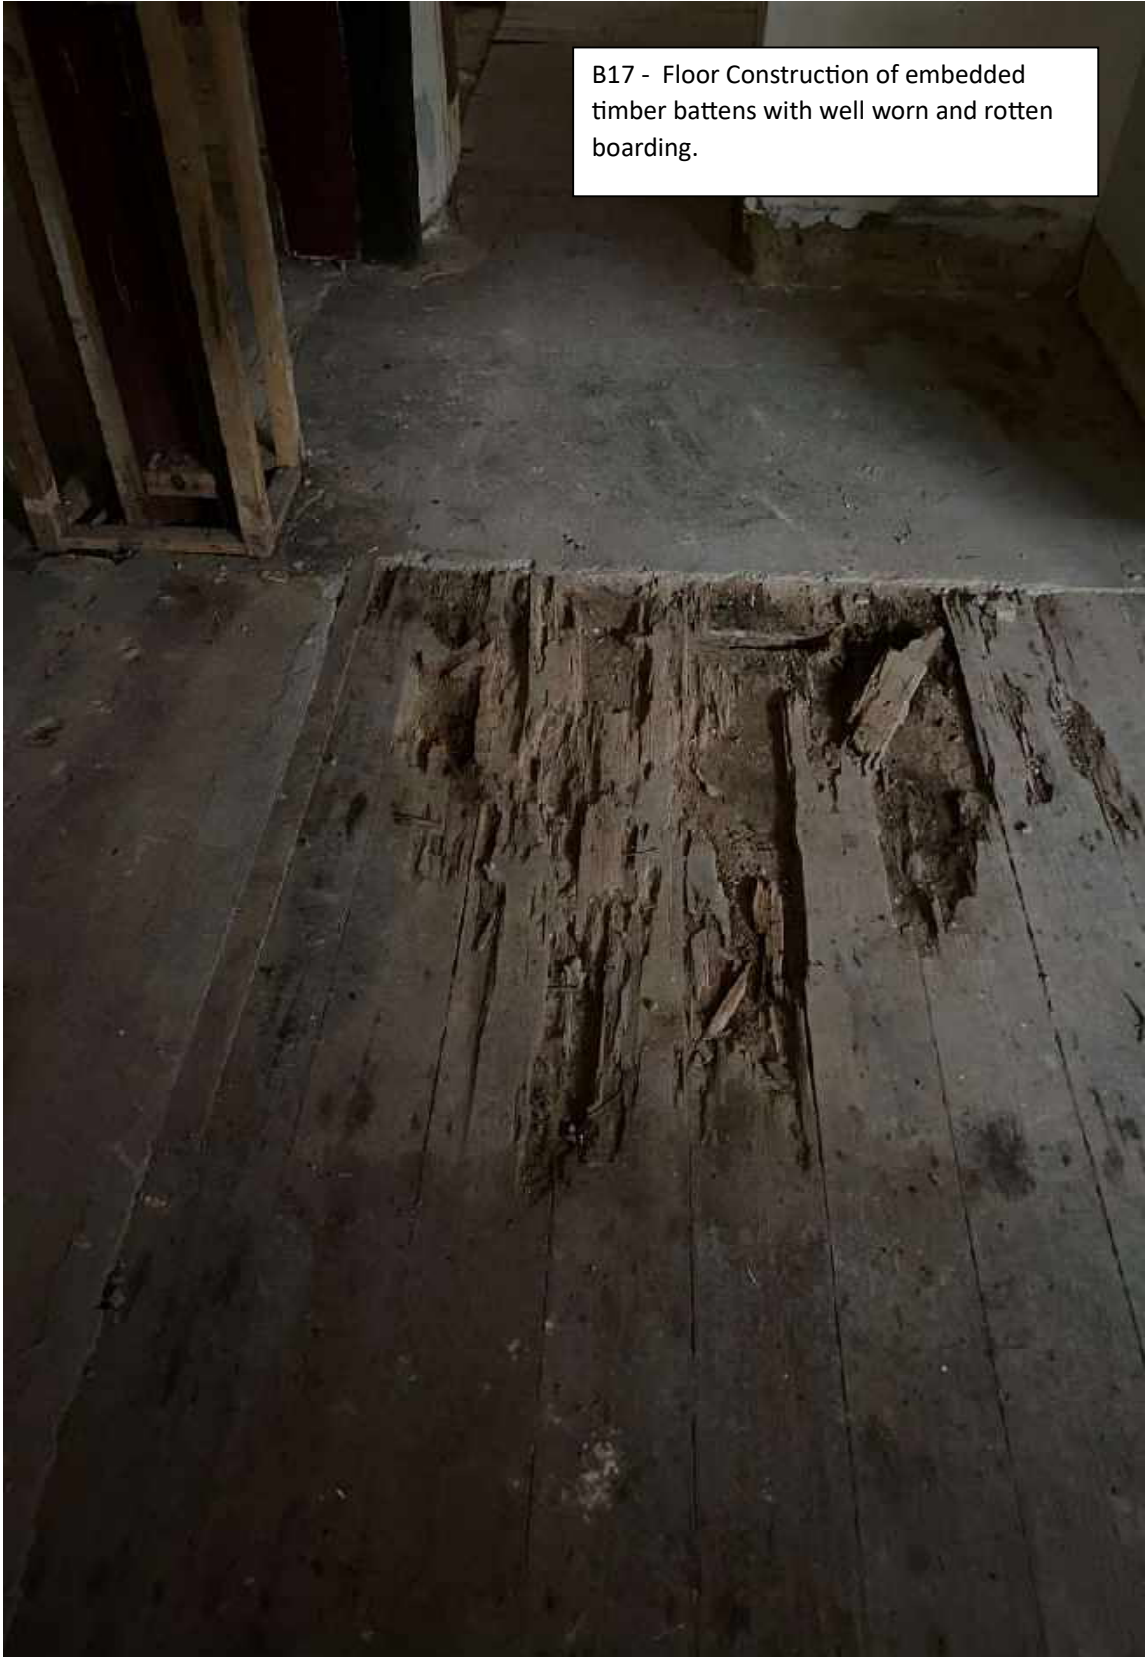
There is a pathway leading from the front vestibule to the rear staircase which retains the original and well-worn flagged floor.

B18 – Original well worn flagged floor leading from entrance vestibule to staircase

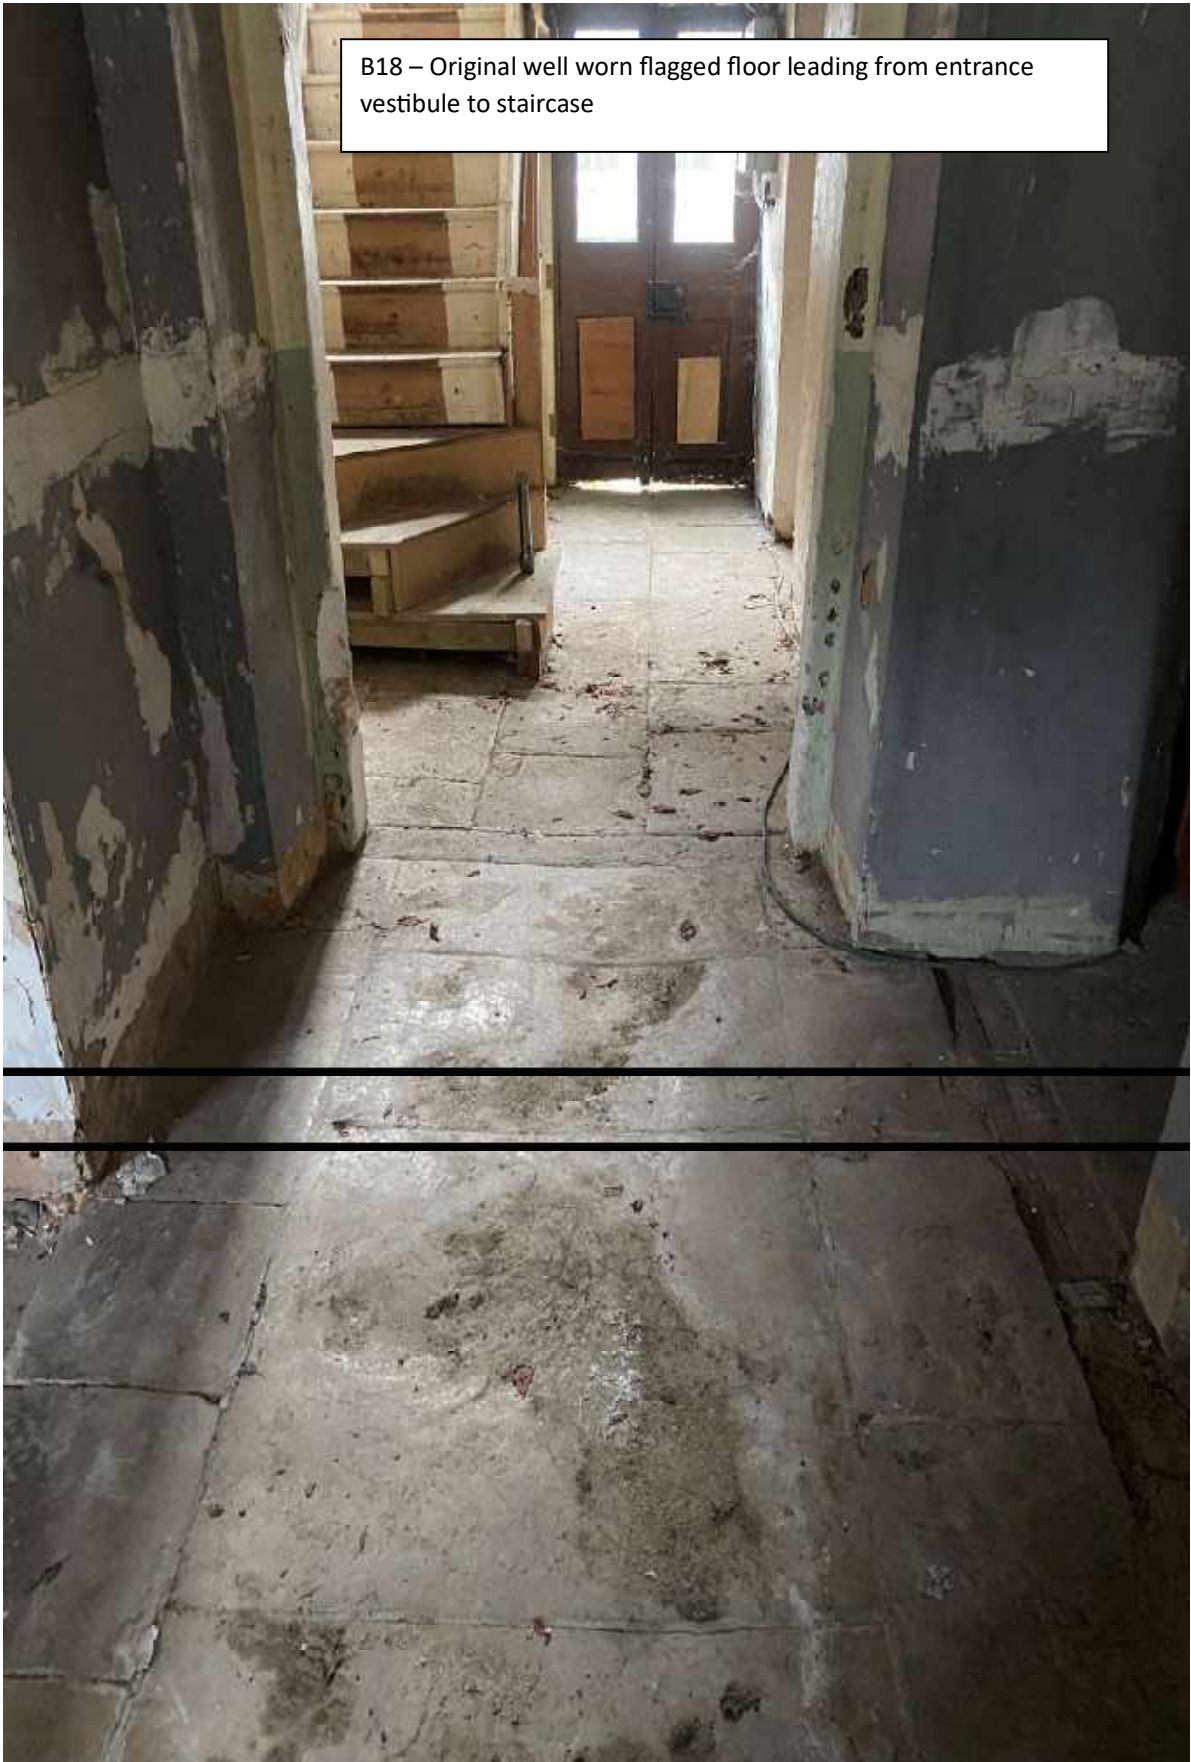
B19 – Original well worn flagged floor leading from entrance vestibule to staircase

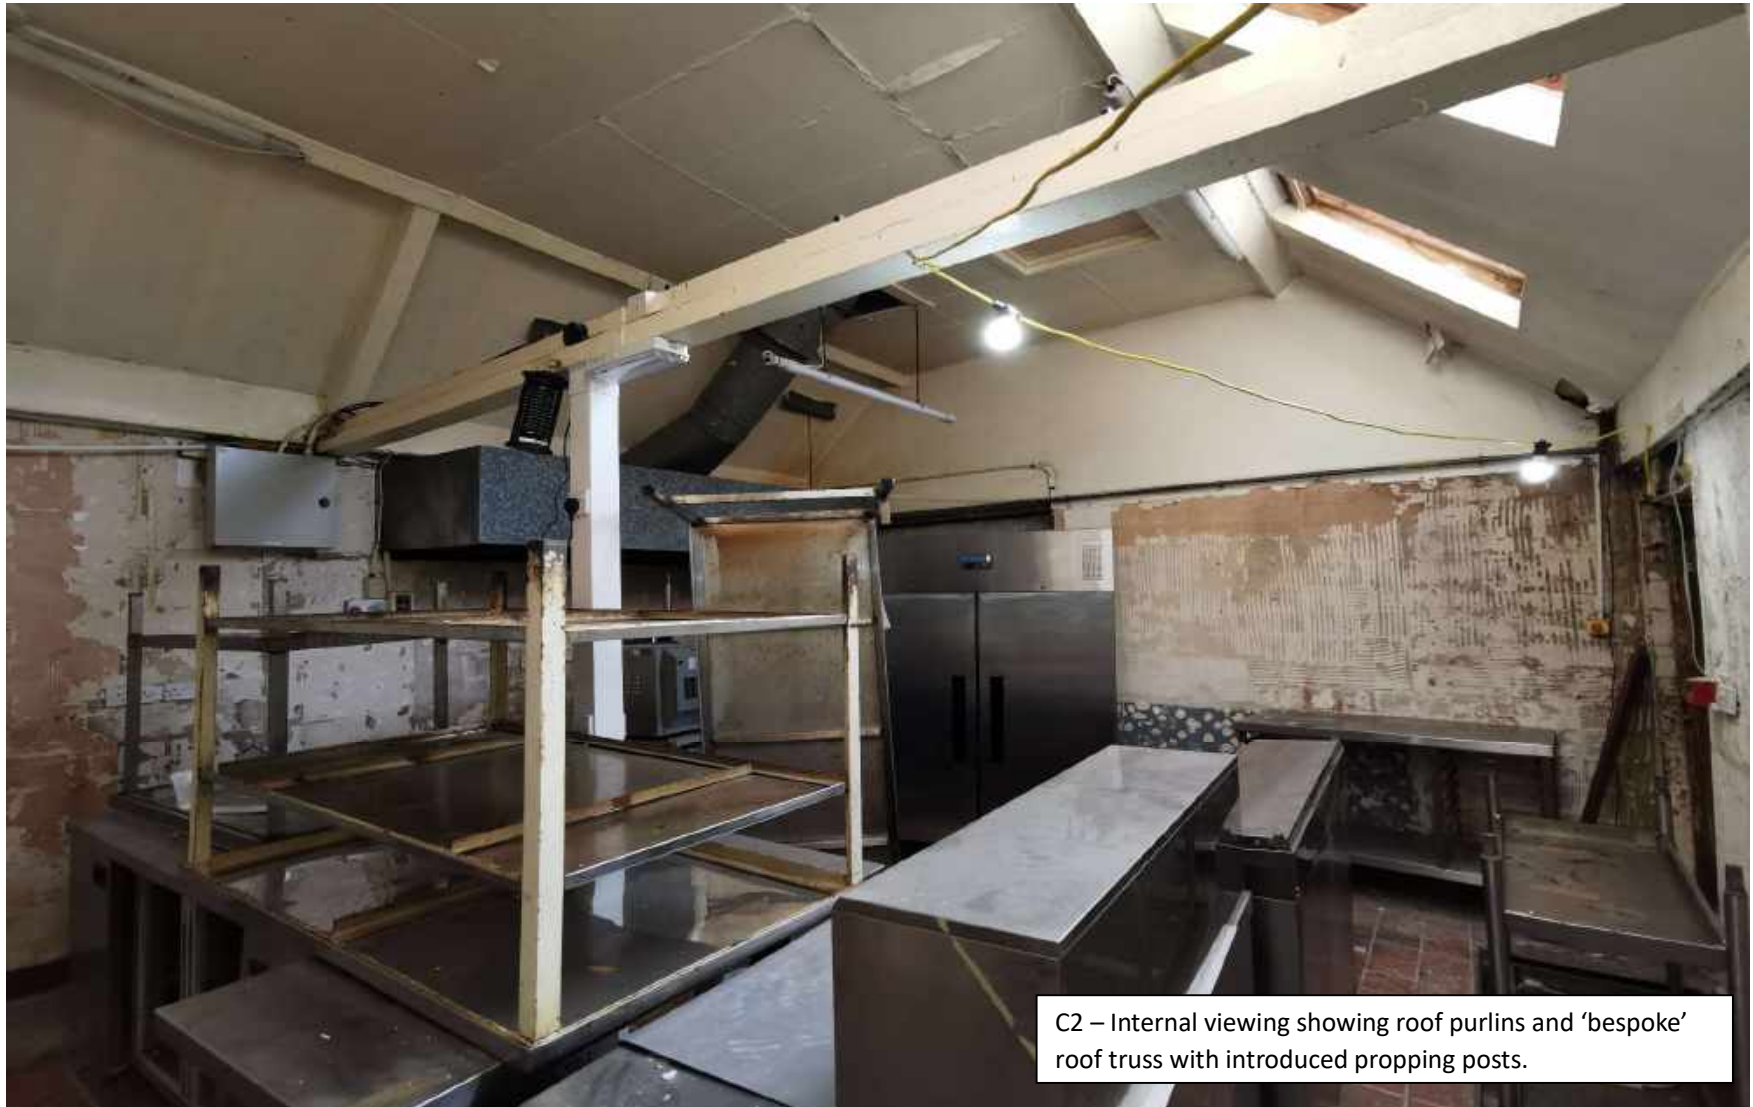
C2 – Internal viewing showing roof purlins and 'bespoke' roof truss with introduced propping posts.

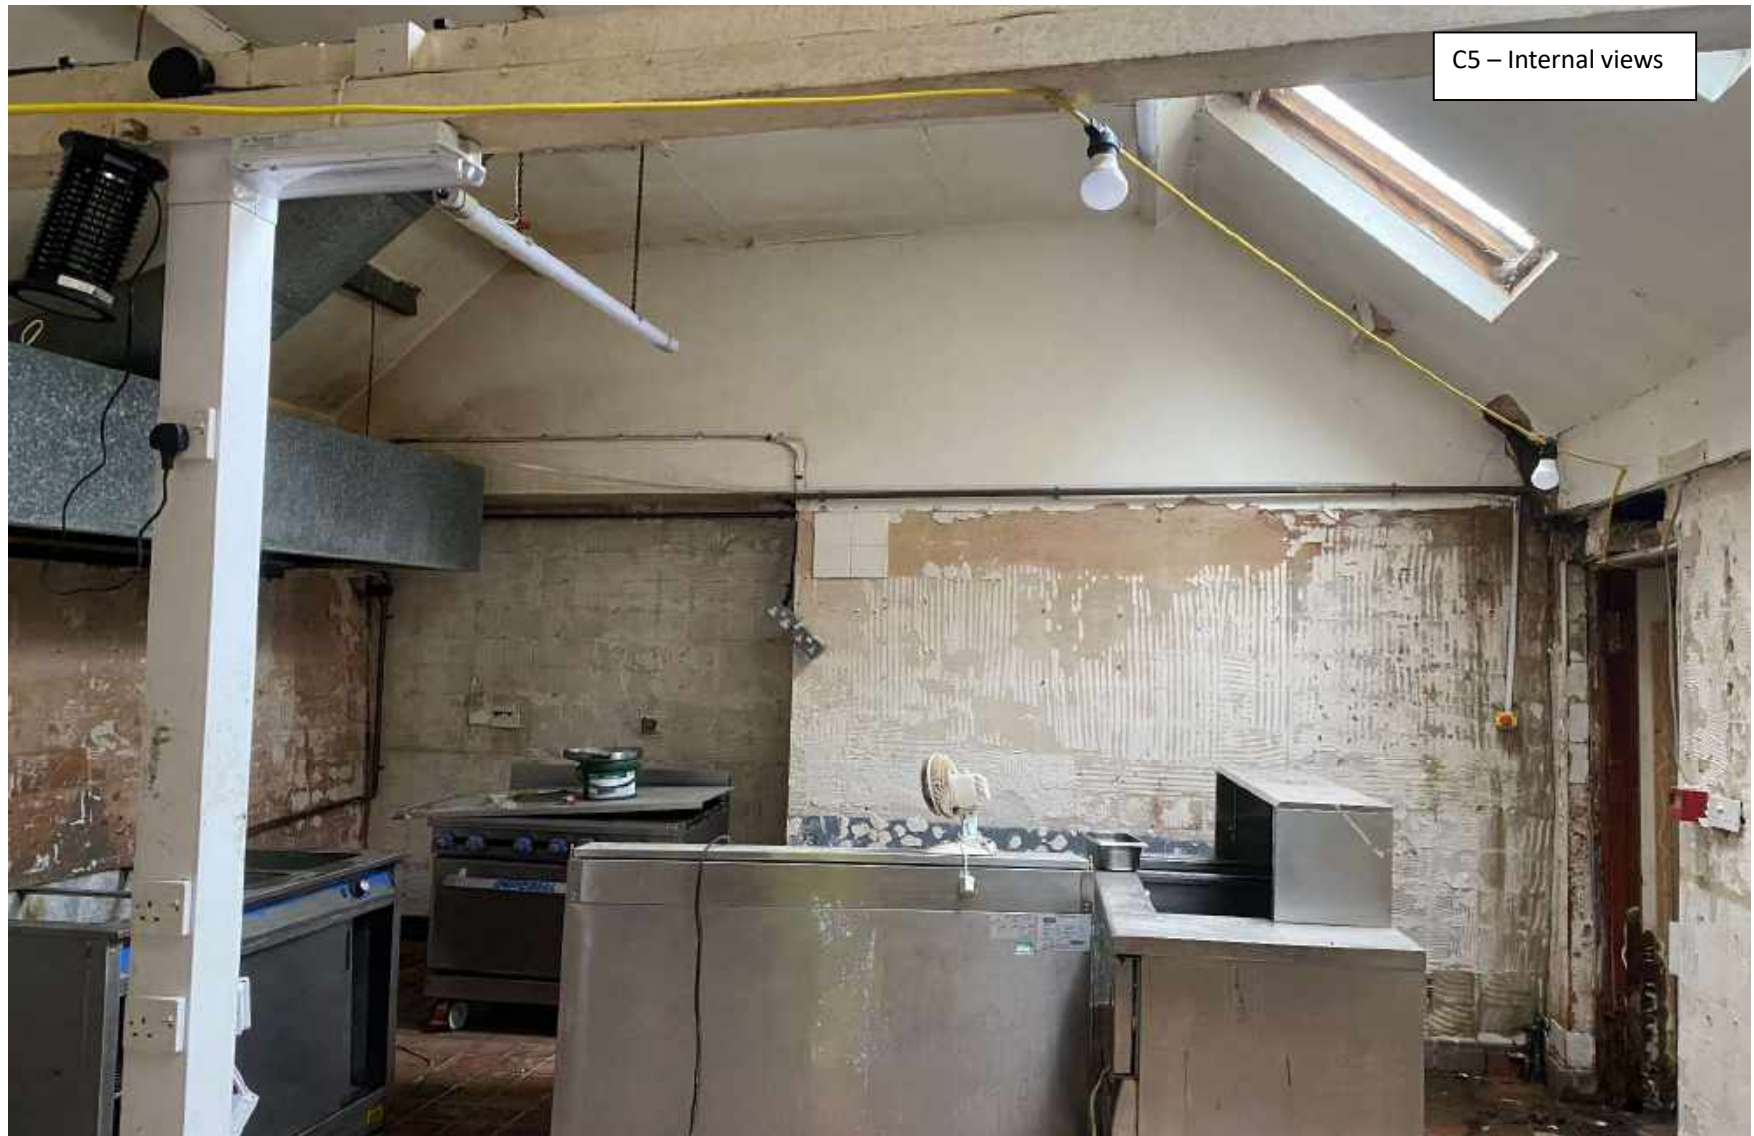
C5 – Internal views

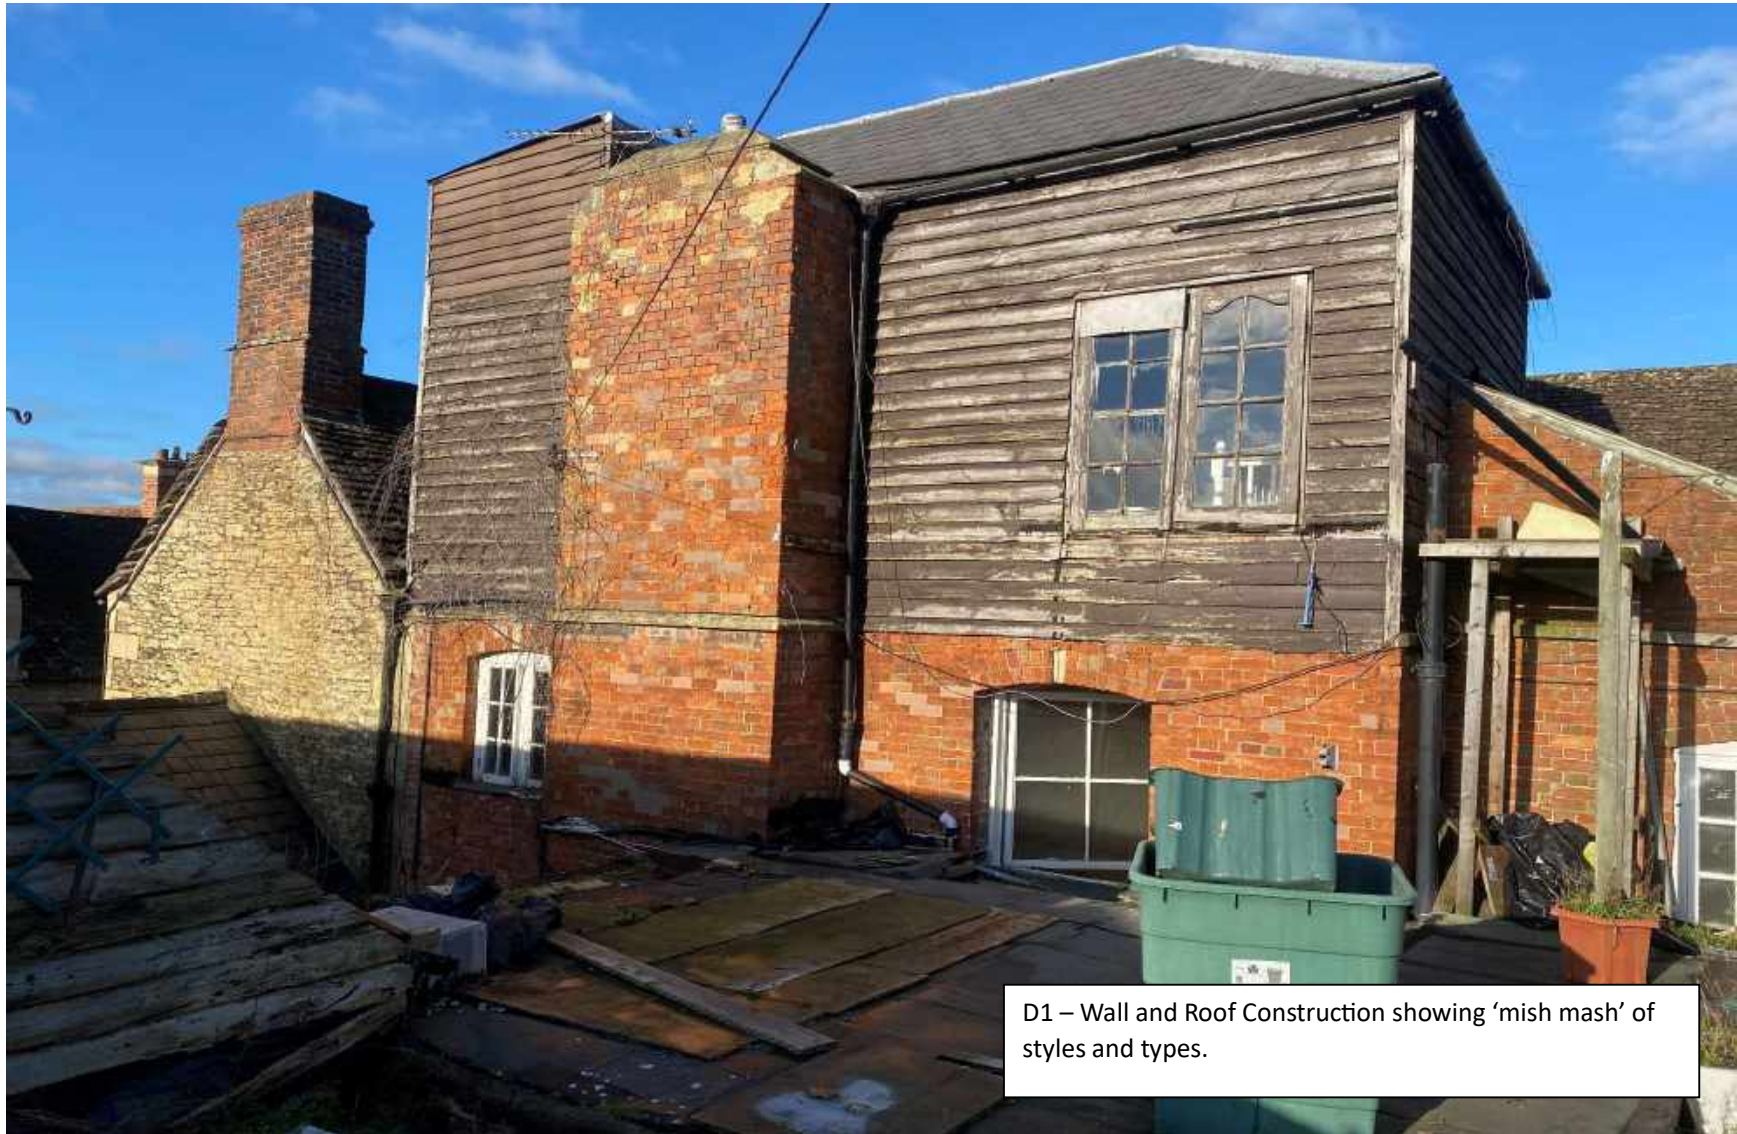
D1 – Wall and Roof Construction showing 'mish mash' of styles and types.

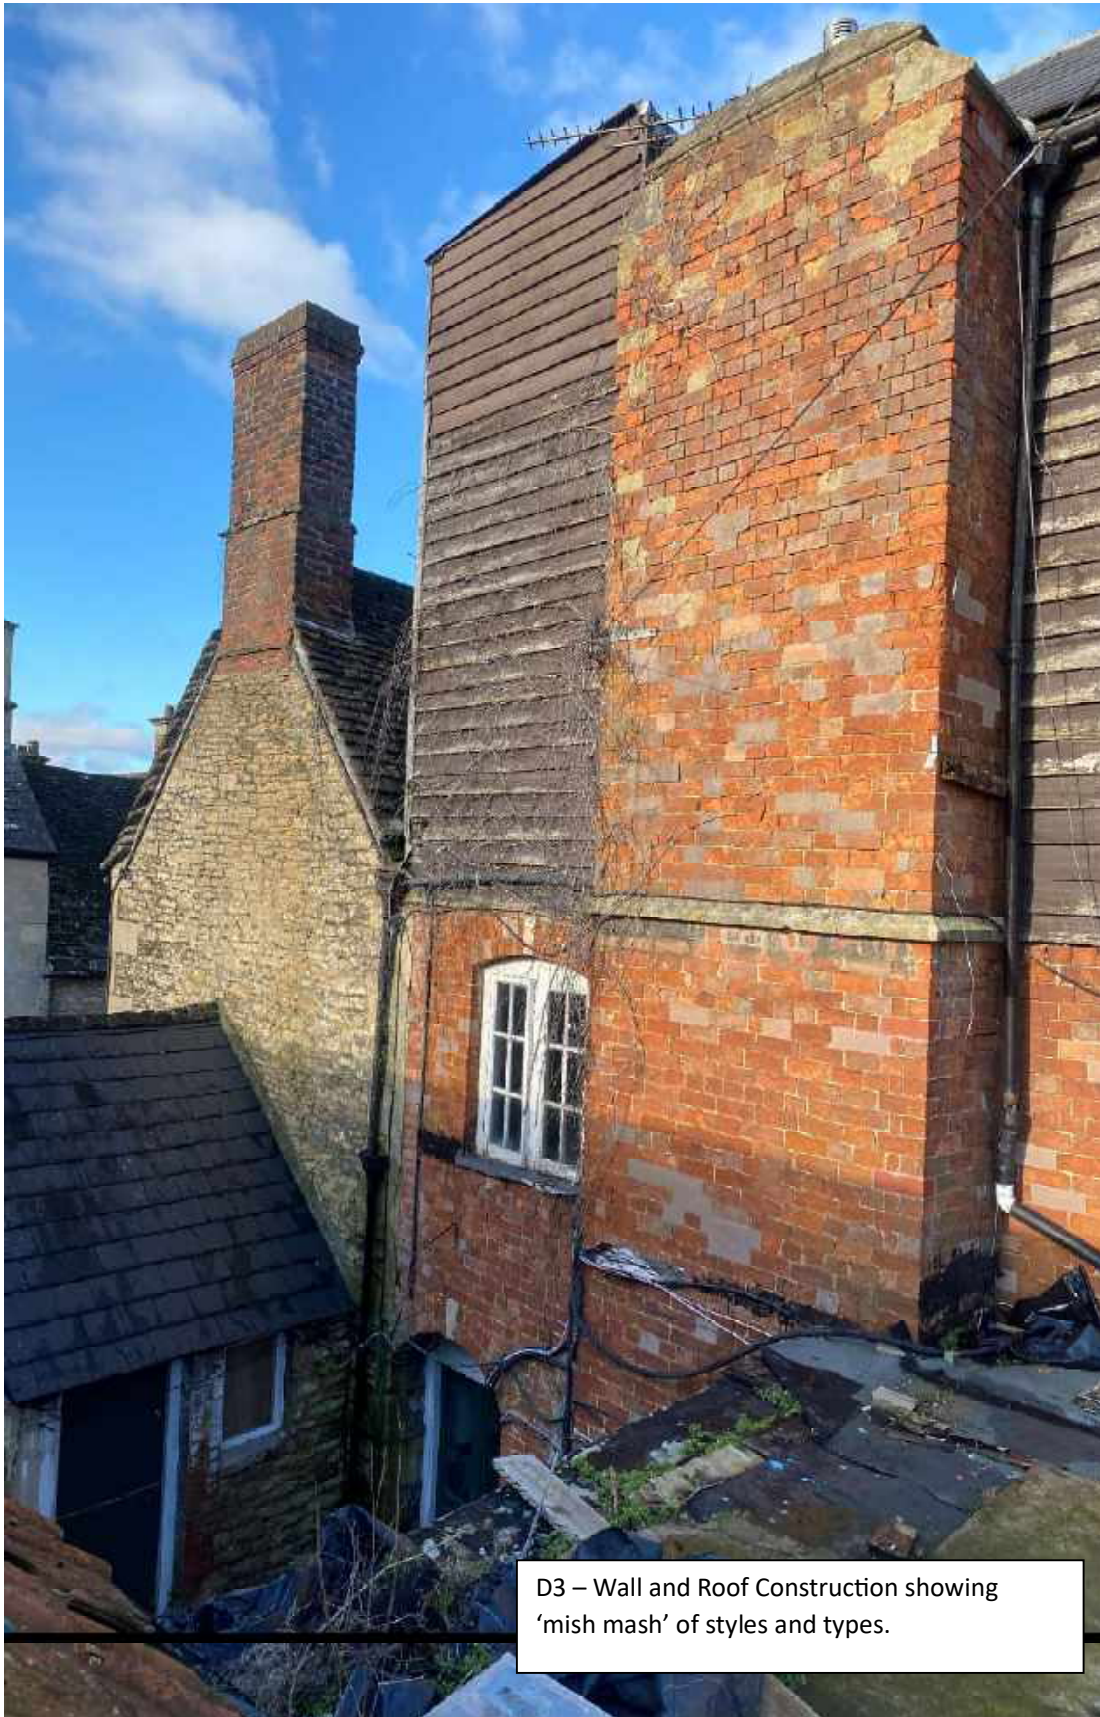
D3 – Wall and Roof Construction showing 'mish mash' of styles and types.

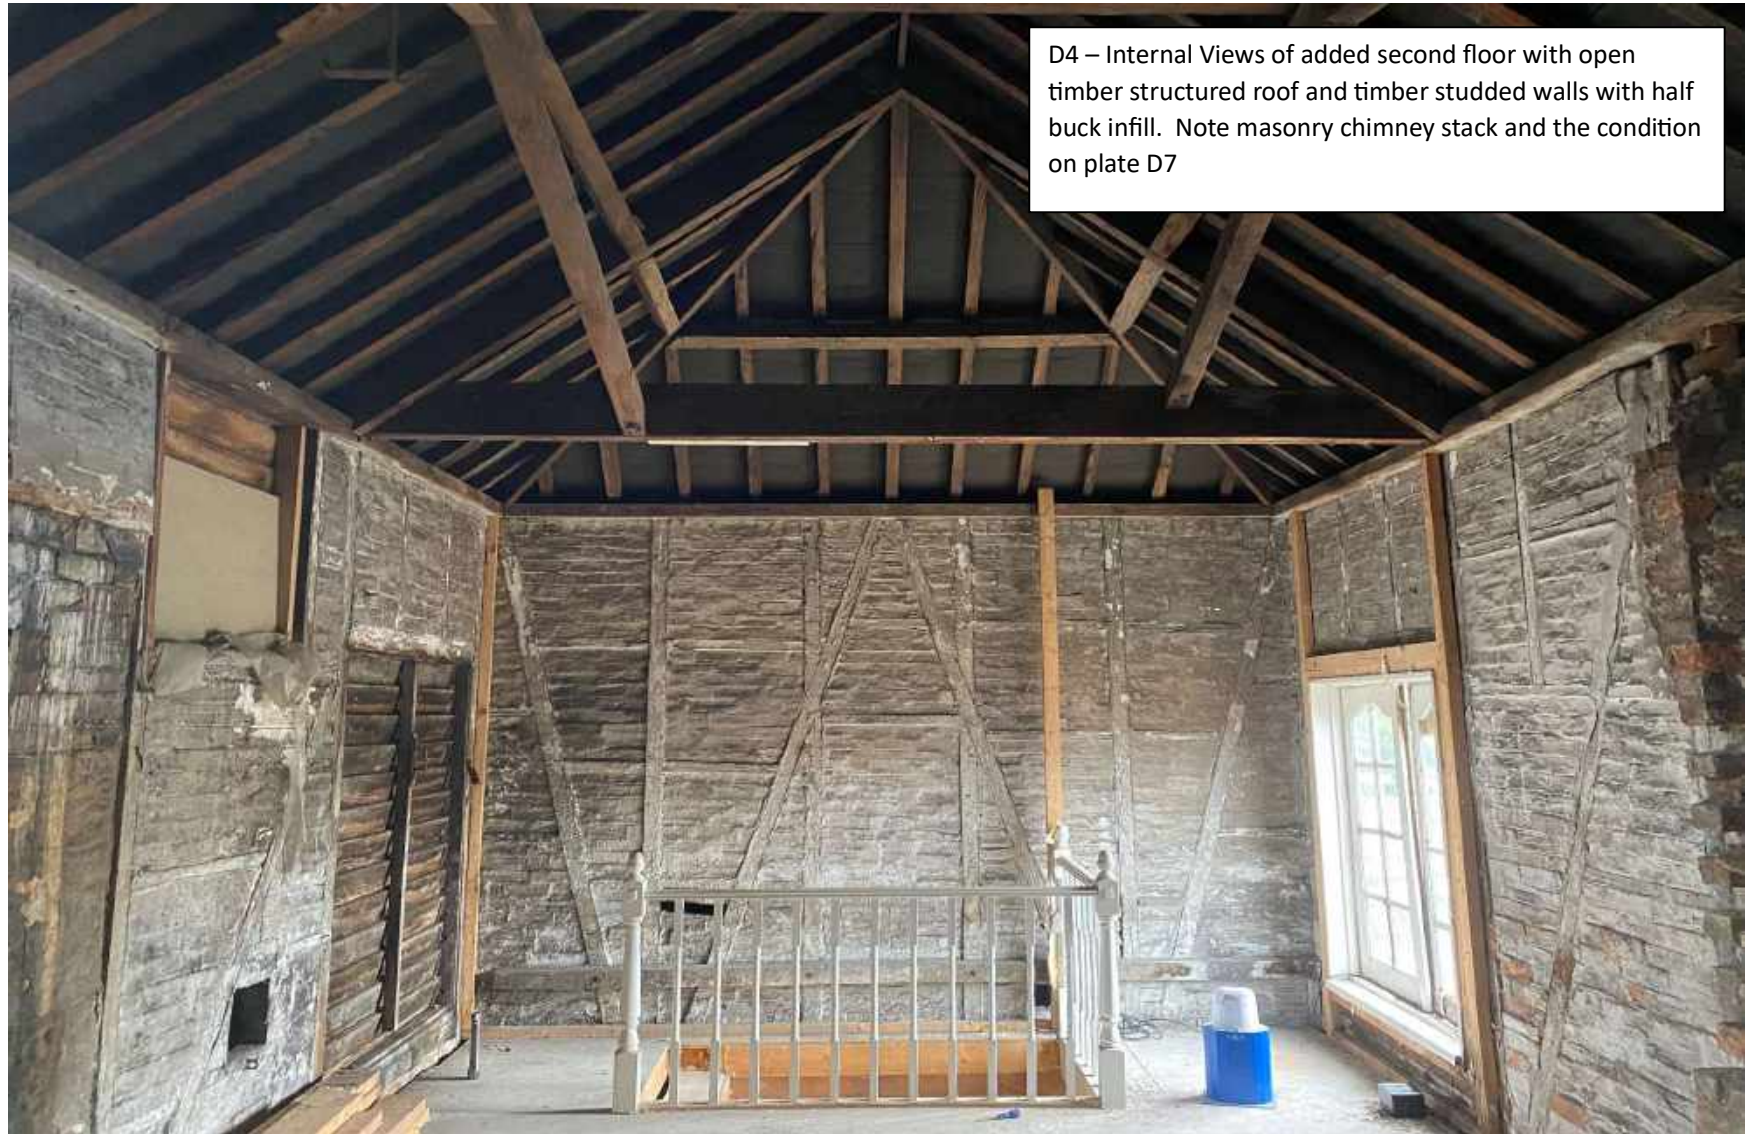
D4 – Internal Views of added second floor with open timber structured roof and timber studded walls with half buck infill. Note masonry chimney stack and the condition on plate D7
