## **STRUCTURAL APPRAISAL**

**THE CARPENTERS ARMS, LACOCK, WILTS, SN15 2LB**

**MR ADRIAN GOTT**

**Project** : 2022.270  
**Date** : February 2024  
**Engineer** : G.Schofield C Eng, MI Struct E, MICE, MIEI  
**Issue No: 1** : 21.02.2024

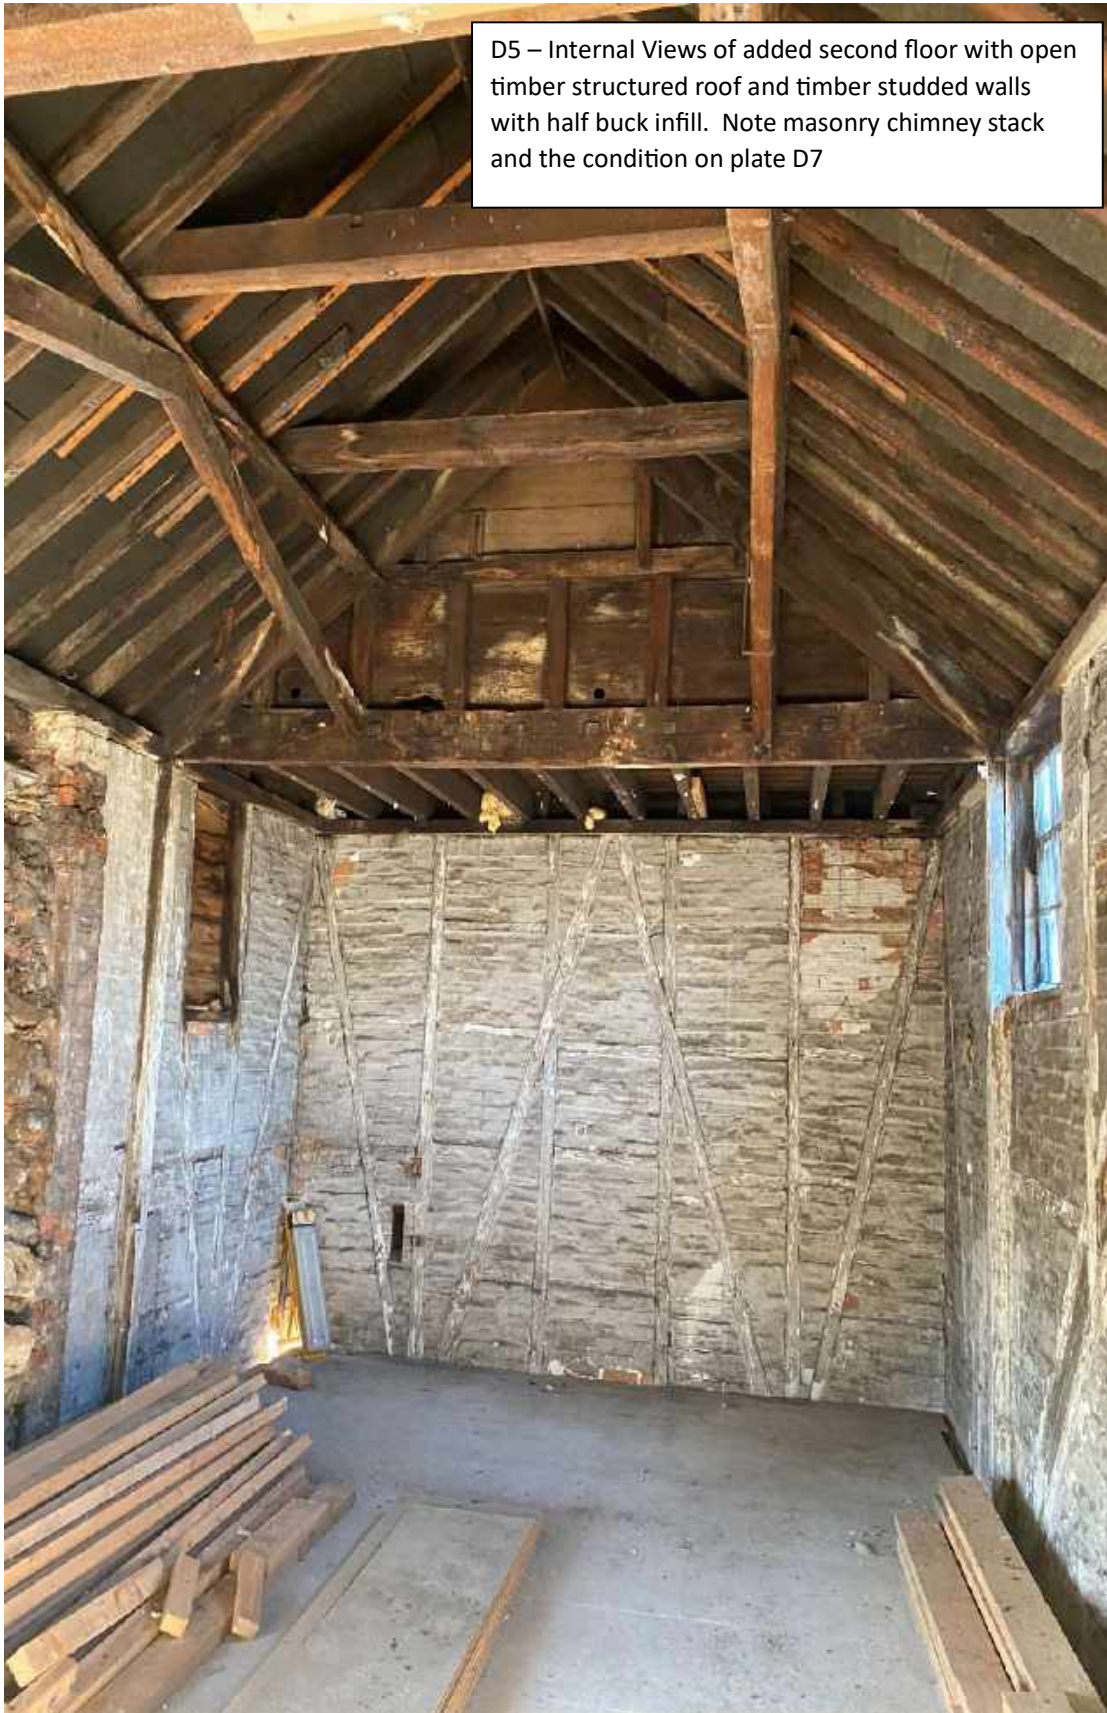
D5 – Internal Views of added second floor with open timber structured roof and timber studded walls with half buck infill. Note masonry chimney stack and the condition on plate D7

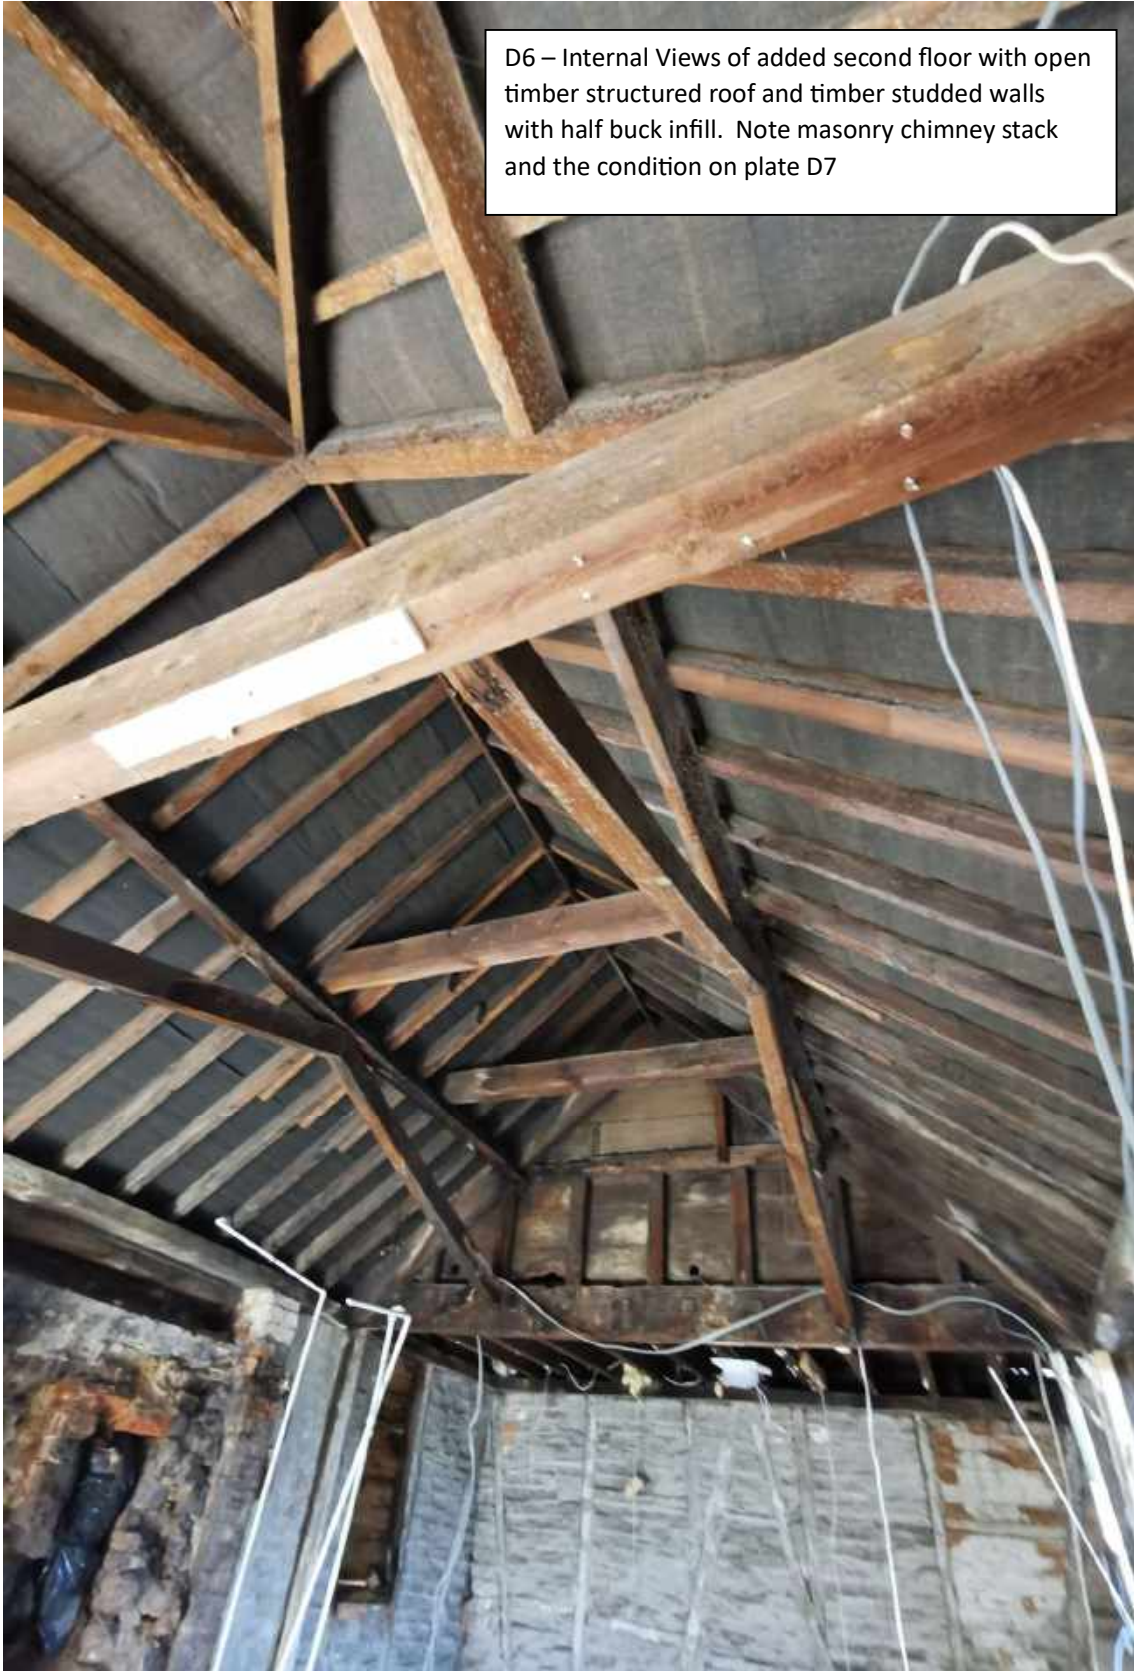
D6 – Internal Views of added second floor with open timber structured roof and timber studded walls with half buck infill. Note masonry chimney stack and the condition on plate D7

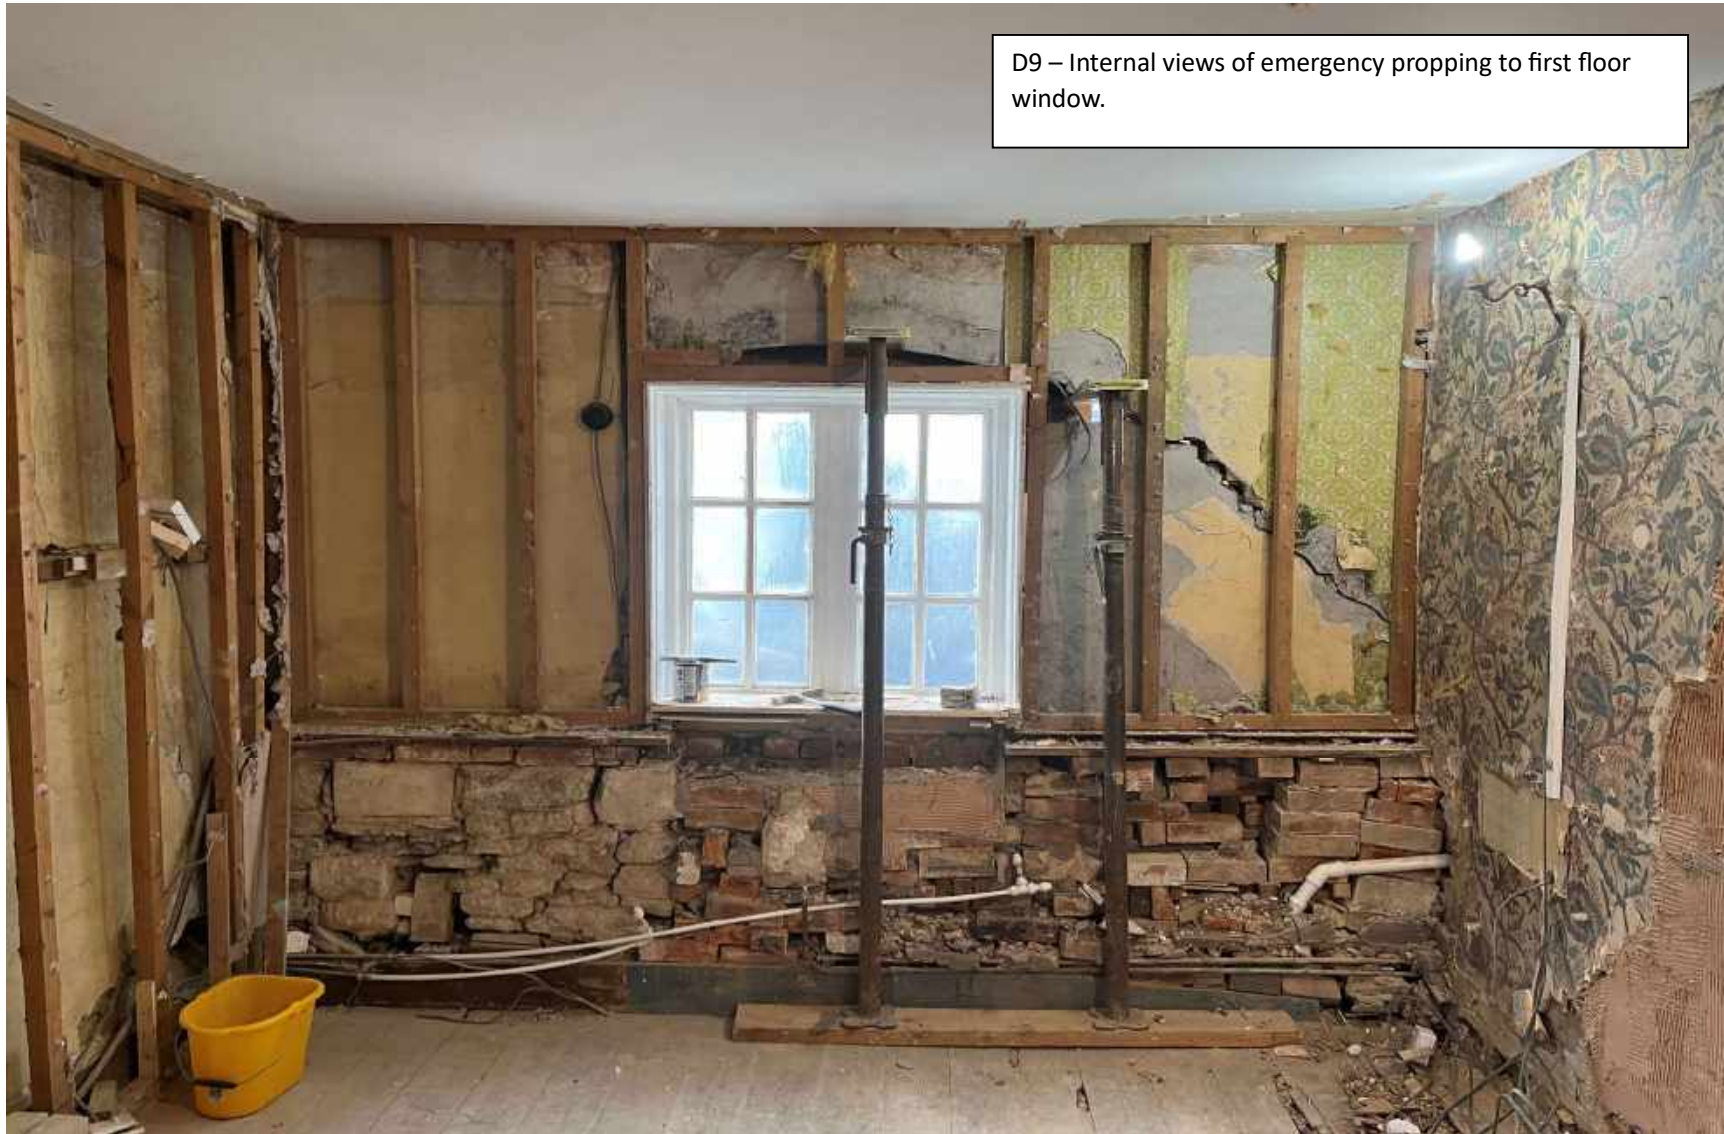
D9 – Internal views of emergency propping to first floor window.

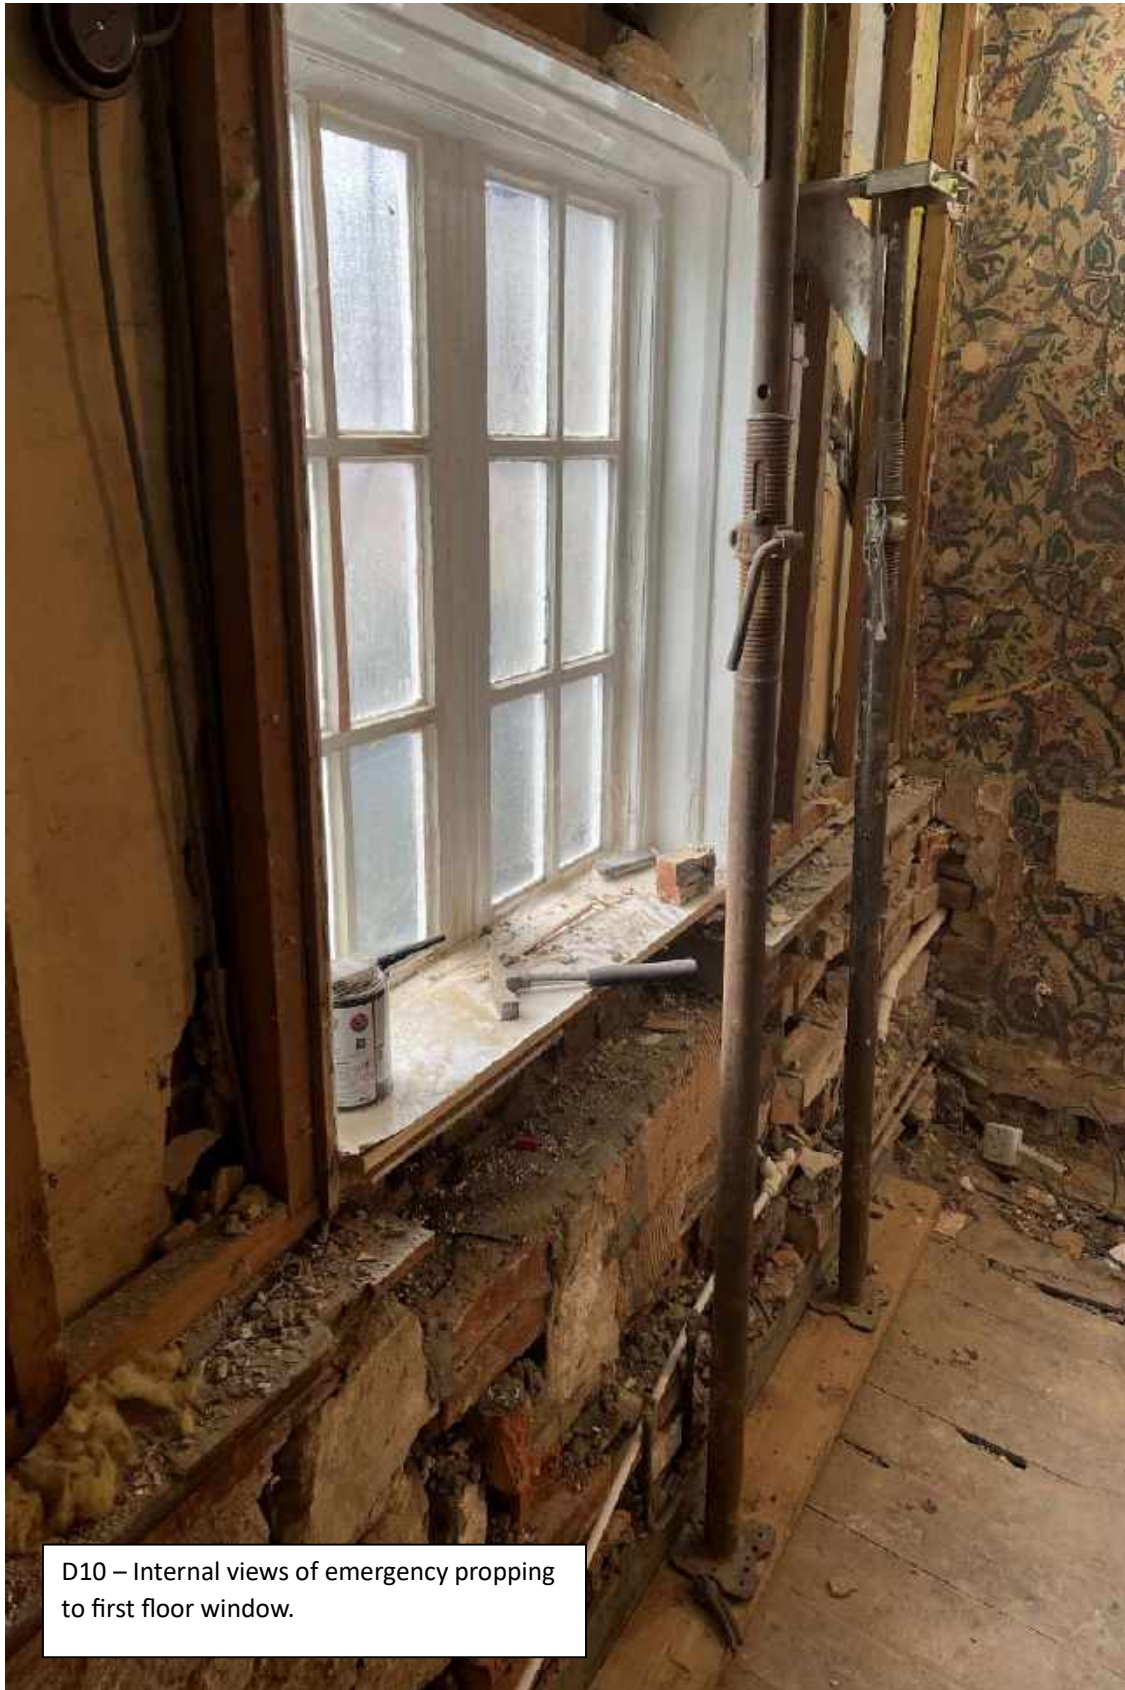
D10 – Internal views of emergency propping to first floor window.

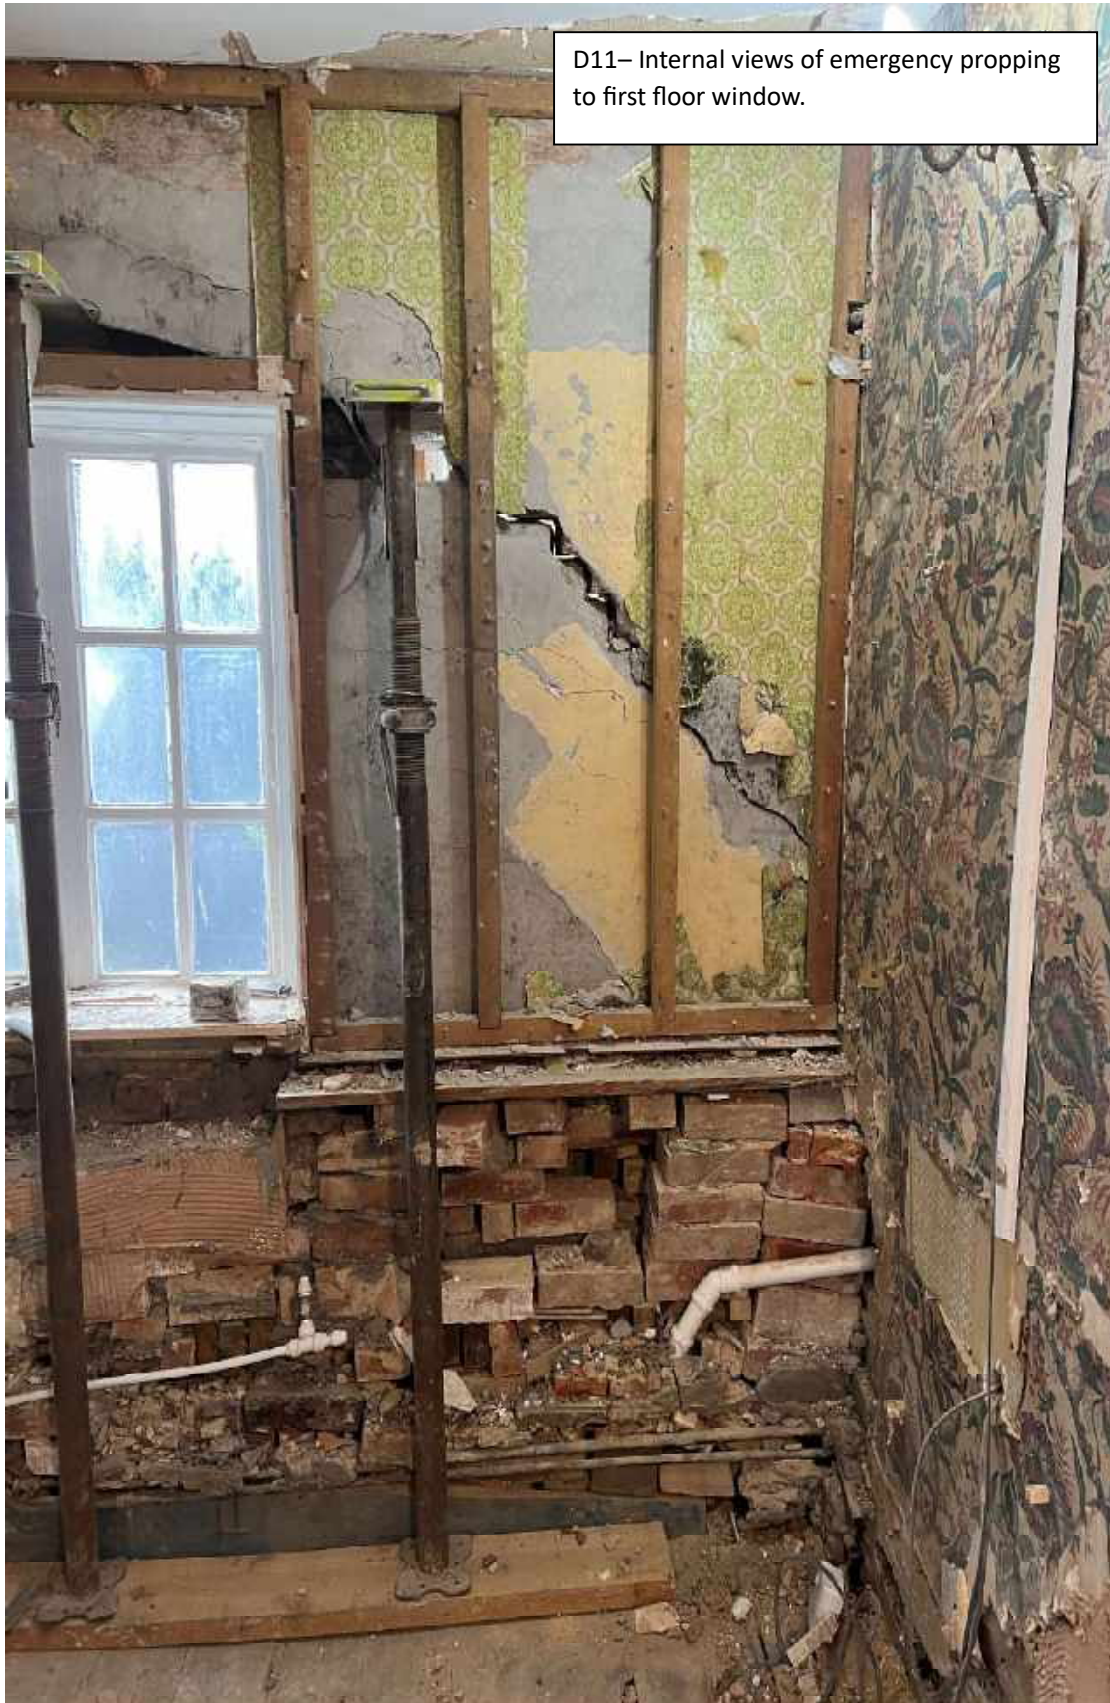
D11- Internal views of emergency propping to first floor window.

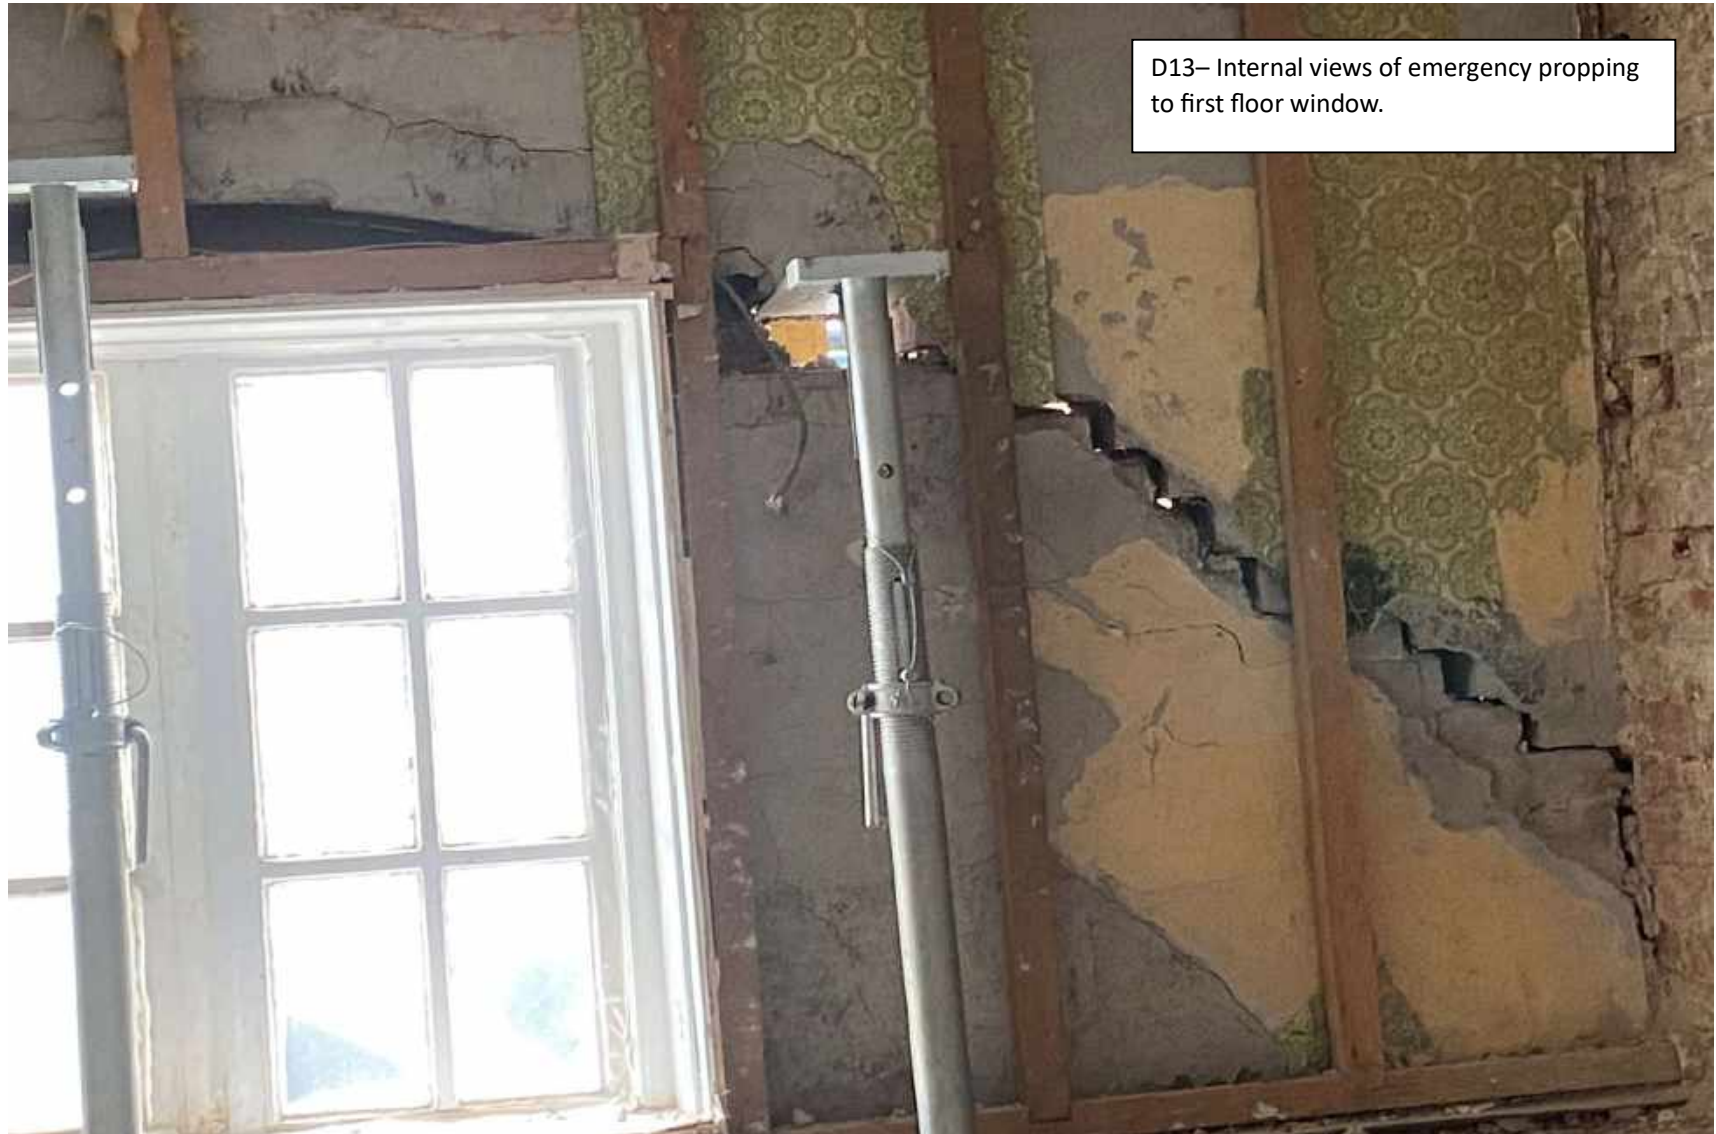
D12- Internal views of emergency propping to first floor window.

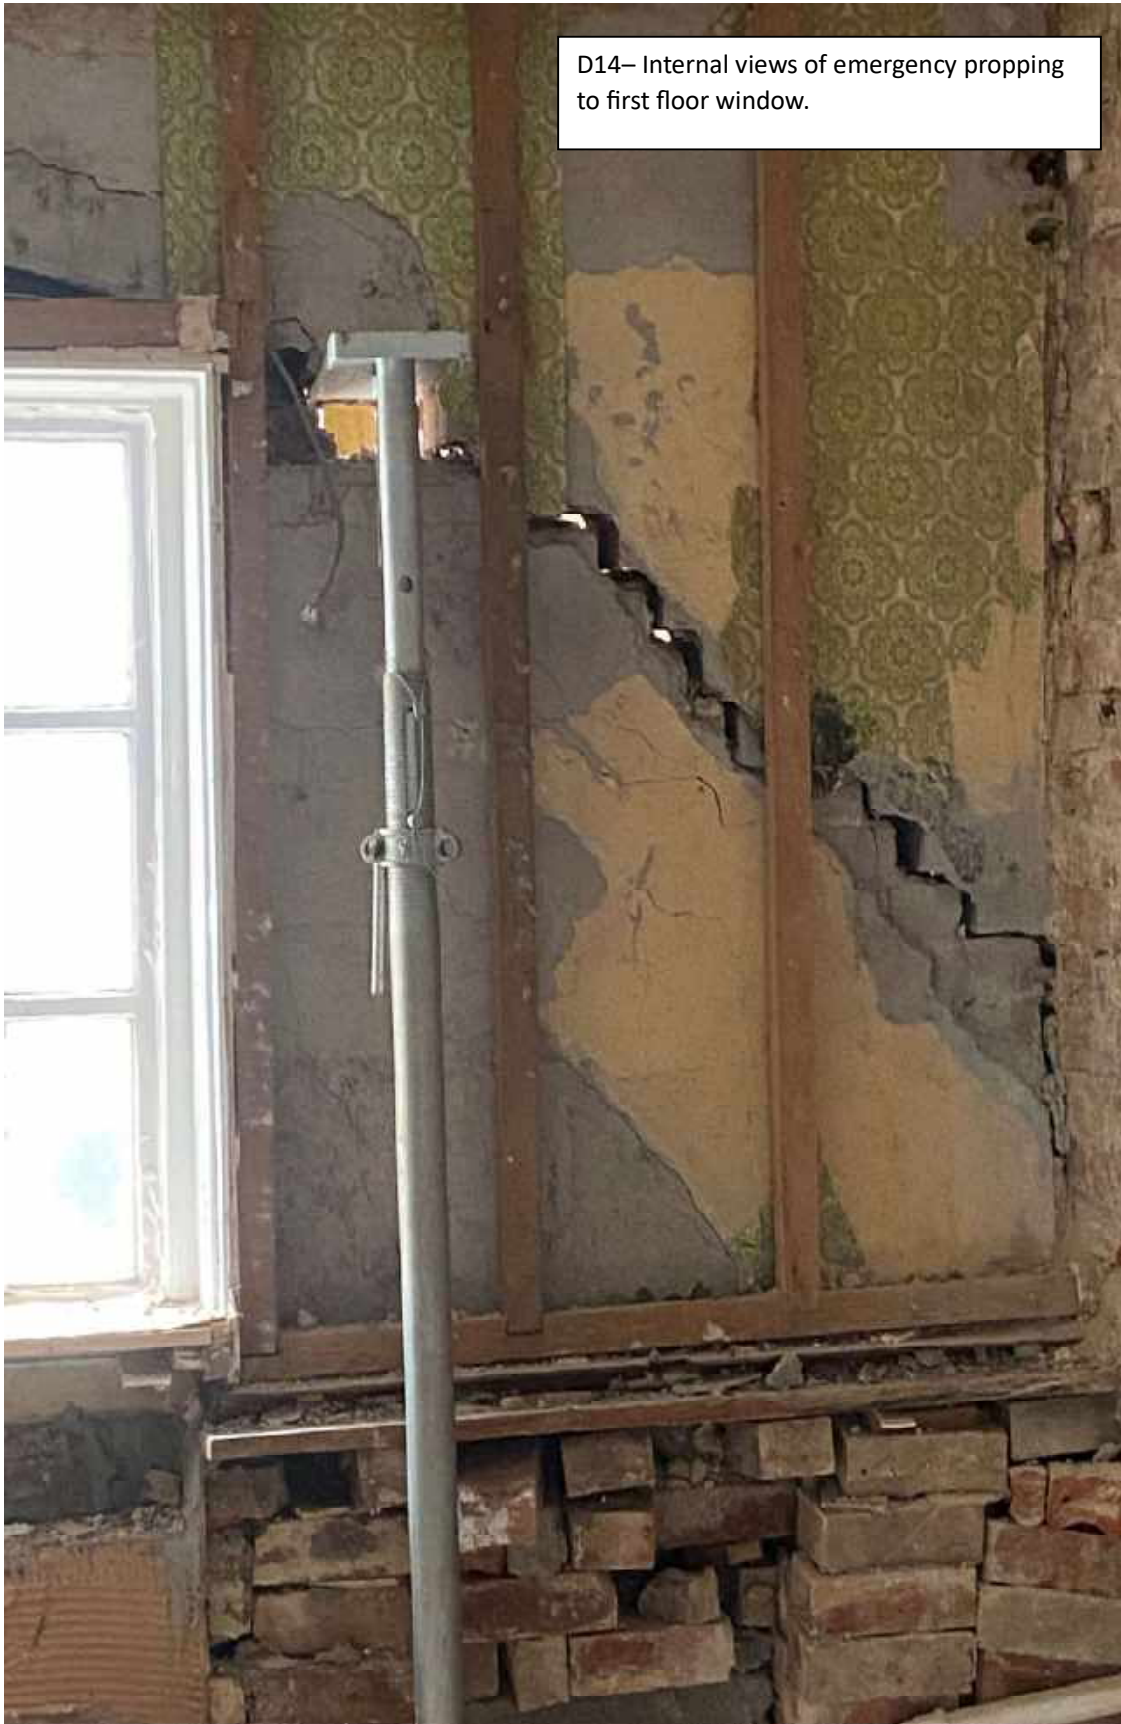
D14– Internal views of emergency propping to first floor window.

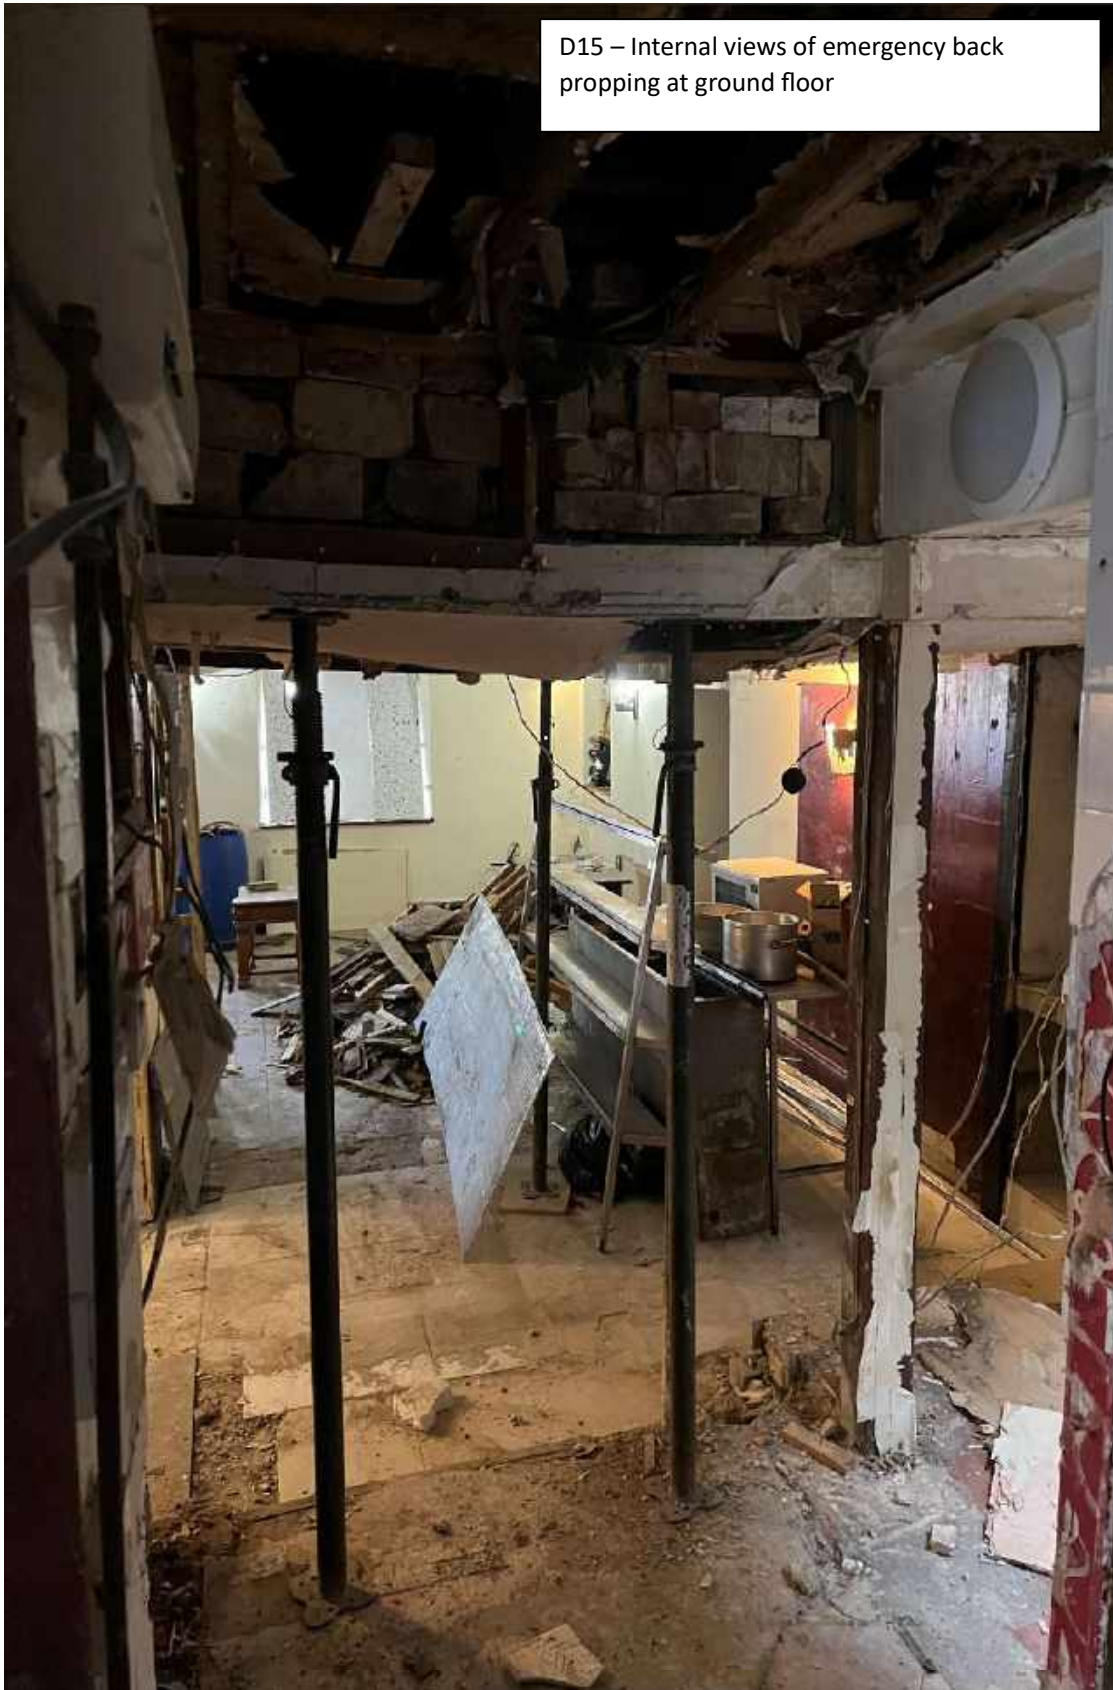
D15 – Internal views of emergency back propping at ground floor

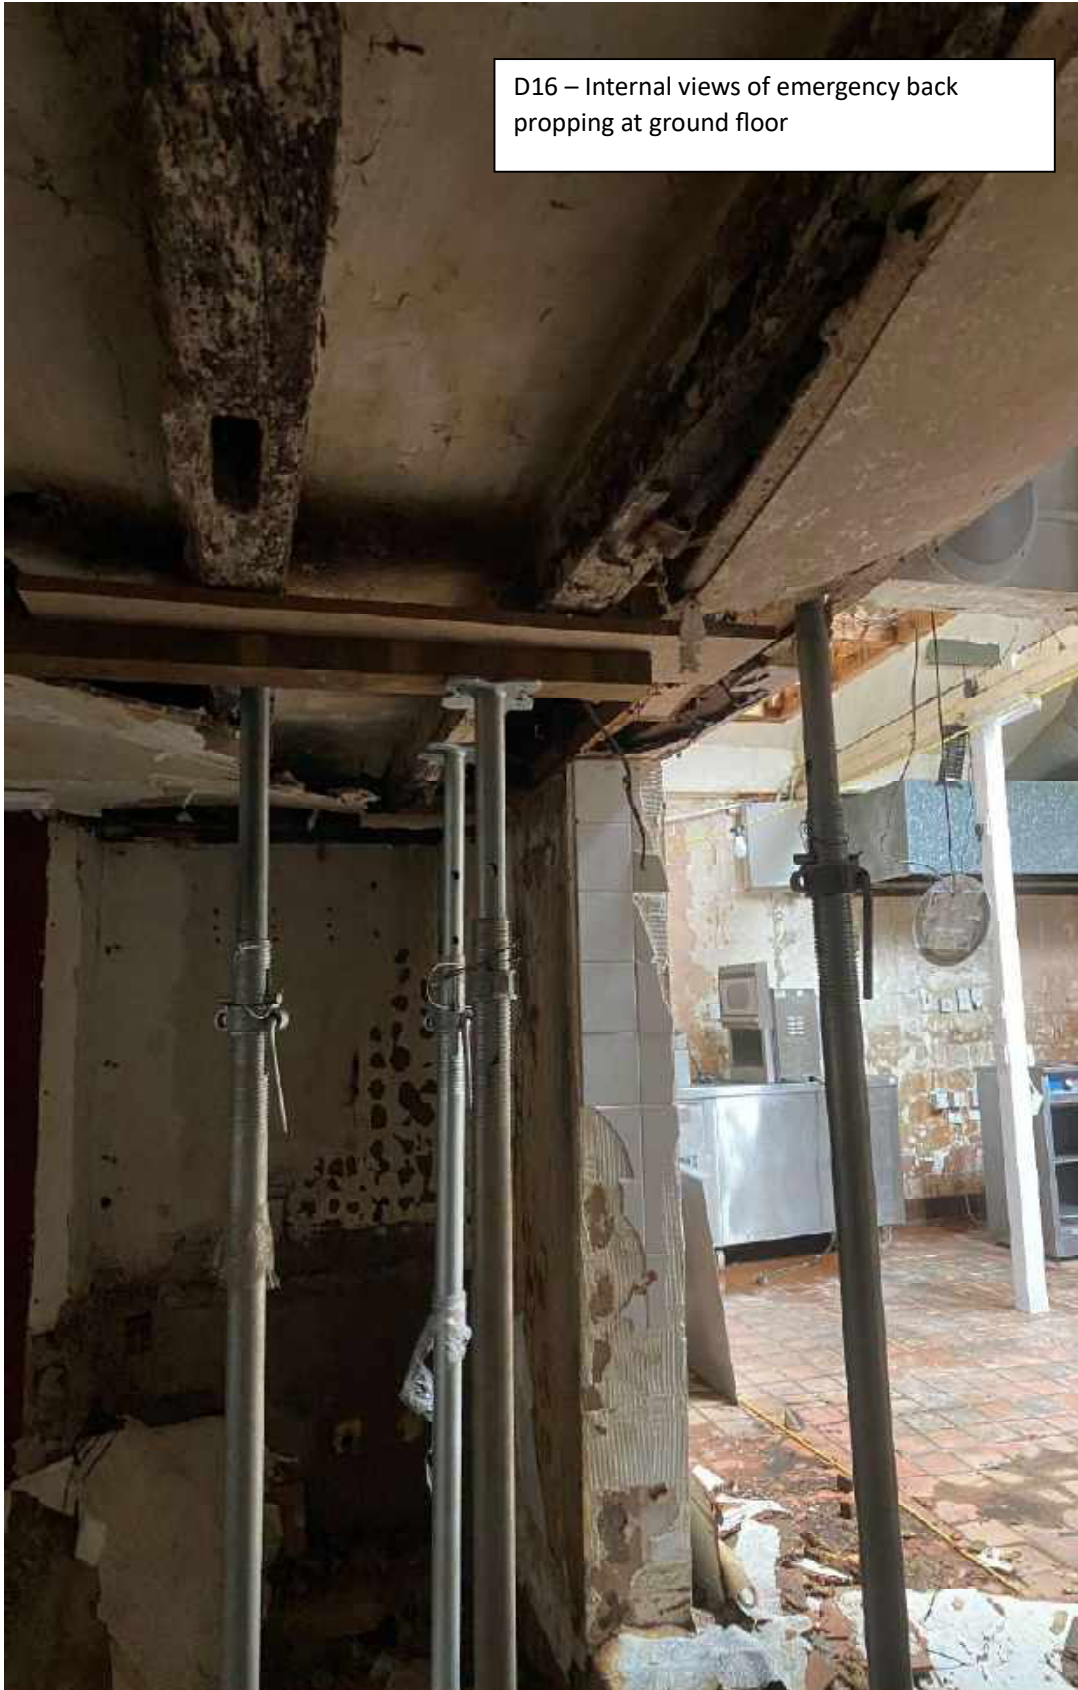
D16 – Internal views of emergency back propping at ground floor

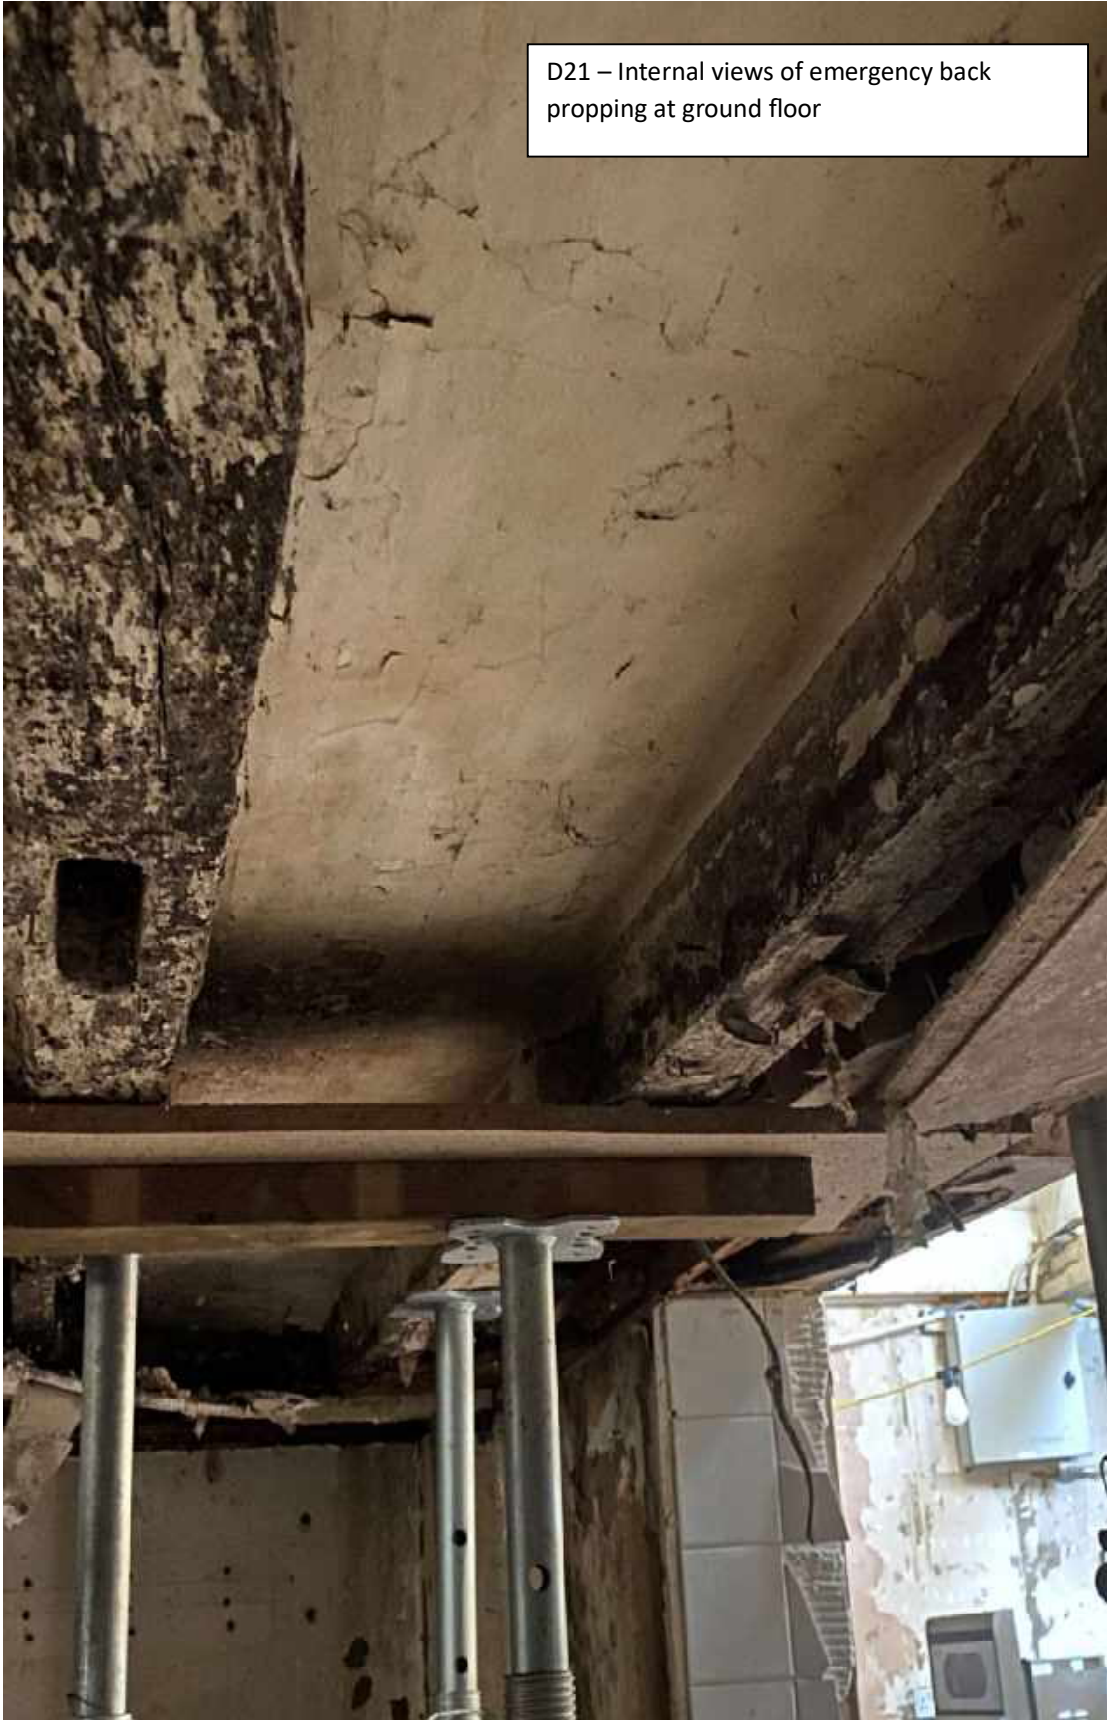
D21 – Internal views of emergency back propping at ground floor

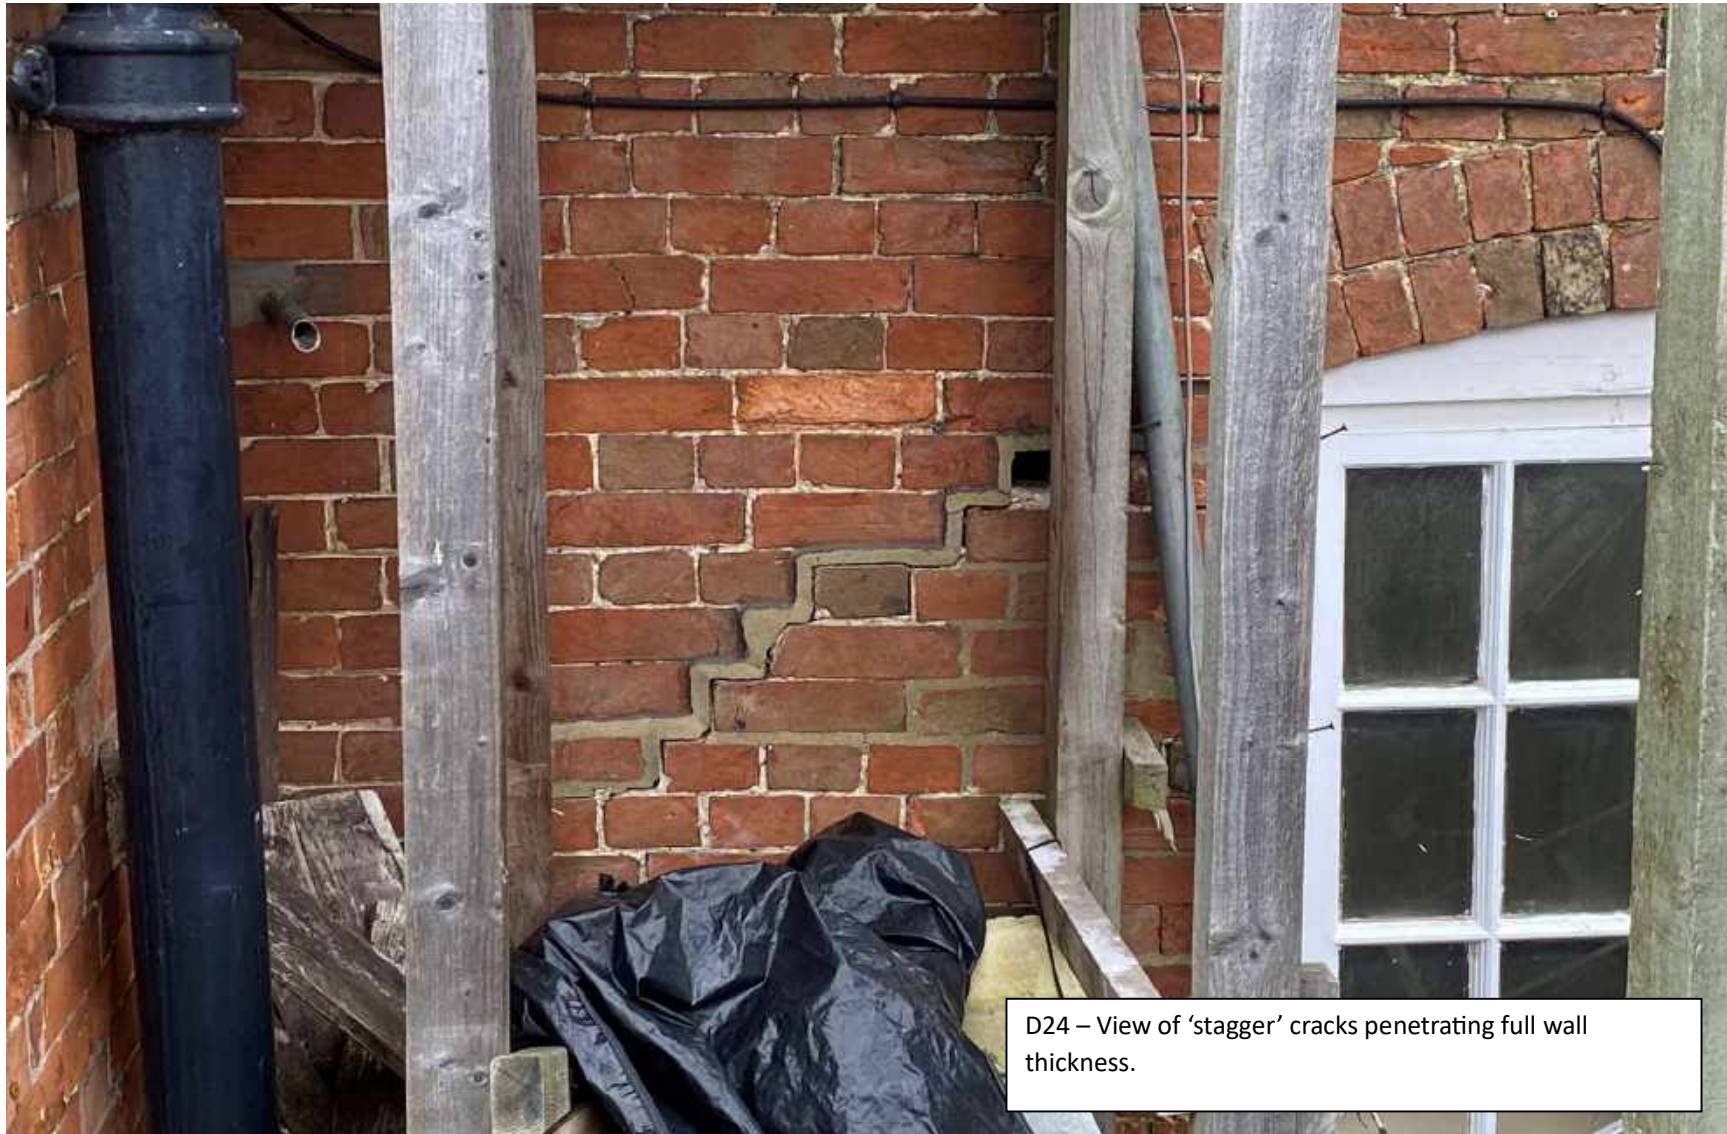
D25 – Typical view of walling to first floor with various types and poor standard of 'making good'.

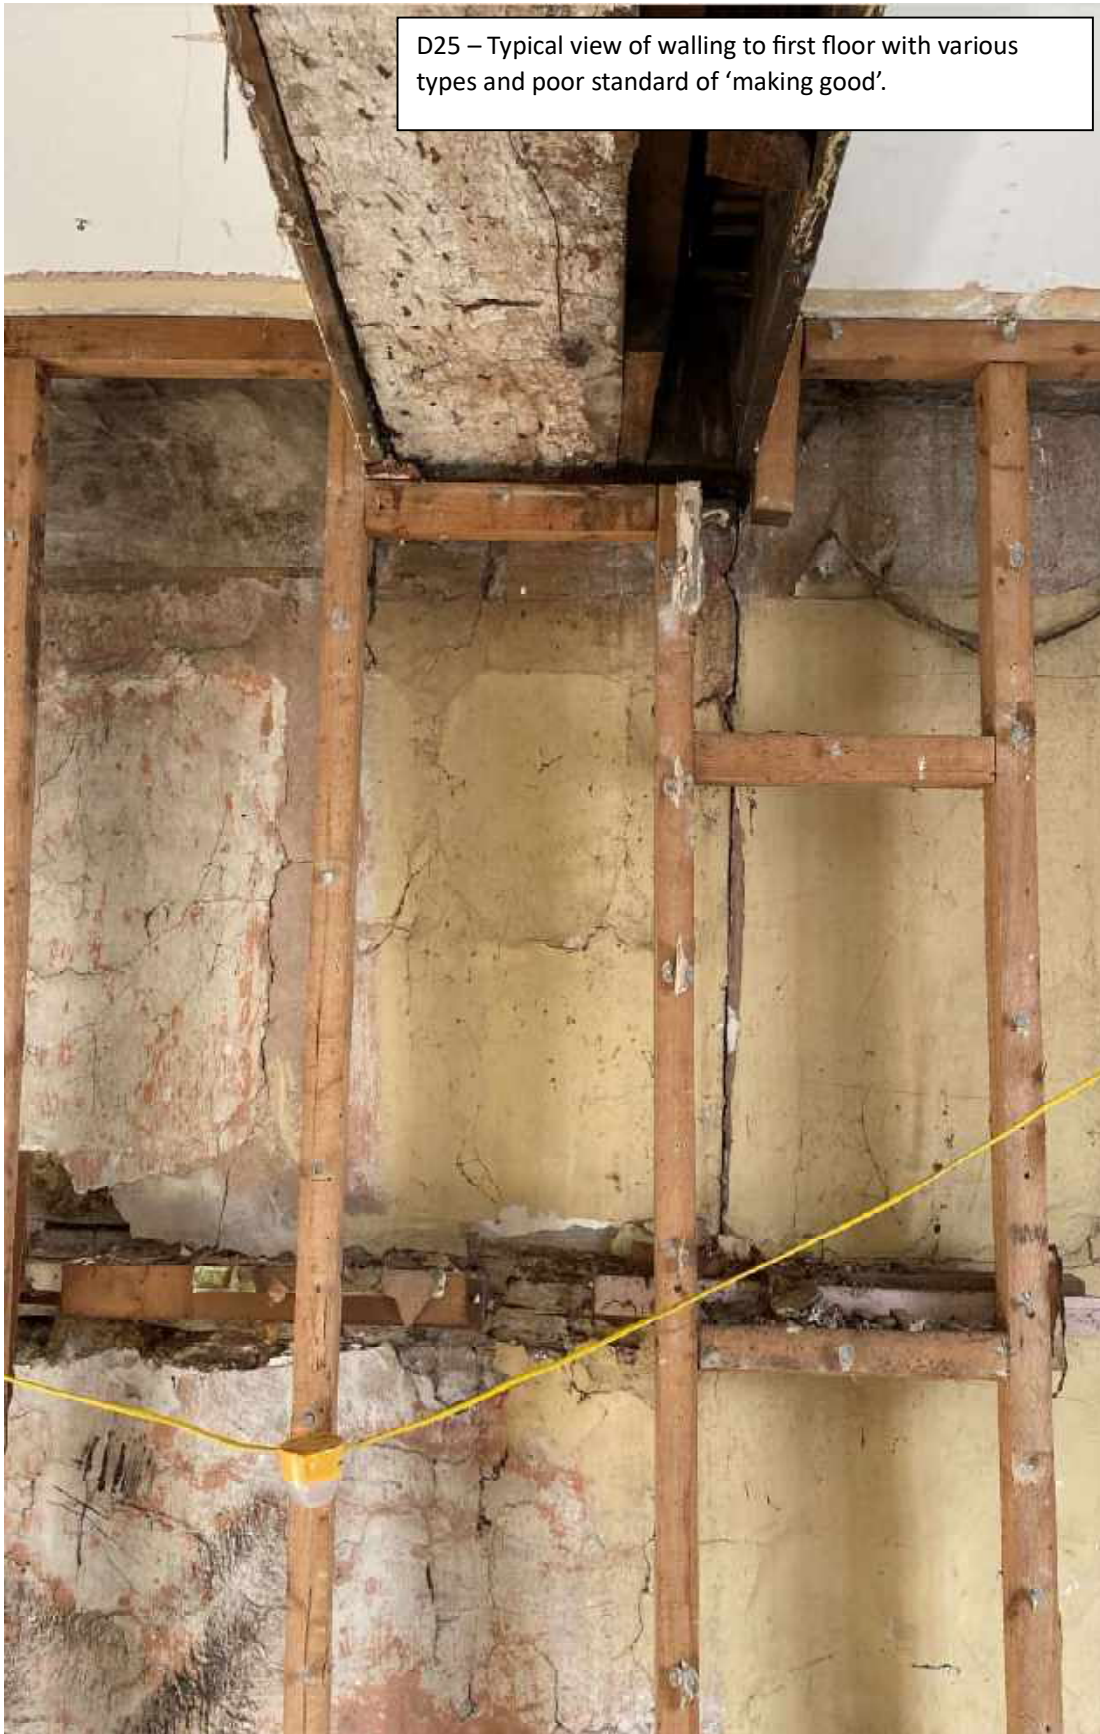
D26 – Typical view of walling to first floor with various types and poor standard of 'making good'.
