## **STRUCTURAL APPRAISAL**

**THE CARPENTERS ARMS, LACOCK, WILTS, SN15 2LB**

**MR ADRIAN GOTT**

**Project** : 2022.270  
**Date** : February 2024  
**Engineer** : G.Schofield C Eng, MI Struct E, MICE, MIEI  
**Issue No: 1** : 21.02.2024

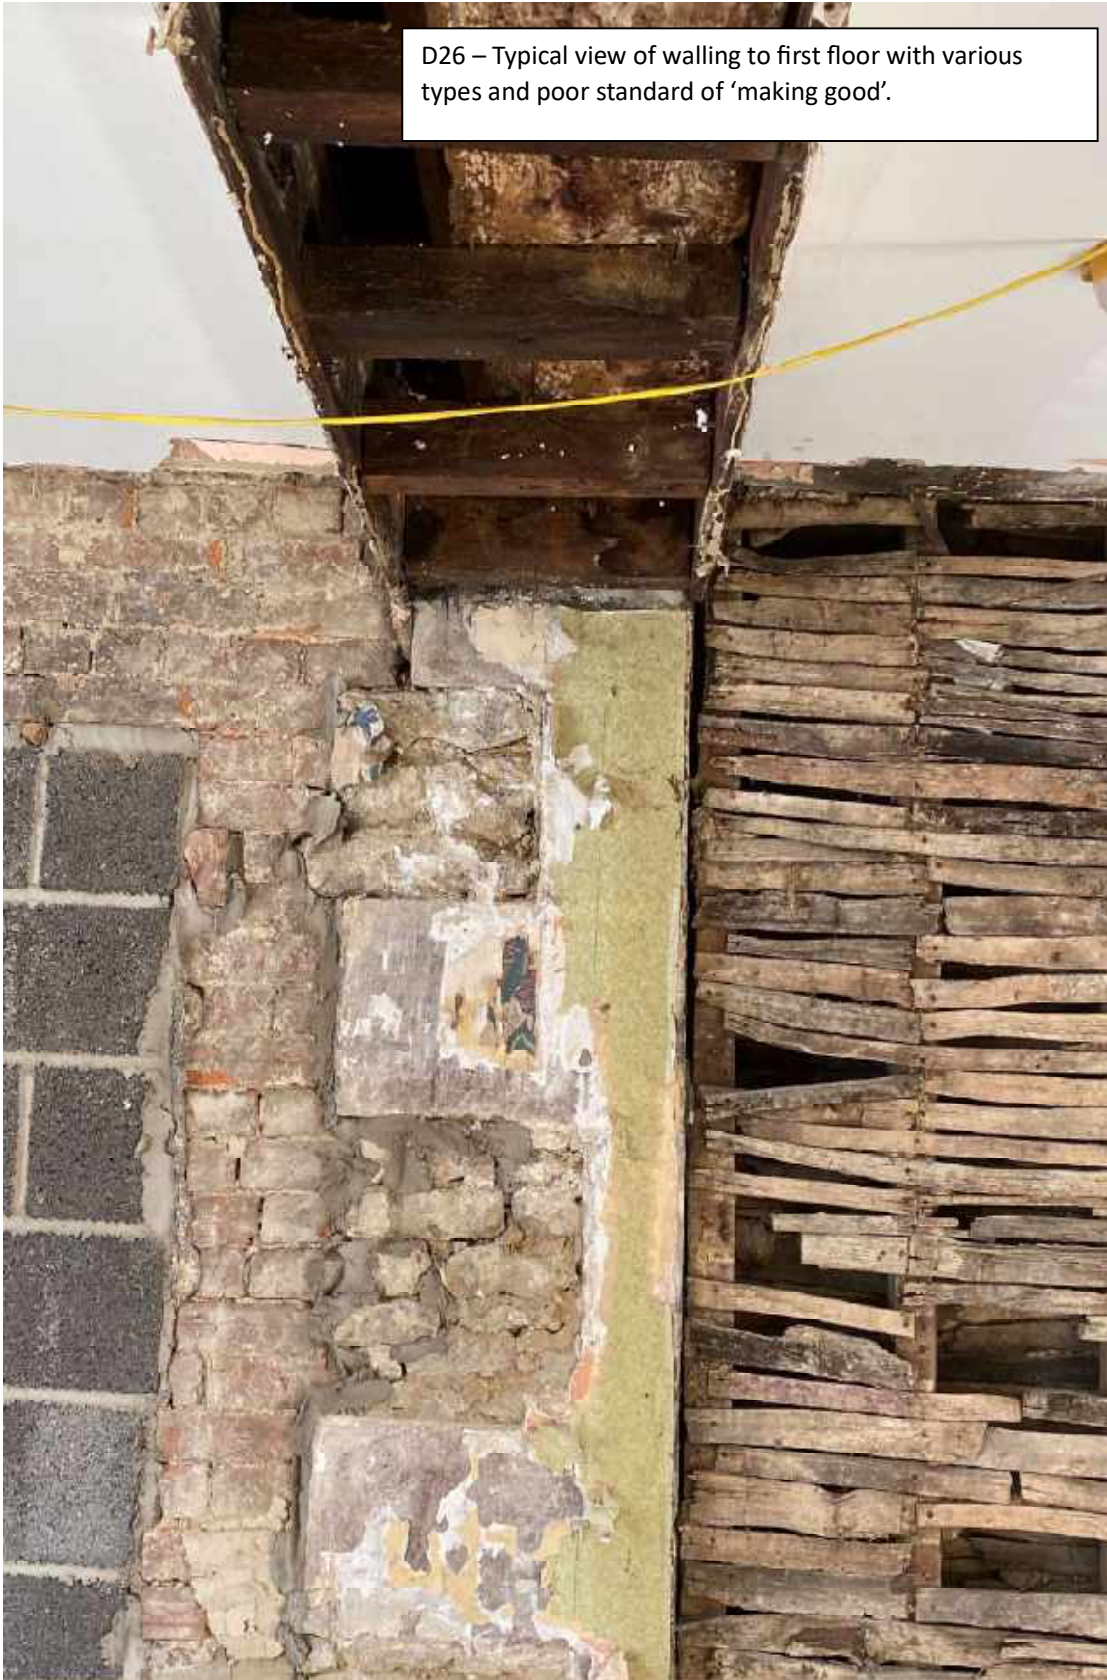
D27 – Typical view of walling to first floor with various types and poor standard of 'making good'.

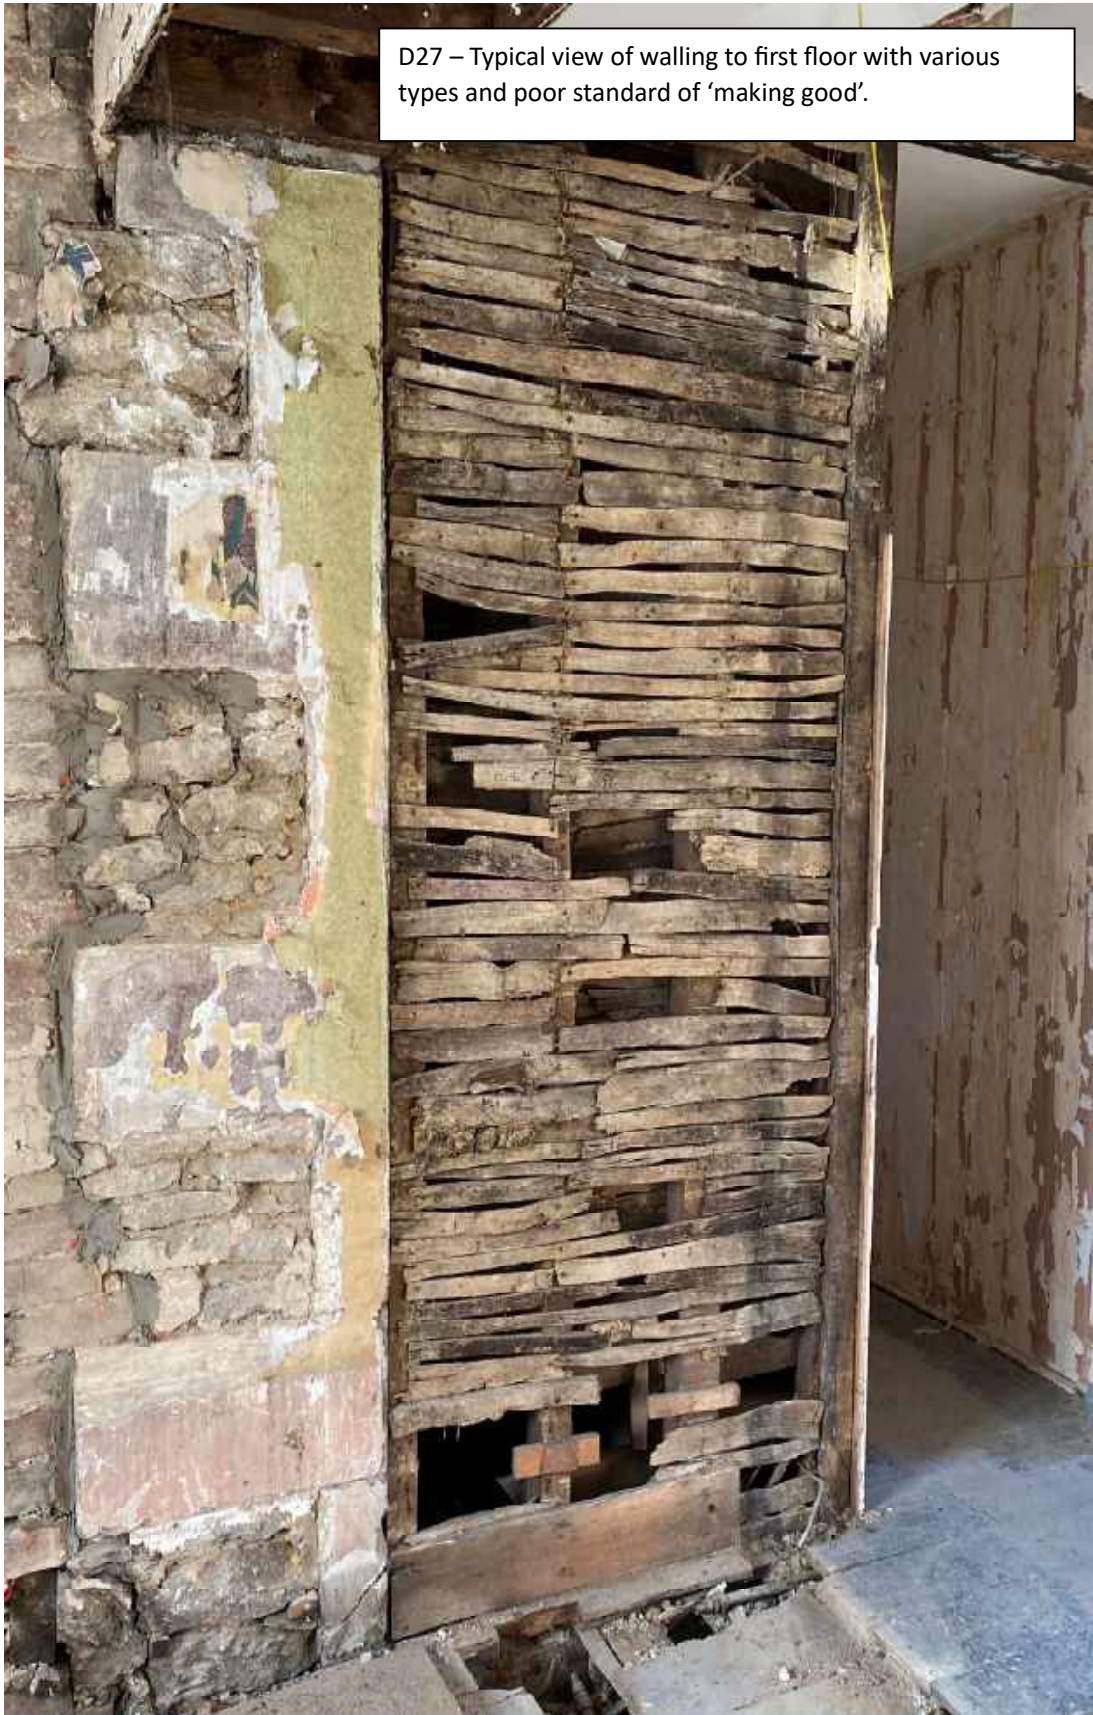
D28 – Typical view of walling to first floor with various types and poor standard of 'making good'.

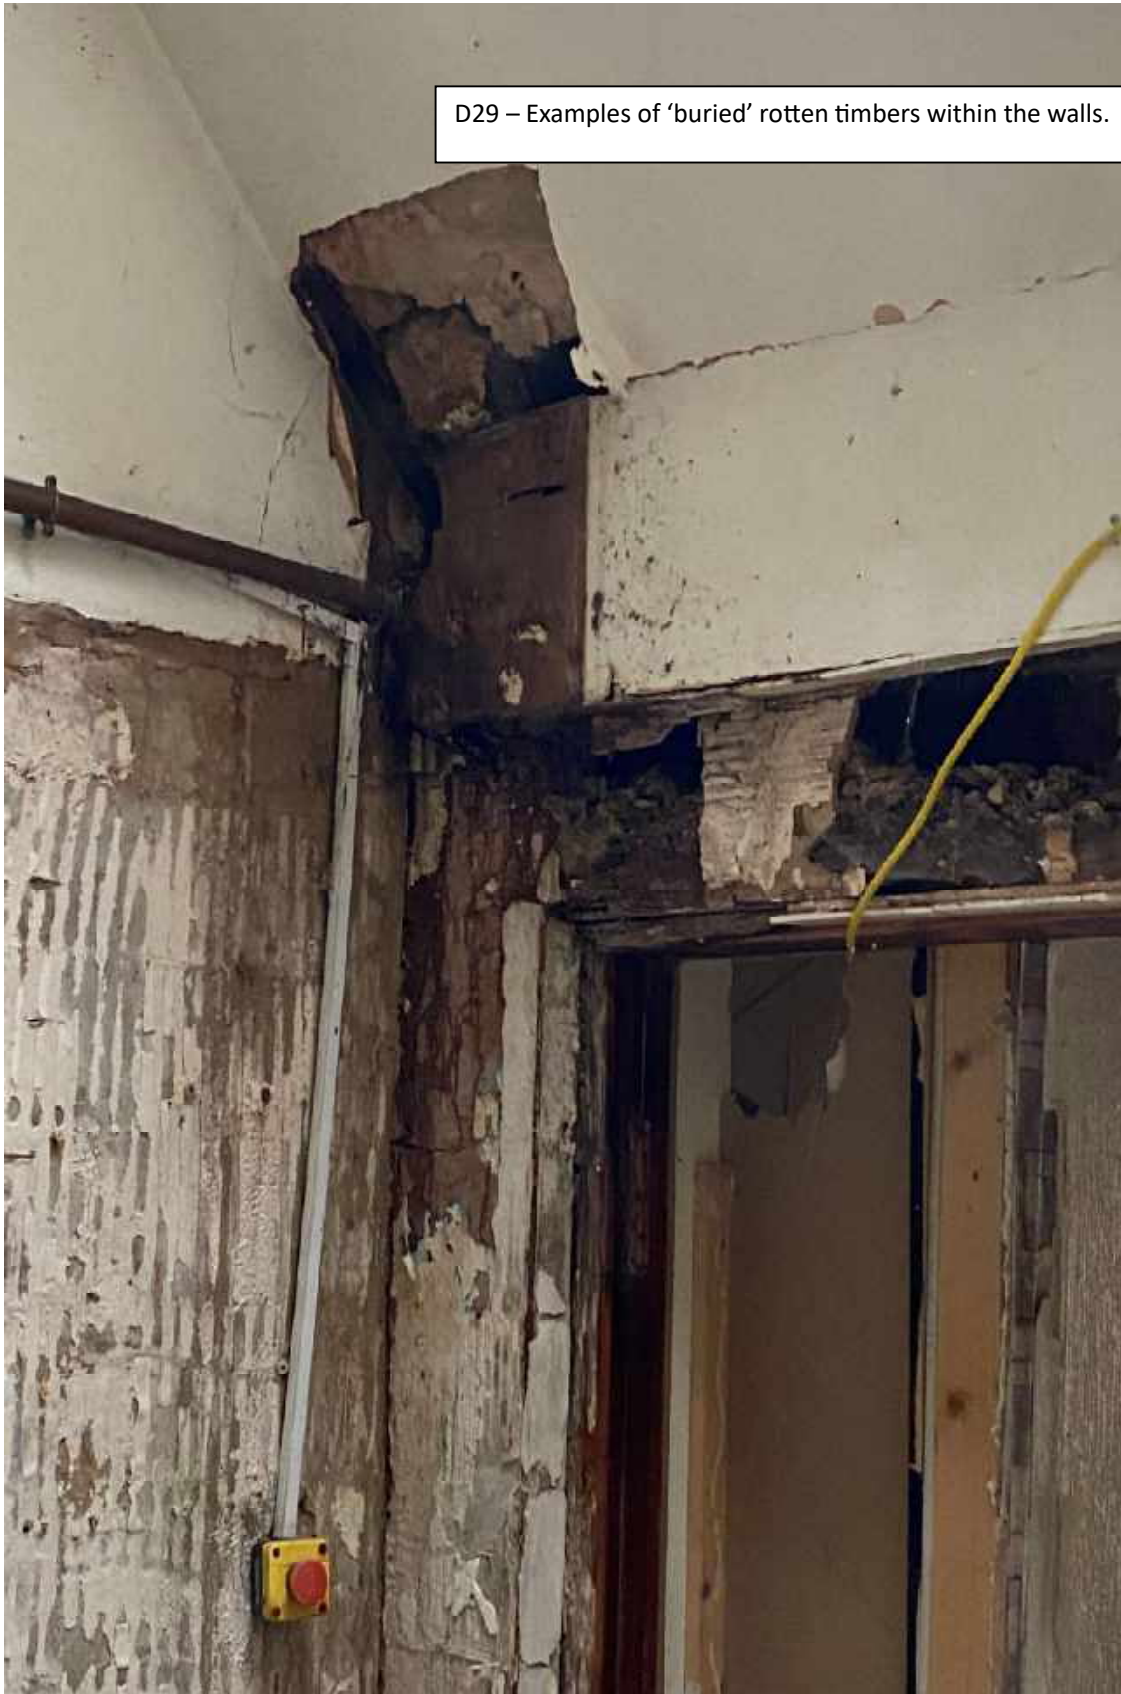
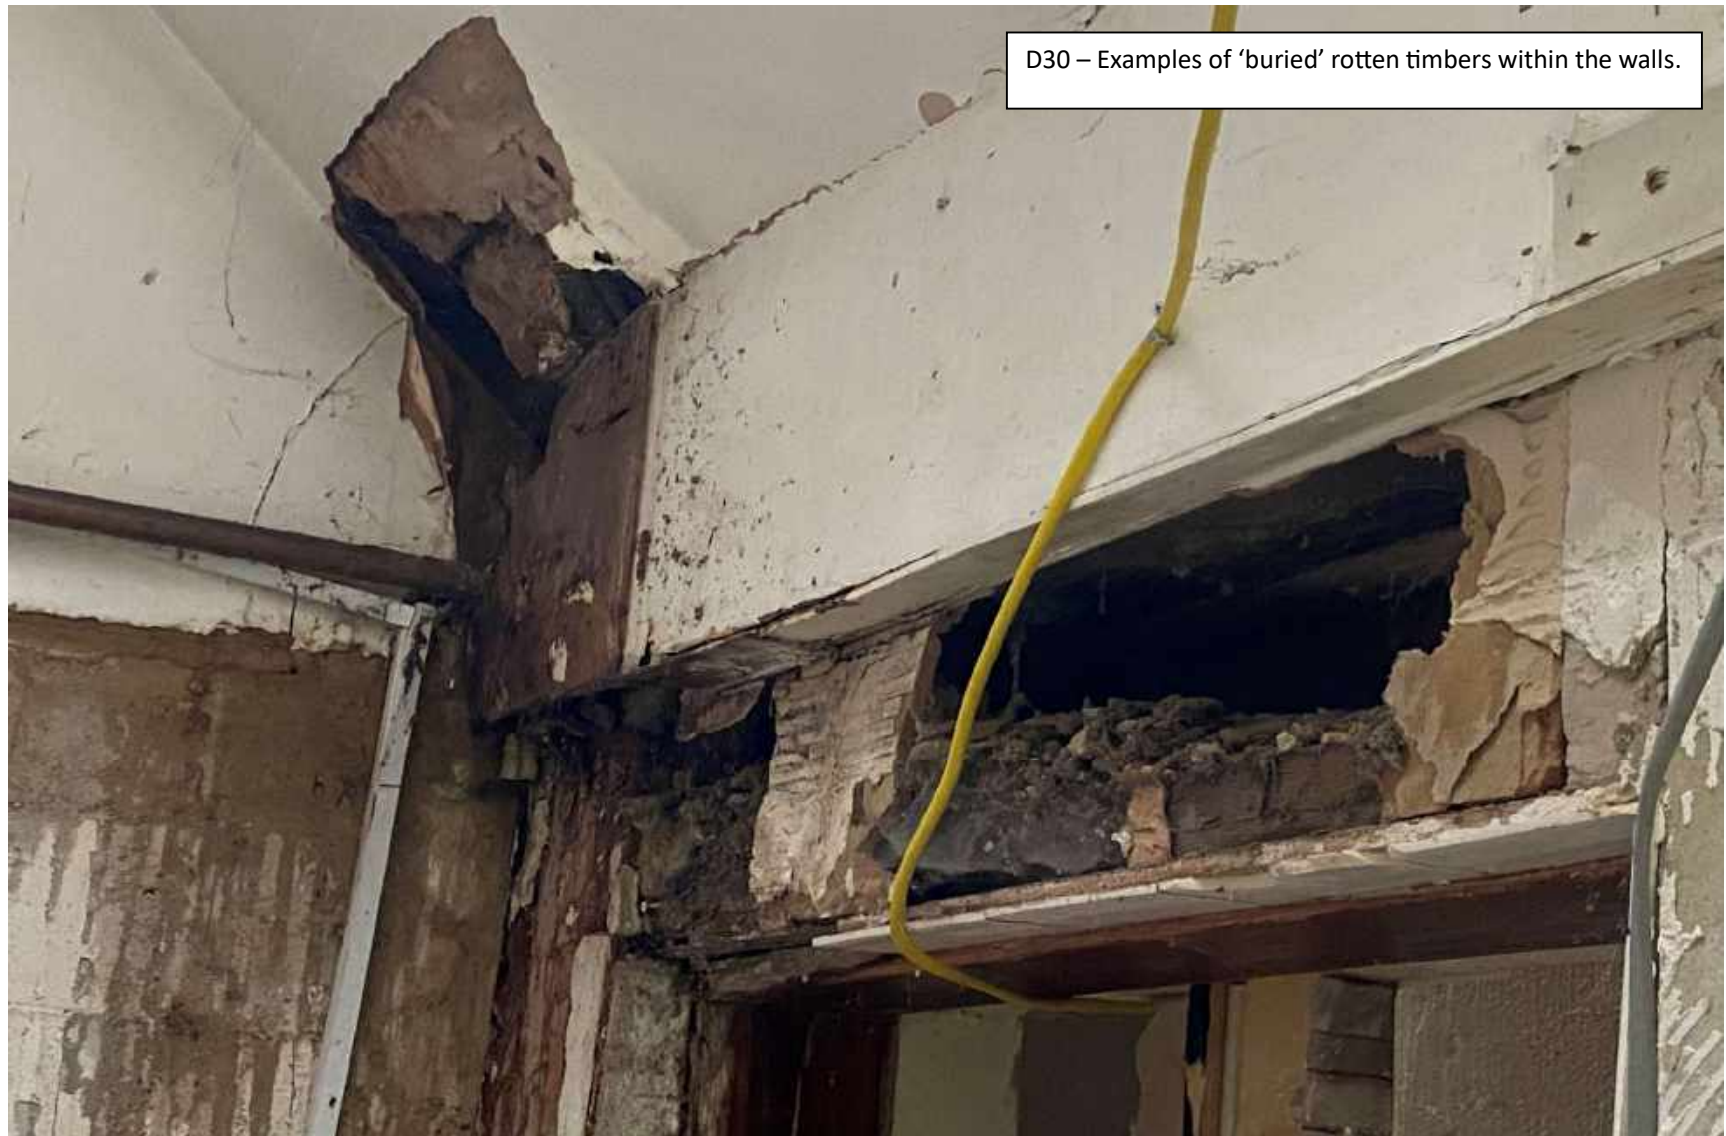
The existence of this defect was only discovered by the removal of detached plasterwork. It should be anticipated that additional similar defects will present themselves throughout the refurbishment of the property. Only the removal of plasterwork will confirm the extent of remedial works.

D30 – Examples of 'buried' rotten timbers within the walls.

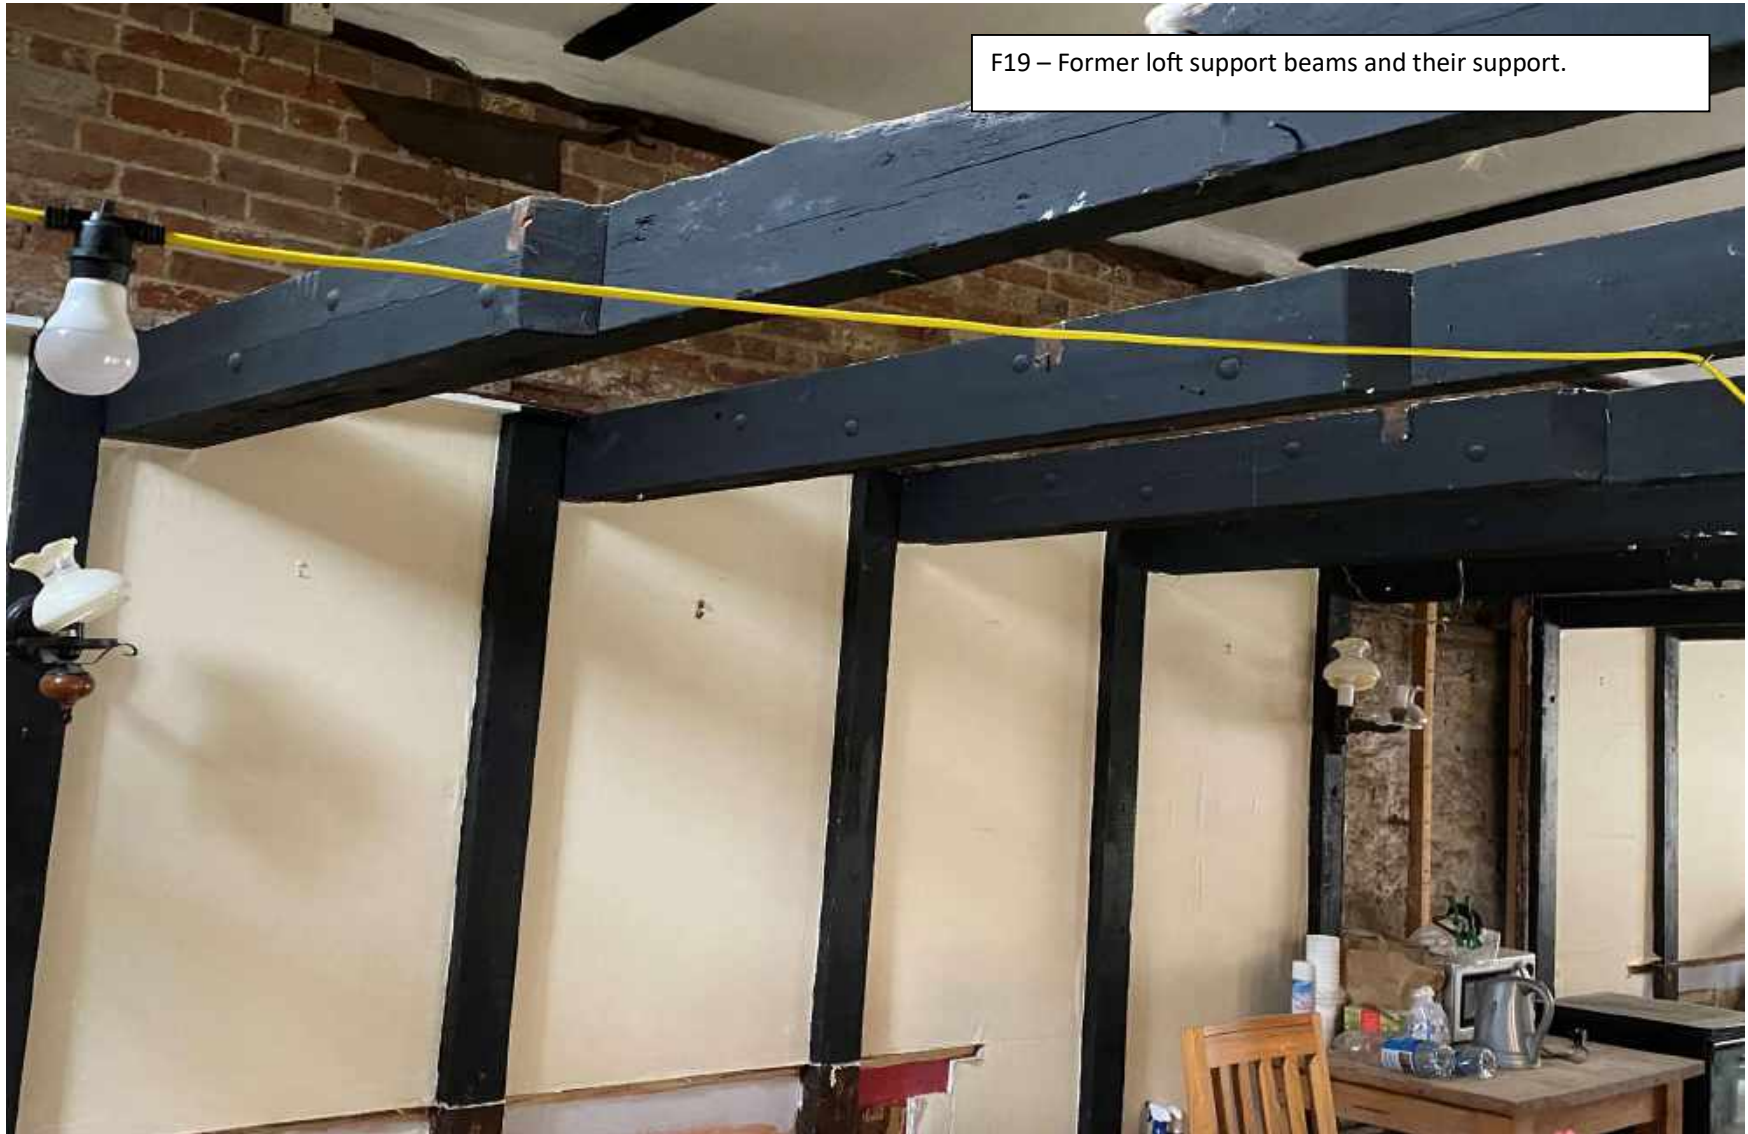
F20— Former loft support beams and their support.

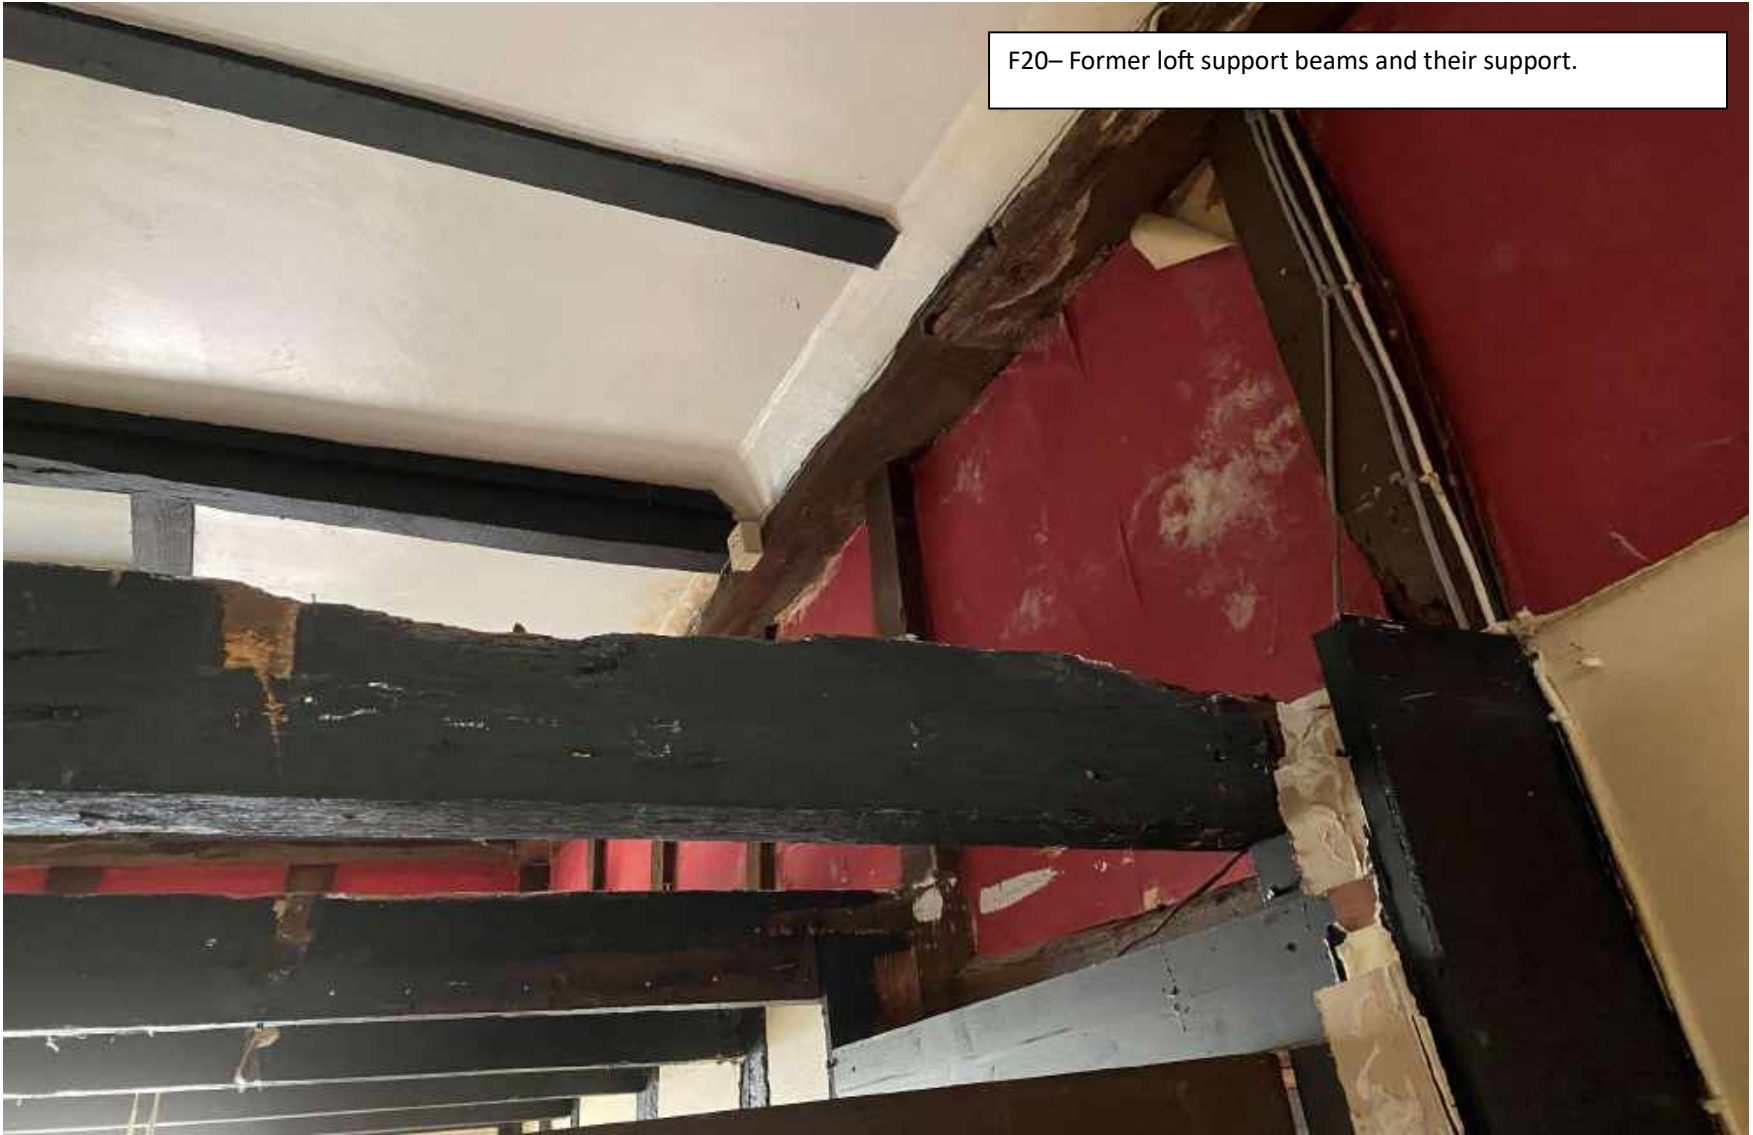
F21 – Former loft support beams and their support.

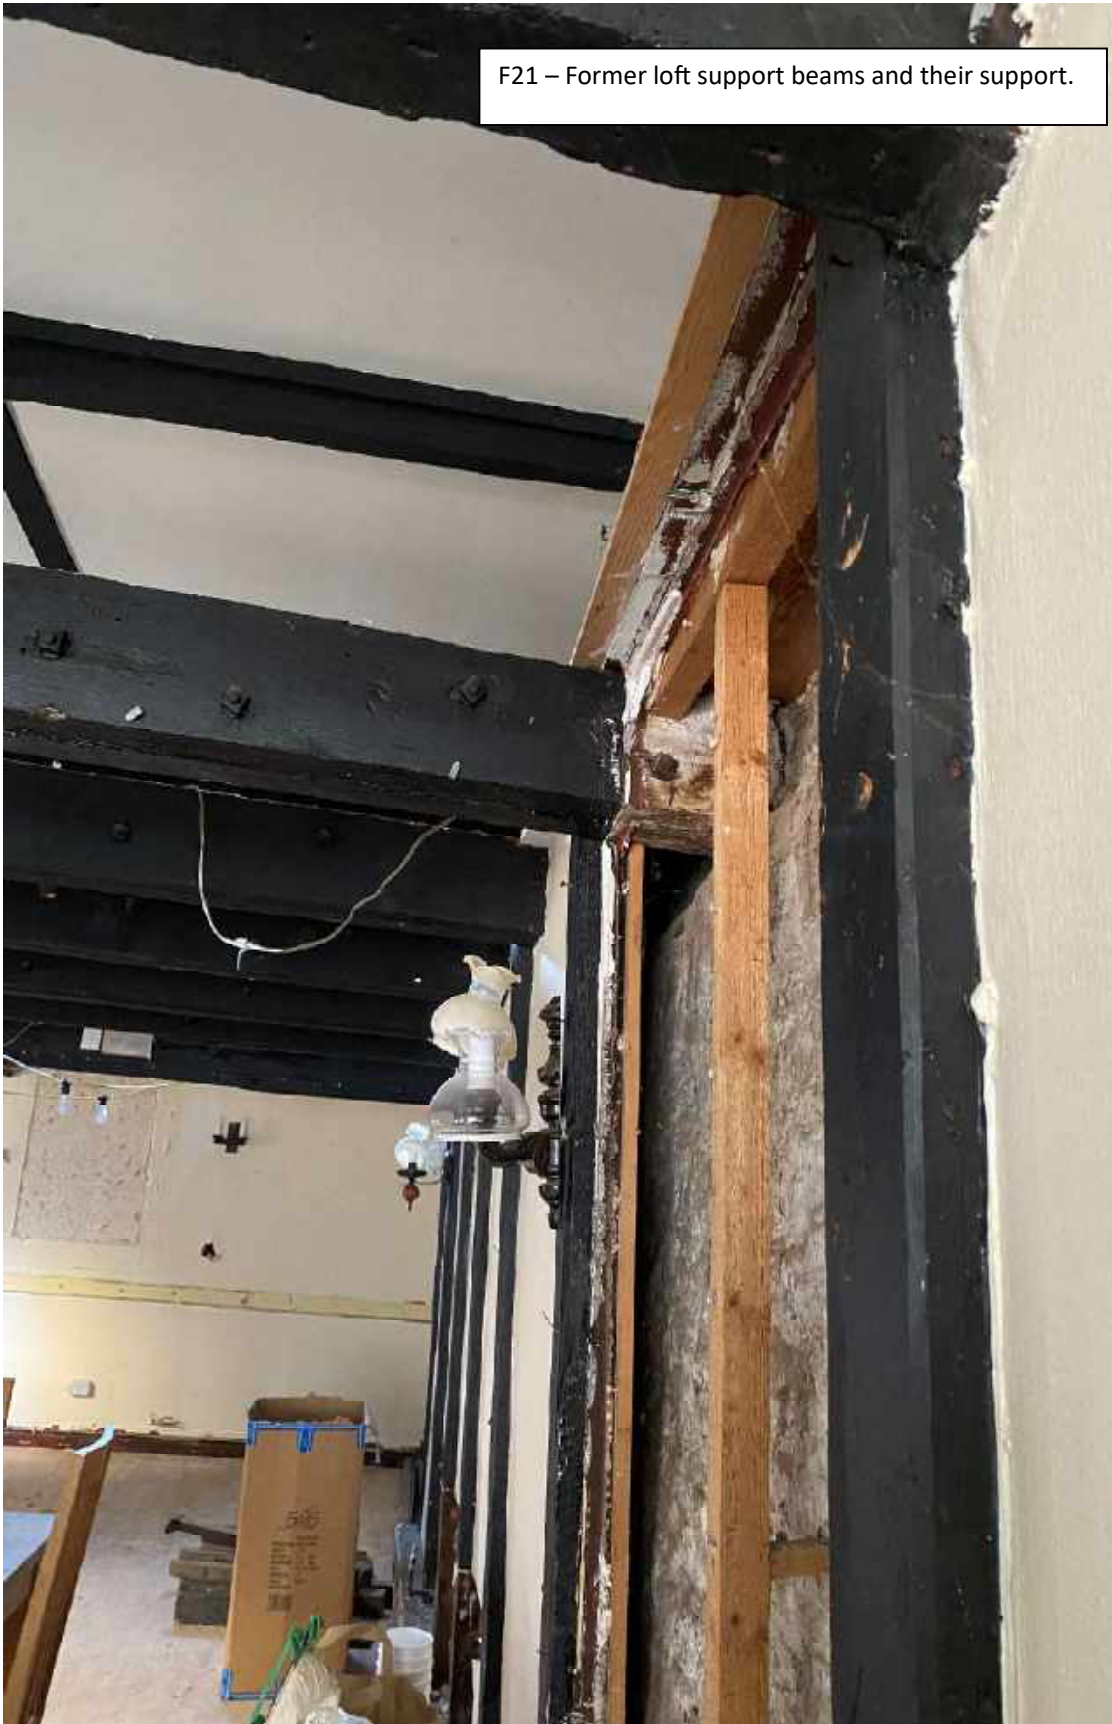
F22 – Internal non structural brick plinth. Timber framing is supported on external plinth – see plates F10 & F11.

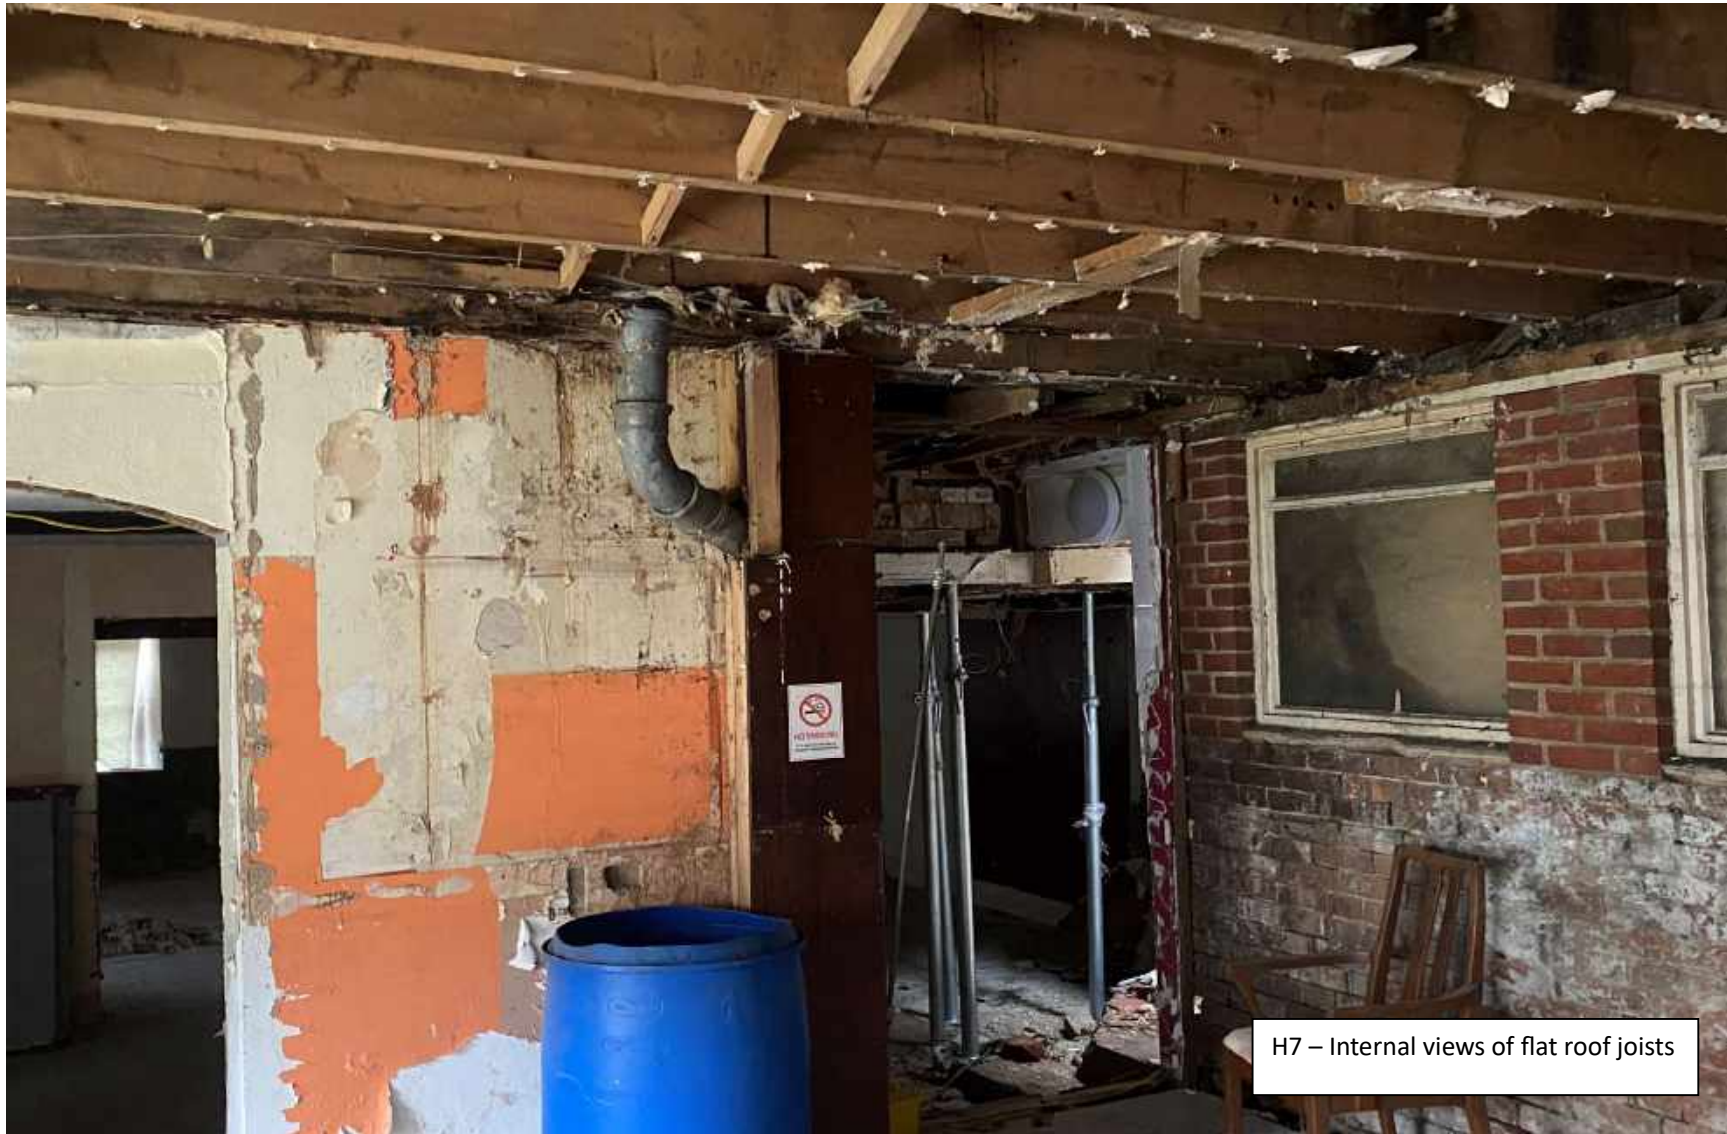
H7 – Internal views of flat roof joists

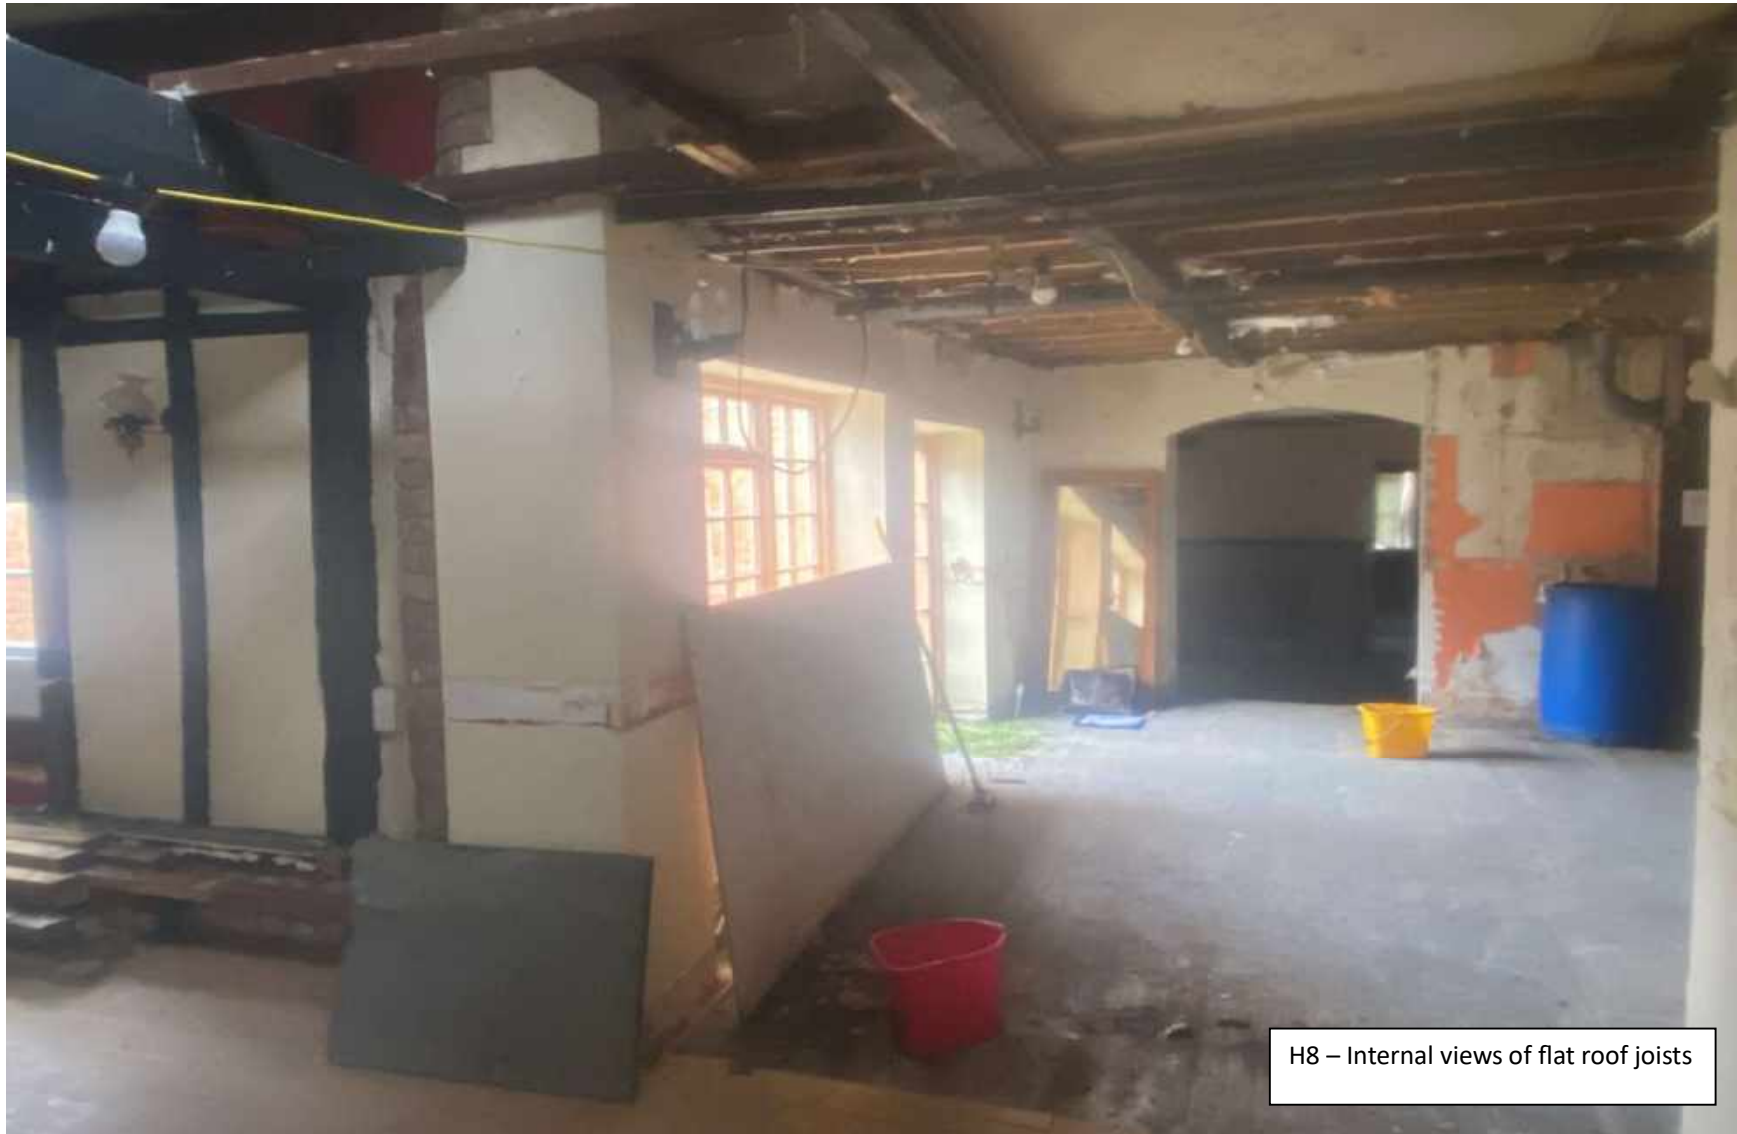
H8 – Internal views of flat roof joists

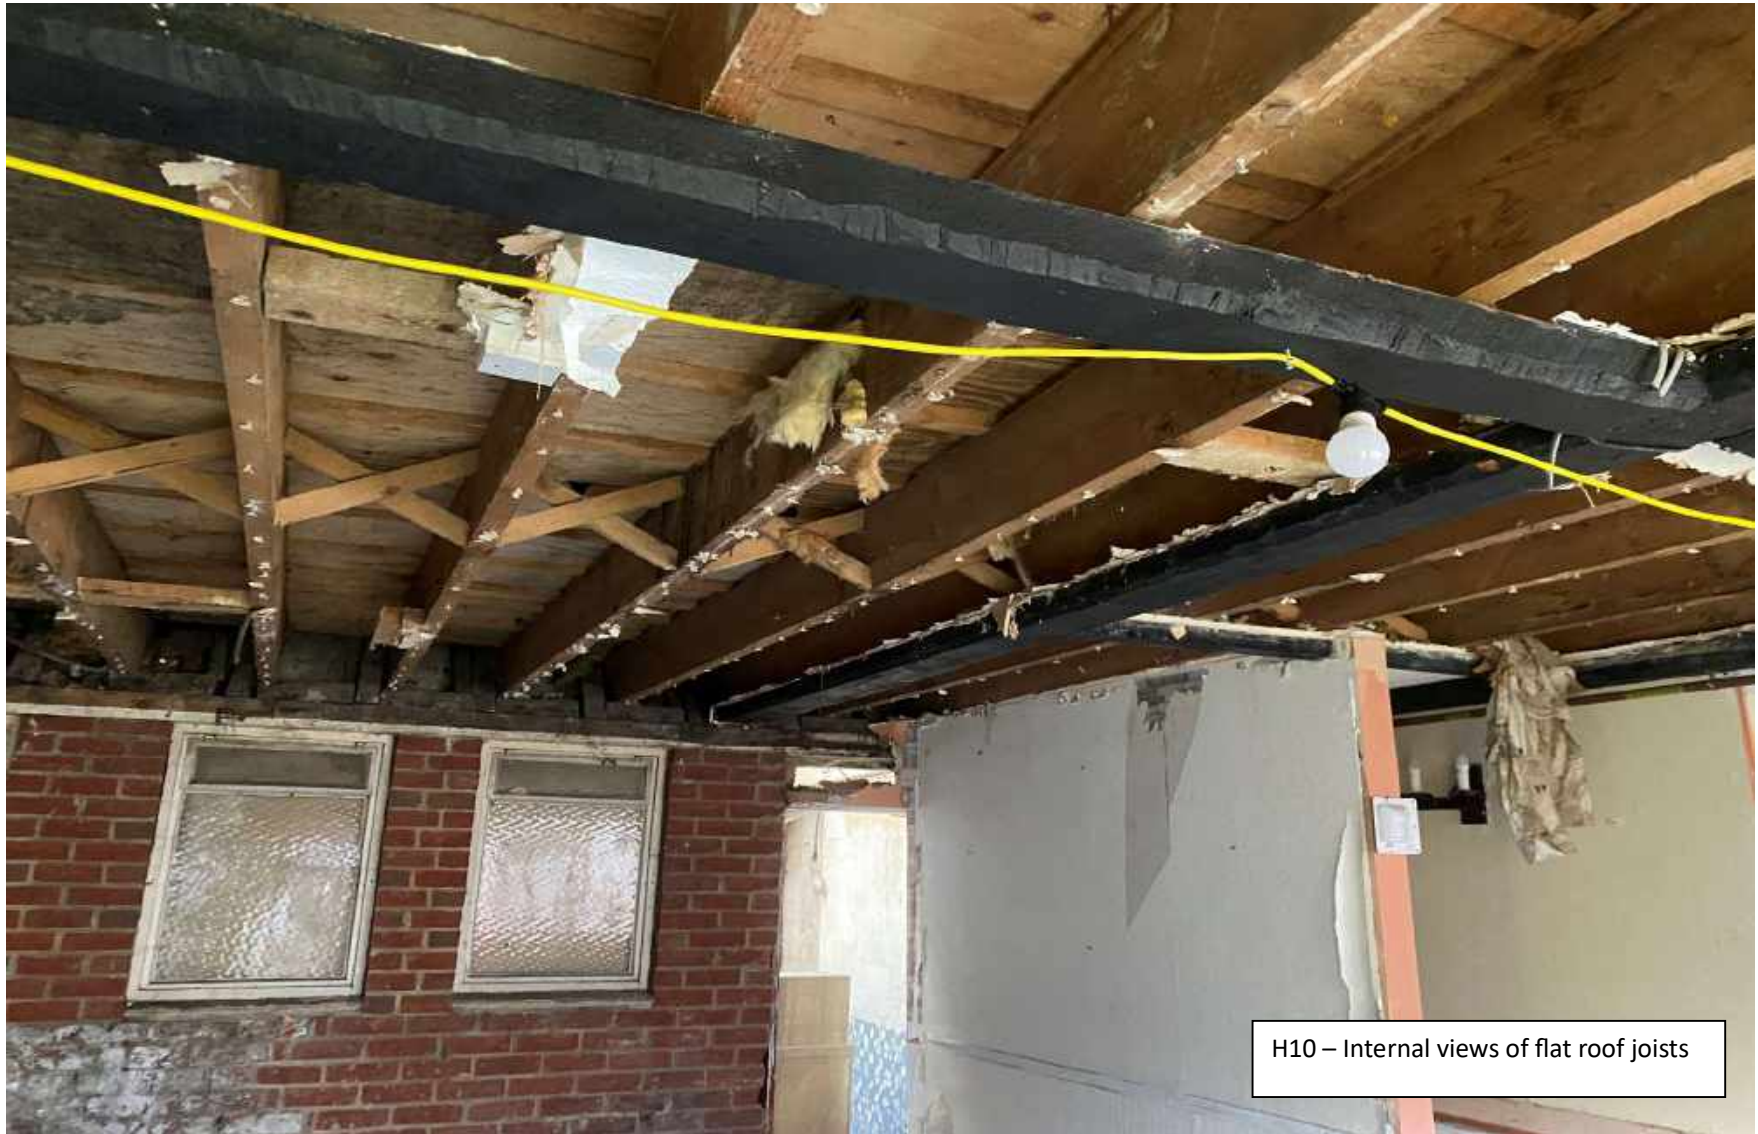
H10 – Internal views of flat roof joists

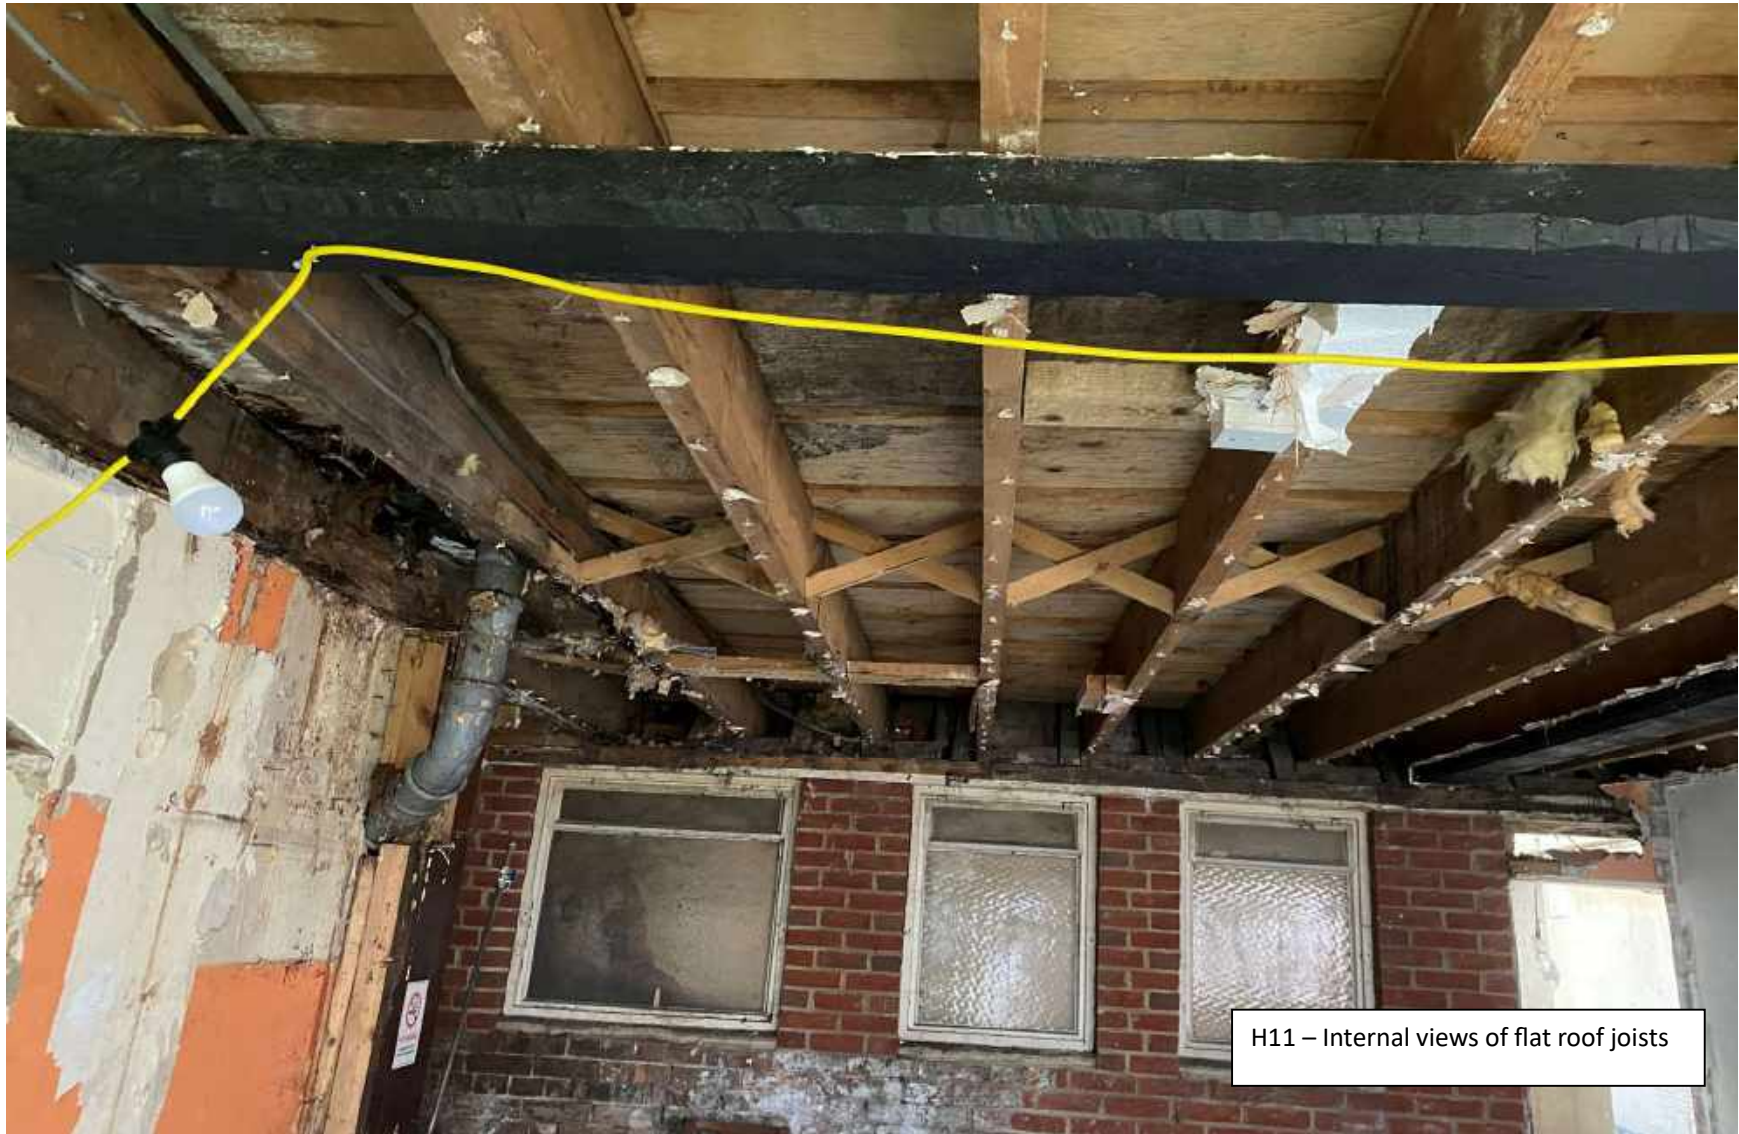
H11 – Internal views of flat roof joists
