## Peregrine Bryant Architects

### Further opening-up works required to Ramsbury Manor House to Facilitate Repair, Reservicing, and Asbestos Removal (HE-RMI 263: Issue V1: 30.04.26)

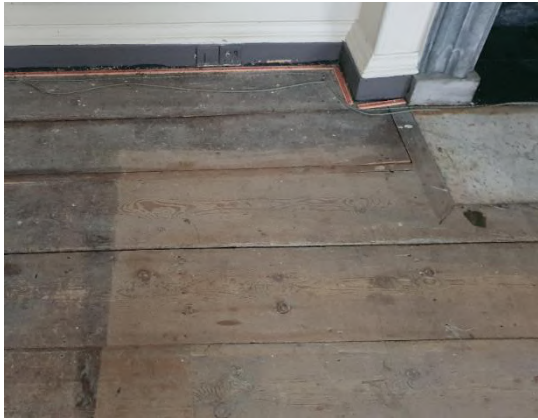
*Figure 82: Timber boards post carpet removal - Mr. Hyams Bedroom FR13*

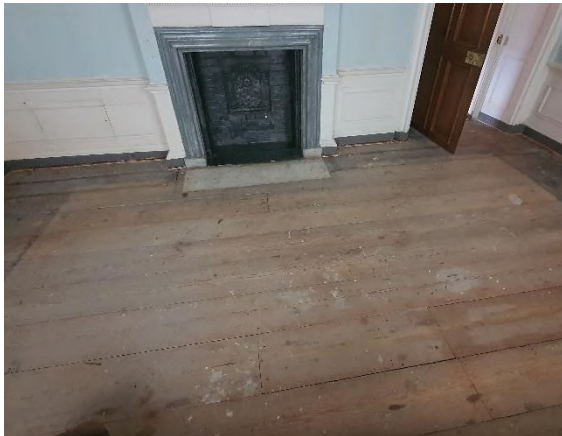
*Figure 84: Timber boards, post carpet removal - Mr. Hyams Bedroom FR13*

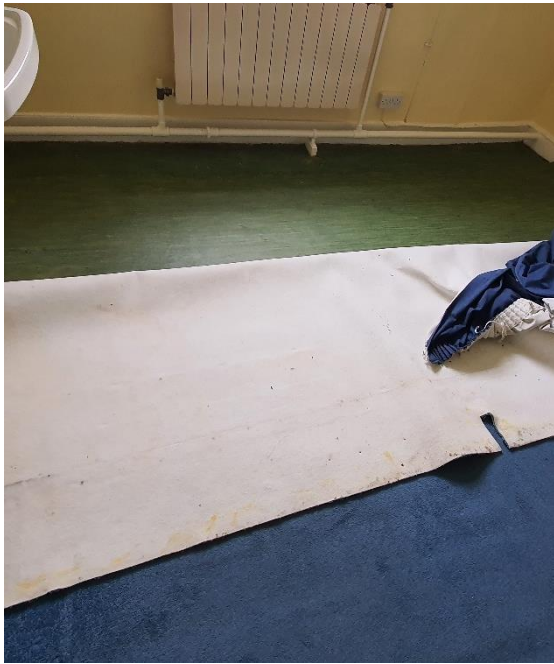
*Figure 10: Vinyl floor under carpet - Staff Sitting Room  
SR02*

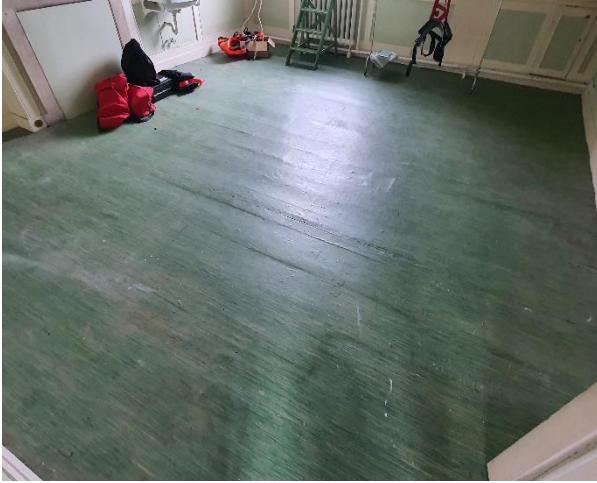
*Figure 15: Vinyl floor - Storeroom SR03*
