# TROWBRIDGE HSBC

Facade Survey

Monday 13 May 2024

Henley Restoration And Remedials Ltd For ISG

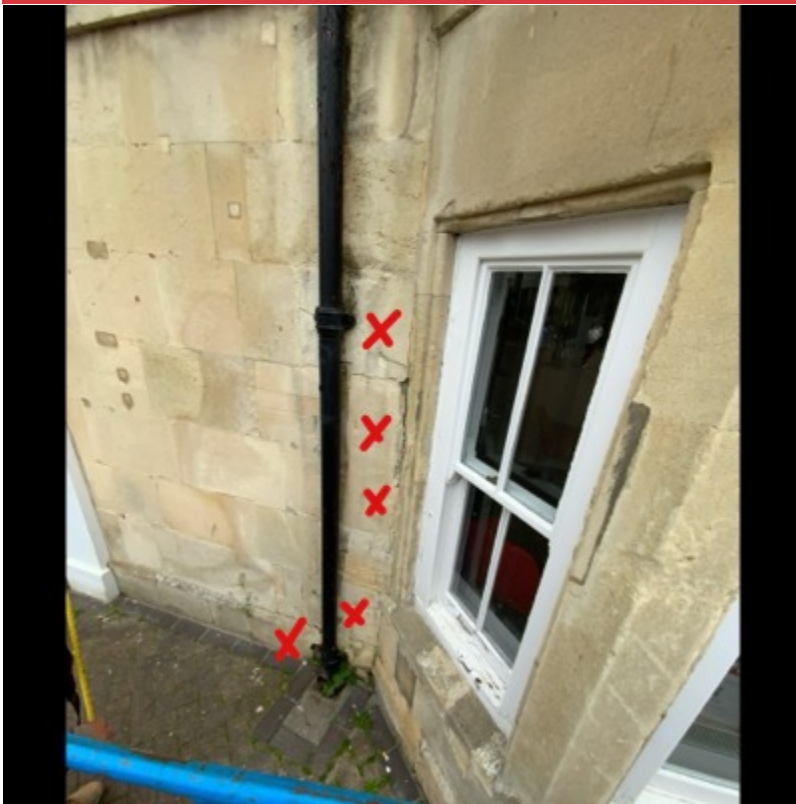
3.8 - Allow to remove fill in fixing holes with colour matched mortar.

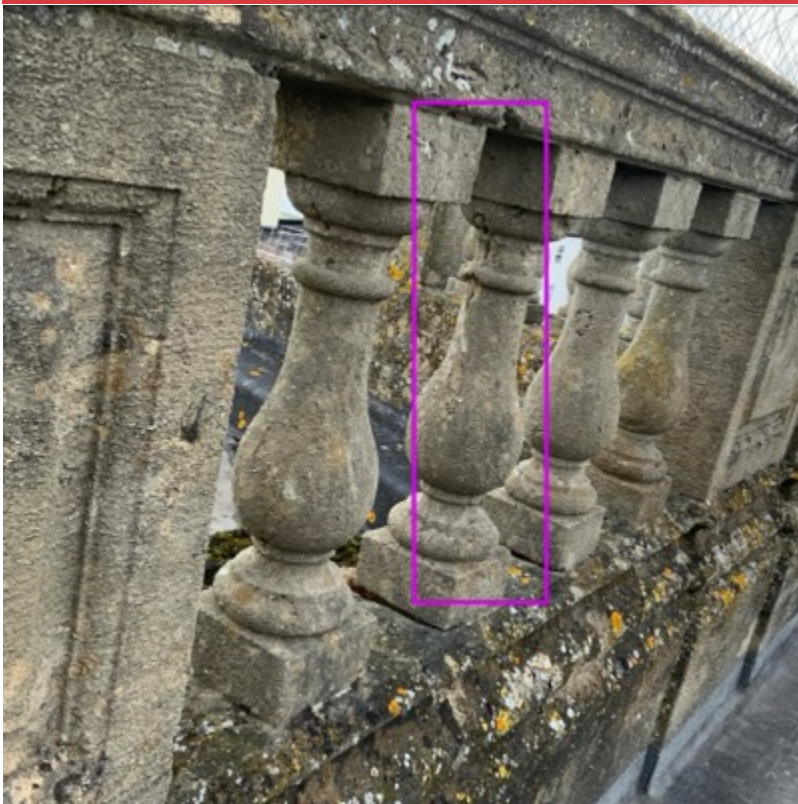
0.3 - Loss of upper corner to balustrade bottle. Looks safe currently.

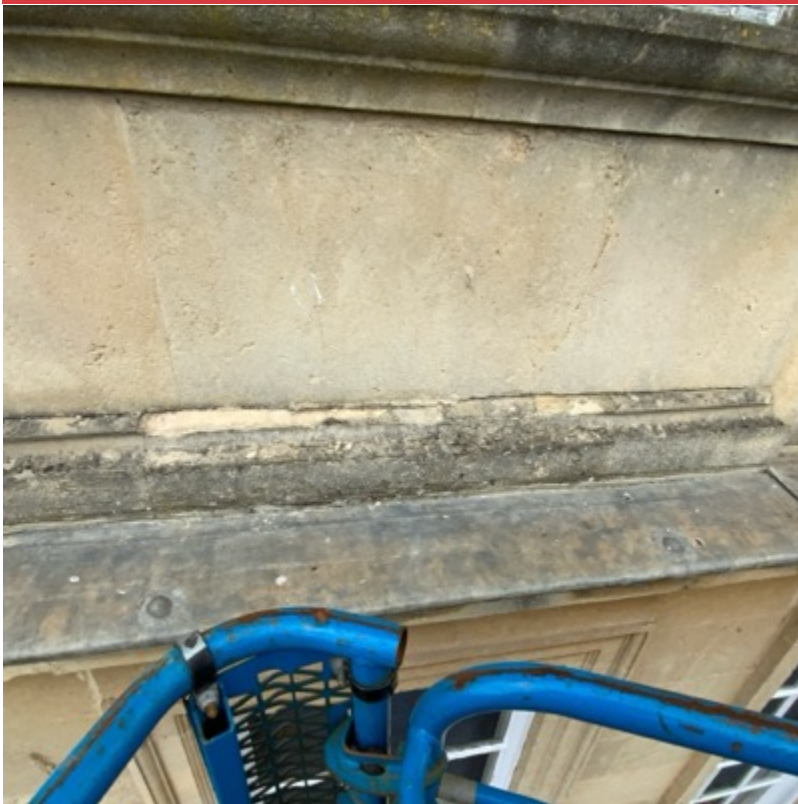
1.3 - Allow to remove and fill previous fixing holes across the facade.

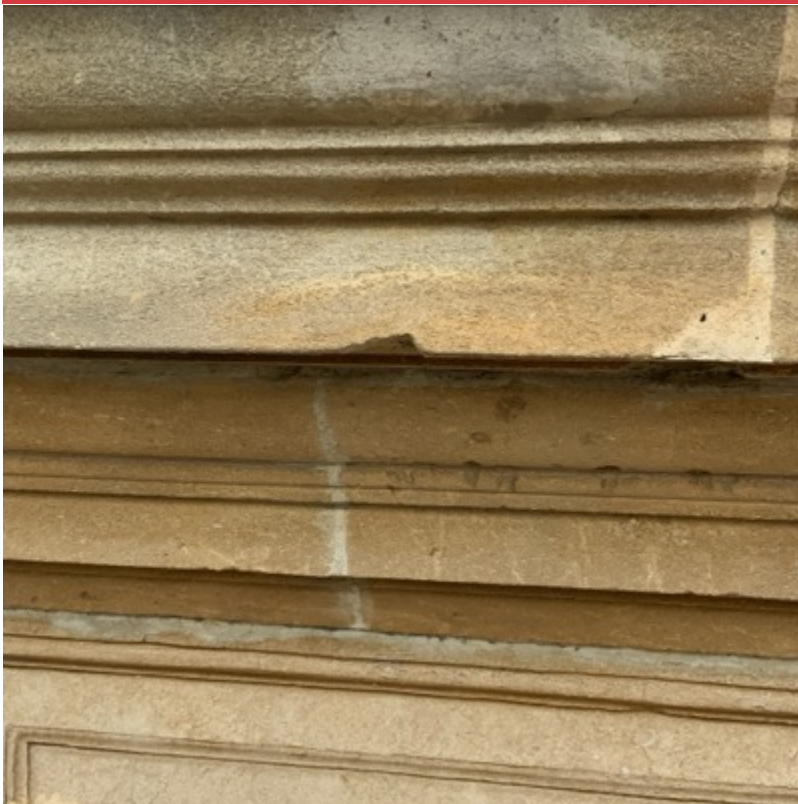
1.5 - Allow to defrass and indent moulded section of cornice. Allow 0.450 x 0.10 x 0.100

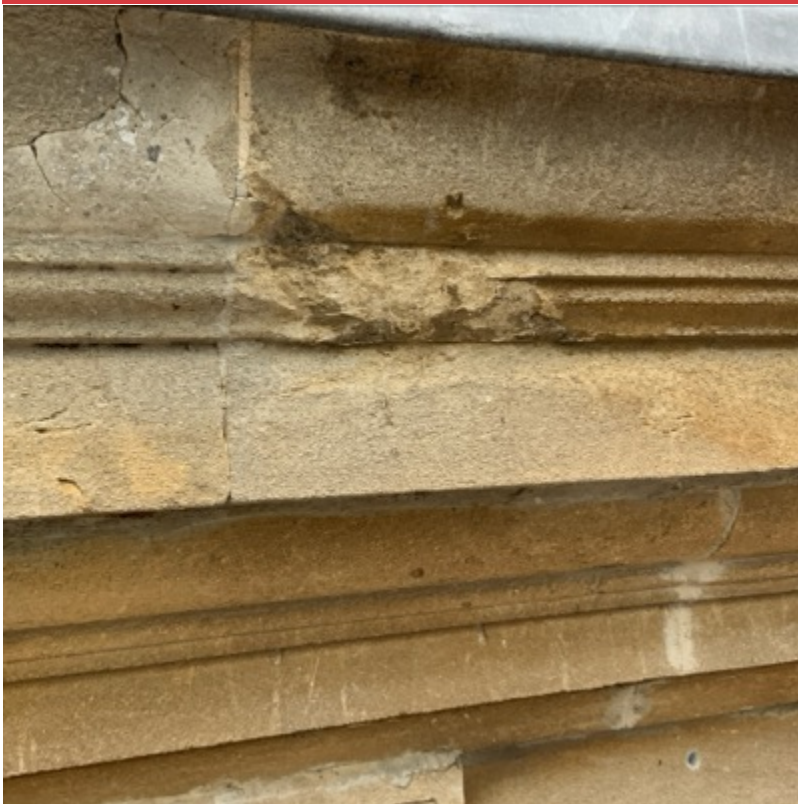
1.7 - Allow to indent frieze drip mould to cornice. Allow 0.100 x 0.050 x 0.100

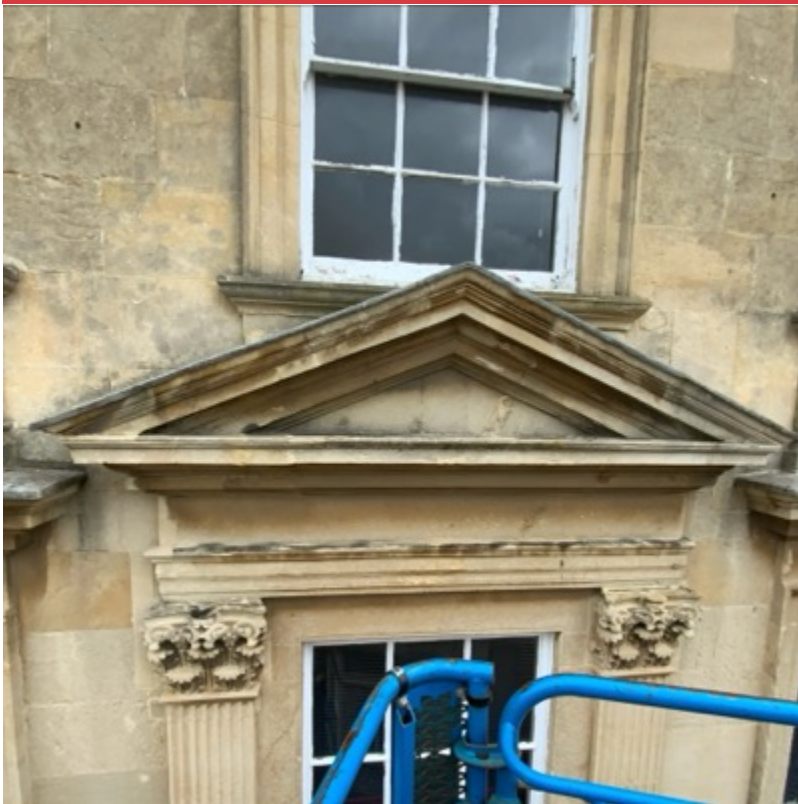
1.9 - Allow to indent frieze drip mould to cornice. Allow 0.100 x 0.050 x 0.100

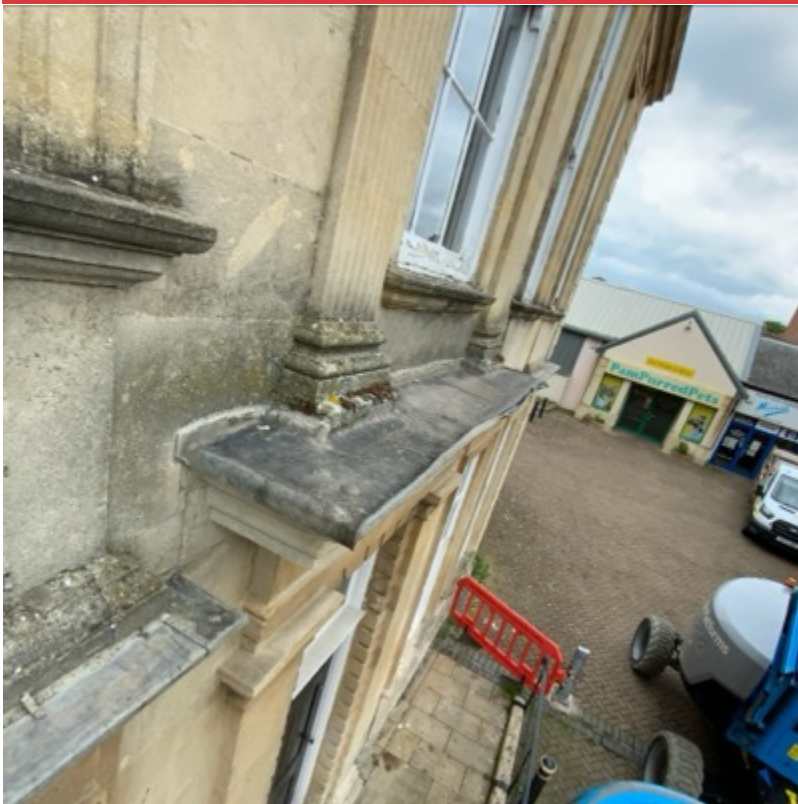
2.2 - Allow to indent frieze drip detail to 2nd floor cornice. Allow 0.230 x 0.050 x 0.075
